**THE CORPORATION OF THE MUNICIPALITY OF MISSISSIPPI MILLS
HERITAGE ADVISORY COMMITTEE AGENDA**

1. Renovations to the St. Paul's Rectory

70 Clyde Ave, Almonte, ON May 22, 2018

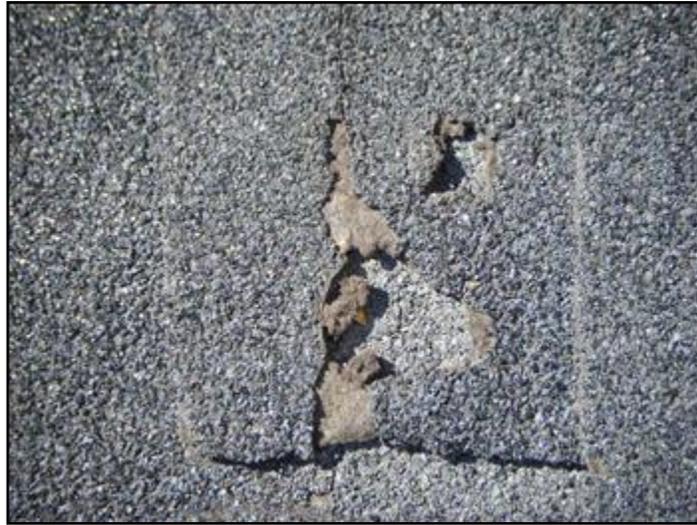
1.

Probability of leakage: • Elevated risk. Sectional Repairs Required

Note: West facing balcony roof is getting pounded by the direct discharge of the valley flashings from the upper main roof. Exposed fasteners and damaged shingles.

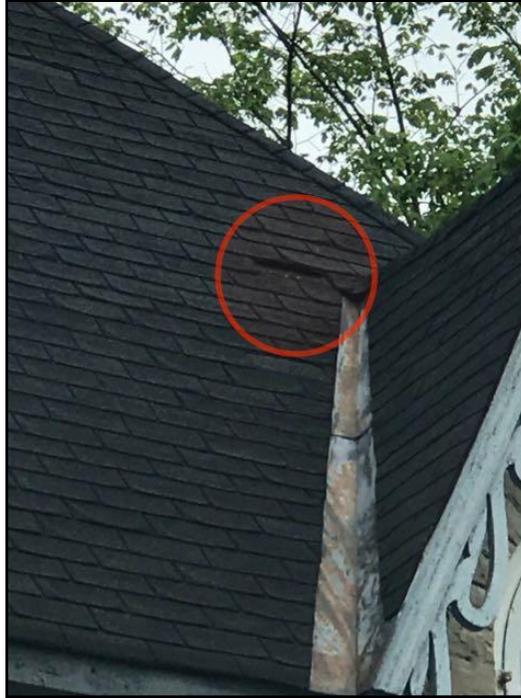
12. Missing, loose or torn

Condition: • [Missing, loose or torn](#)

One torn shingle to be replaced

Implication(s): Chance of water damage to contents, finishes and/or structure

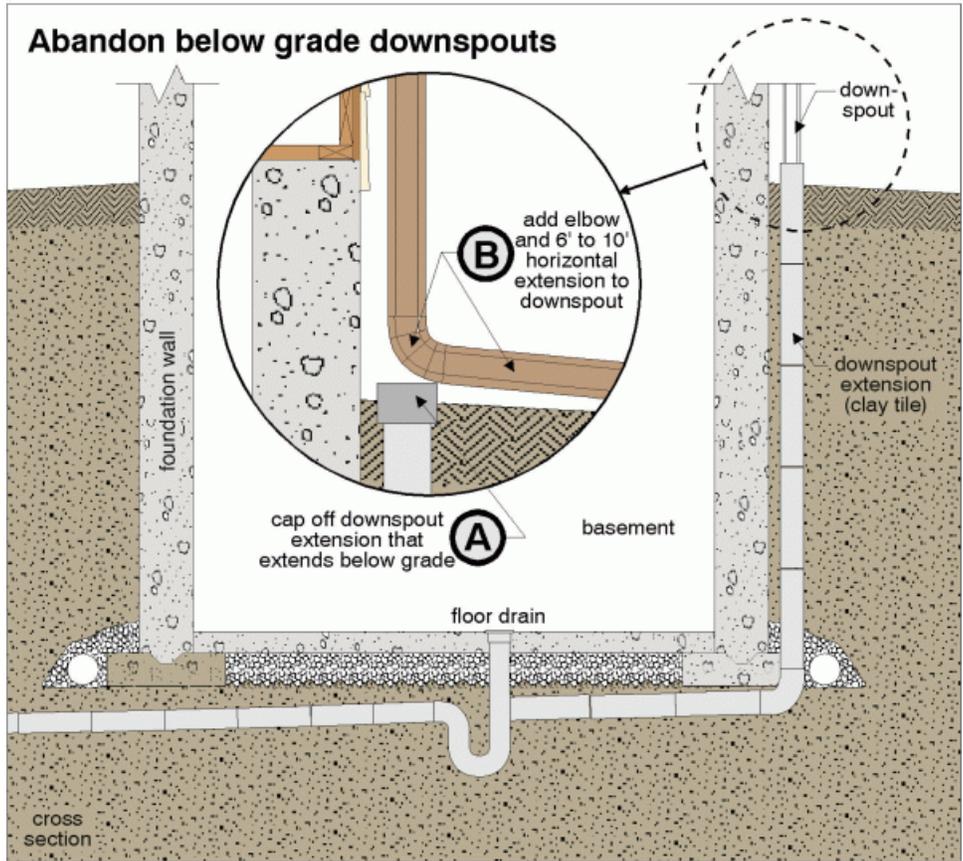
17. Discharge below grade

Condition: • [Discharge below grade](#)

Make sure this discharges away from the house. There is moisture noted on the basement panels. This could be one source.

Implication(s): Chance of water damage to contents, finishes and/or structure

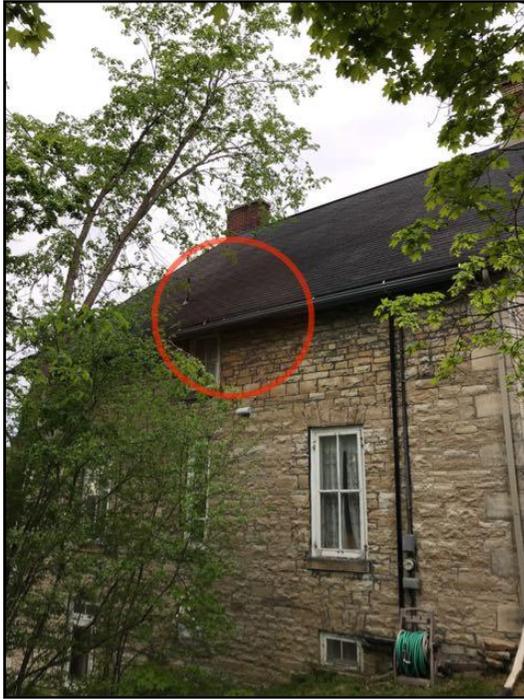
20. Rot or insect damage

Condition: • [Rot or insect damage](#)

Increased rot at the upper west fascia.

Implication(s): Material deterioration | Chance of water damage to contents, finishes and/or structure

Task: Repair or replace

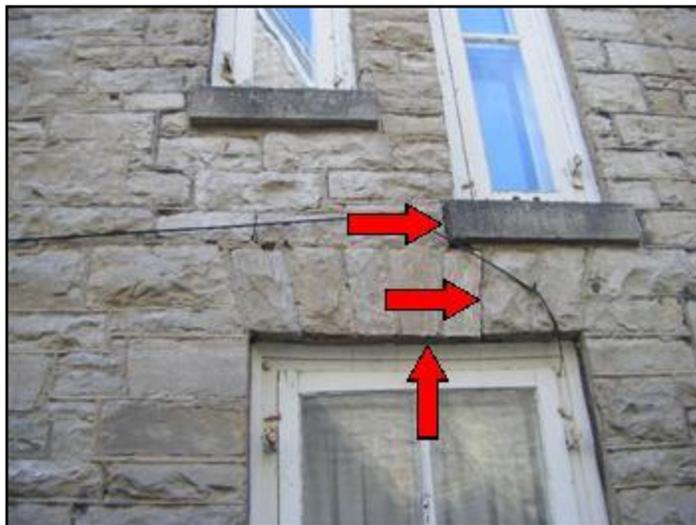
22.

Condition: • Step cracking in stone mortar joints

The mortar is damaged at the base of the upper window sill and the stones have dropped creating a sag in the lintel of the lower window. Reset the stone lintel and repoint the mortar to eliminate the strain on the wooden window frame.

Task: Repair

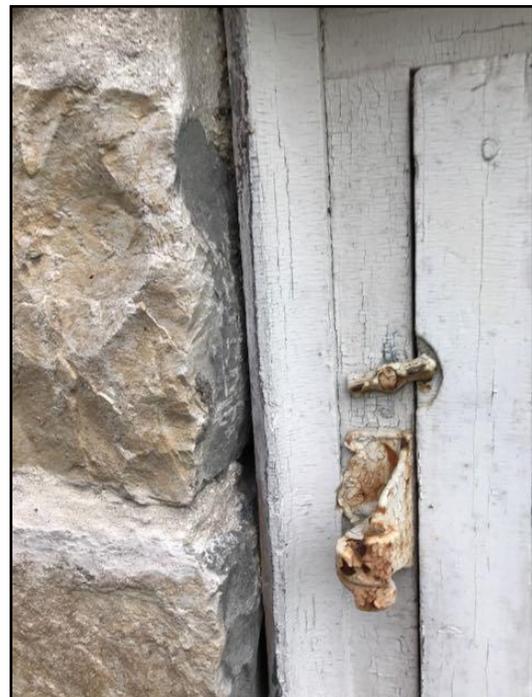
34. Caulking loose, missing or deteriorated

Condition: • [Caulking loose, missing or deteriorated](#)

Most of the windows and doors are suffering from loose and falling mortar where the frame meets the stone. Apply exterior caulking to these seams for a longer lasting weather proofing seal.

Implication(s): Increased heating and cooling costs | Chance of water damage to contents, finishes and/or structure

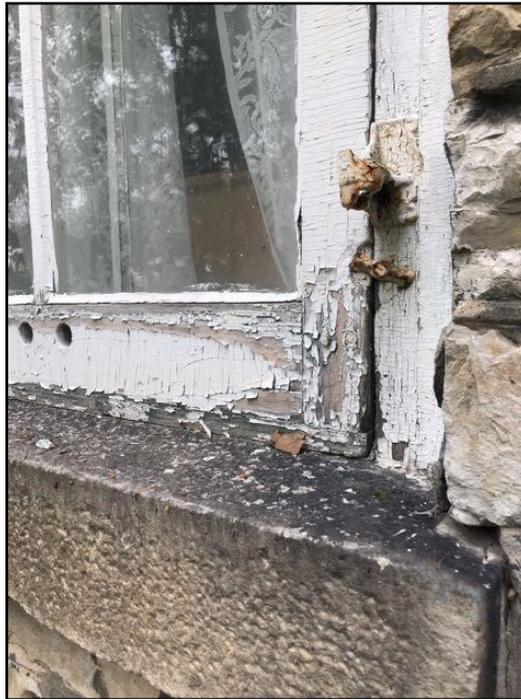
35. Paint or stain needed

Condition: • [Paint or stain needed](#)

Implication(s): Material deterioration | Chance of water damage to contents, finishes and/or structure

Task: Repair

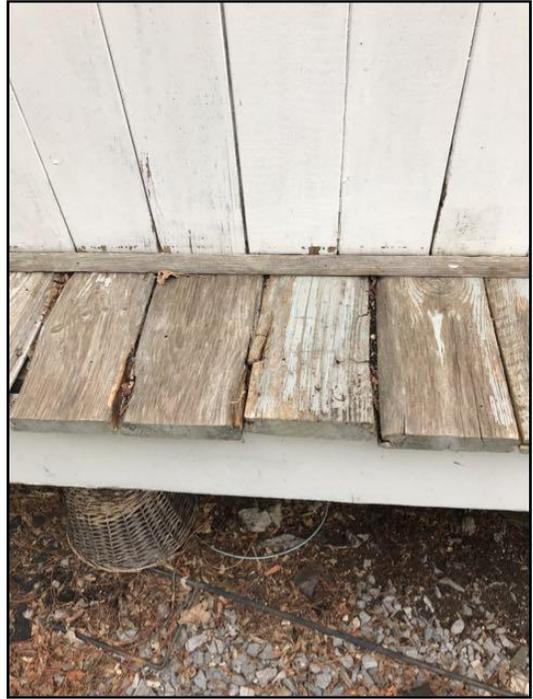
39. Sections noted with wood rot. Remove and...

Condition: • Sections noted with wood rot. Remove and replace damaged sections.

Task: Replace

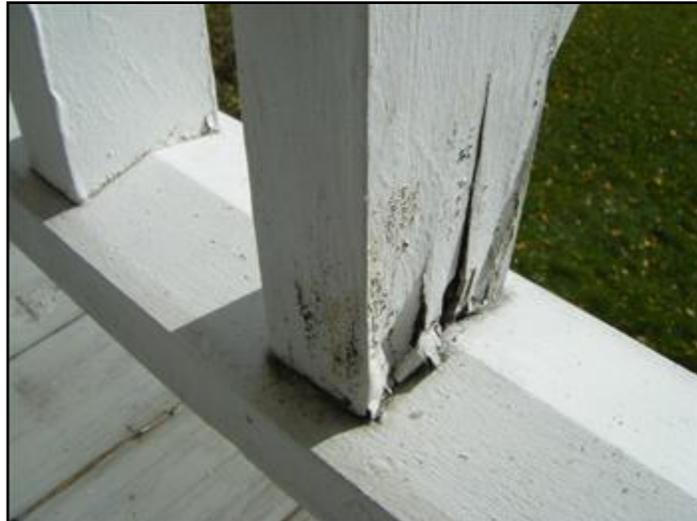
41.

Condition: • Wood rot at spindles. Replace all damaged pieces

Location: West Exterior

Task: Replace
Time: Immediate

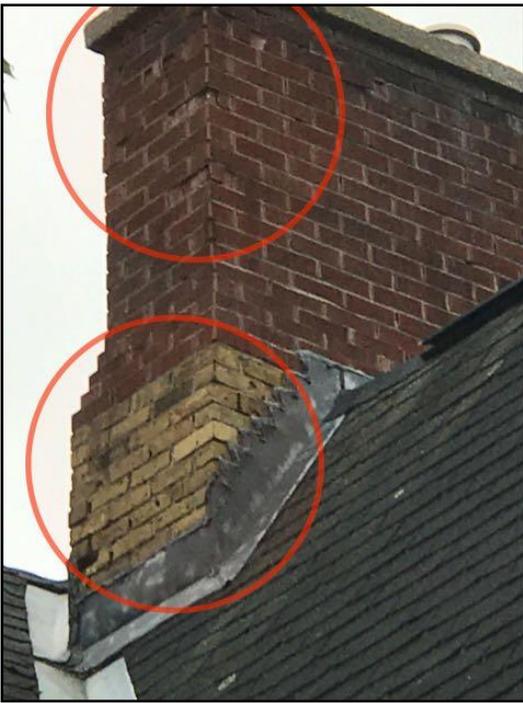
62. Loose, missing or deteriorated mortar

Condition: • [Loose, missing or deteriorated mortar](#)

Loose brick and mortar at the masonry chimney. repair this condition before bricks start to fall off the roof.

Implication(s): Material deterioration

Task: Repair

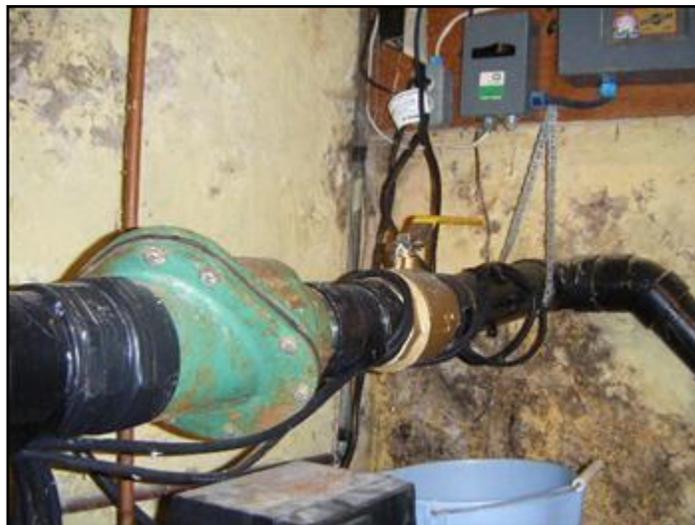
70.

- Cast Iron Piping: Budget to replace cast iron drains in house. These are prone to rusting from the inside leading to breakage and sewer discharge into the house. Vertical stacks are less risk but this is a horizontal line by the basement stairs.

Task: Replace

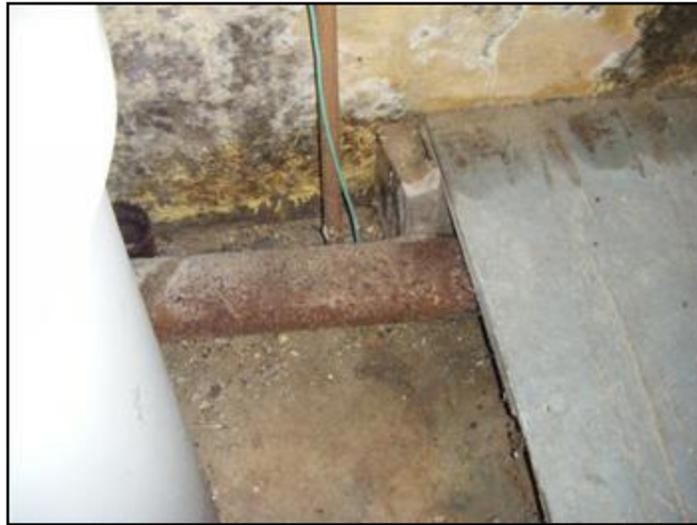
71.

- Galvanized Water Supply Lines
- Replace small section of galvanized water pipe and install a Frost Free Hose spigot
- Implication(s):** Split and leak
- Location:** Exterior Wall
- Task:** Replace
- Cost:** \$200

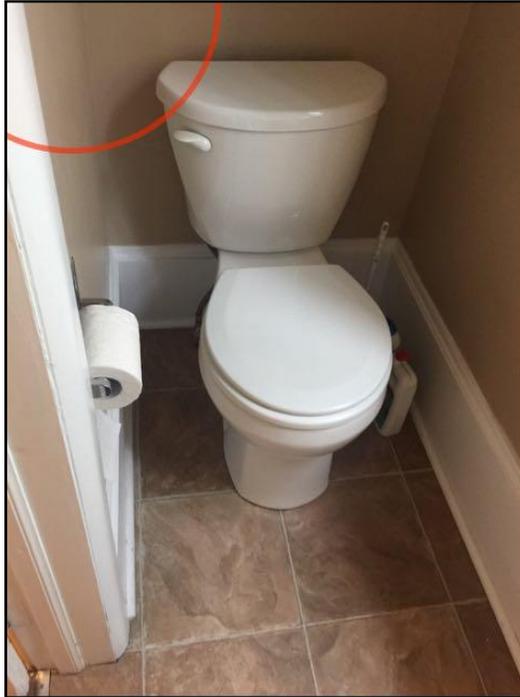
79. Replace wax ring and secure toilet to the...

Condition: • Replace wax ring and secure toilet to the floor

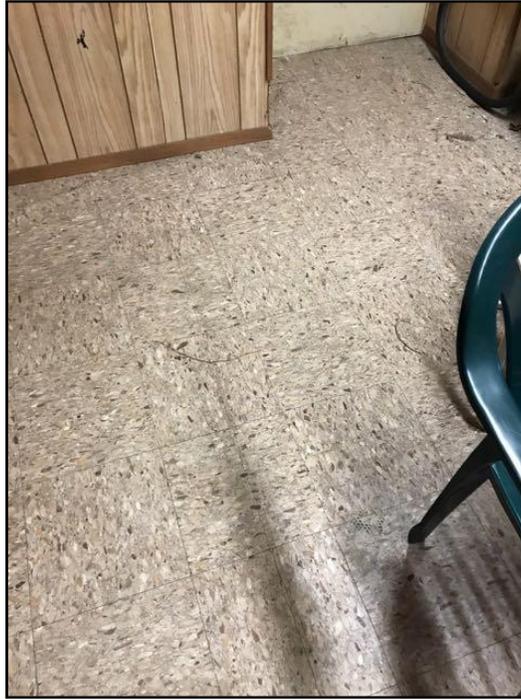
92. Older floor tiles may contain asbestos....

Condition: • Older floor tiles may contain asbestos. Seek a professional flooring company for advice on how to seal and cover (or remove) if floor upgrades are desired.
