Phase I Environmental Site Assessment

5 & 6 Frank Davis Street
Almonte, Ontario

Report: PE6477-1
March 12, 2024

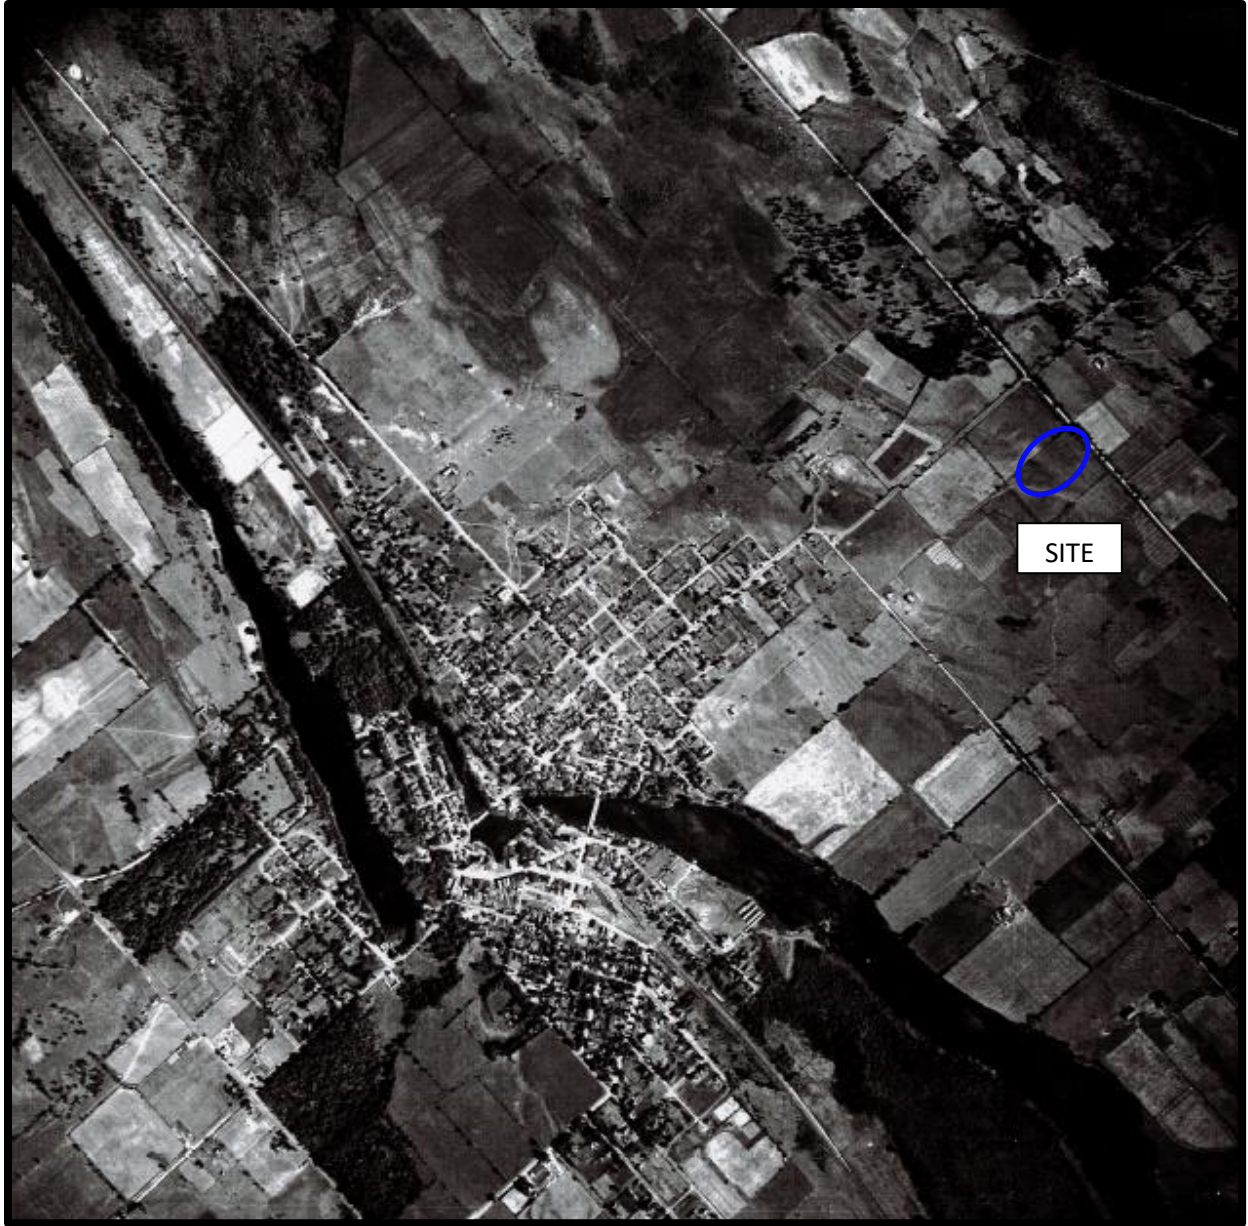
AERIAL PHOTOGRAPH
1946

- 1946 The subject site and surrounding properties appear to be vacant or used for agricultural purposes.
- 1978 No significant changes are apparent with respect to the subject site or the neighbouring lands.

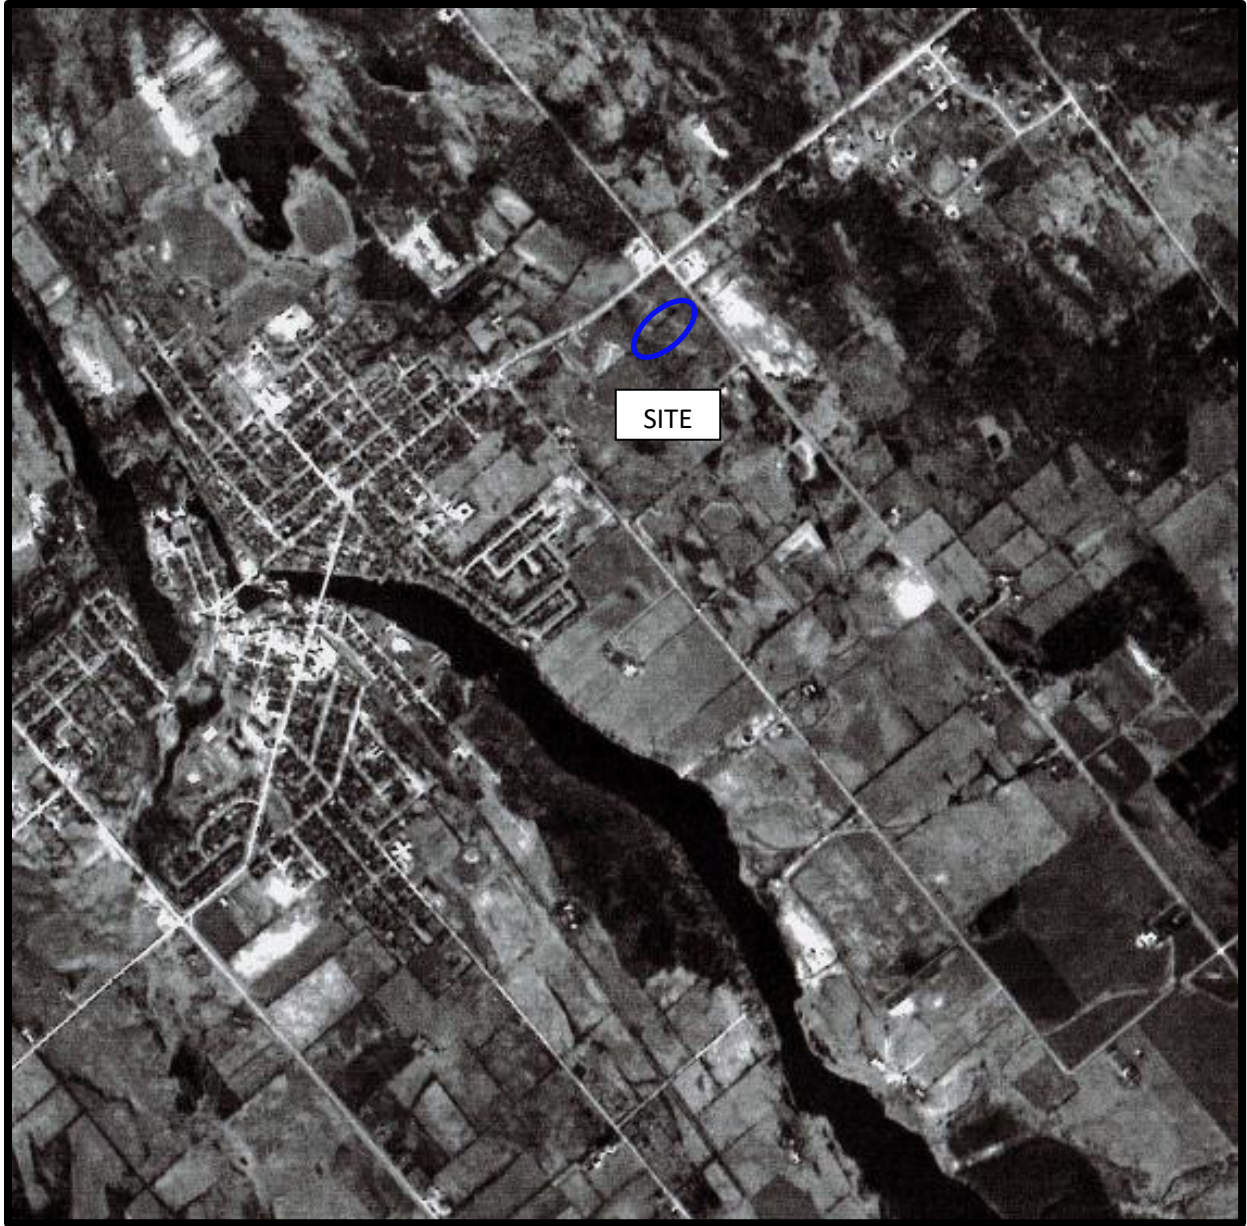
AERIAL PHOTOGRAPH
1988

- 1988 No significant changes are apparent with respect to the subject site. To the east of the subject site, the beginning of Industrial Drive is visible. A commercial building has been developed to the north of the subject site, along Ottawa Street. No other significant changes to the neighbouring lands are apparent.

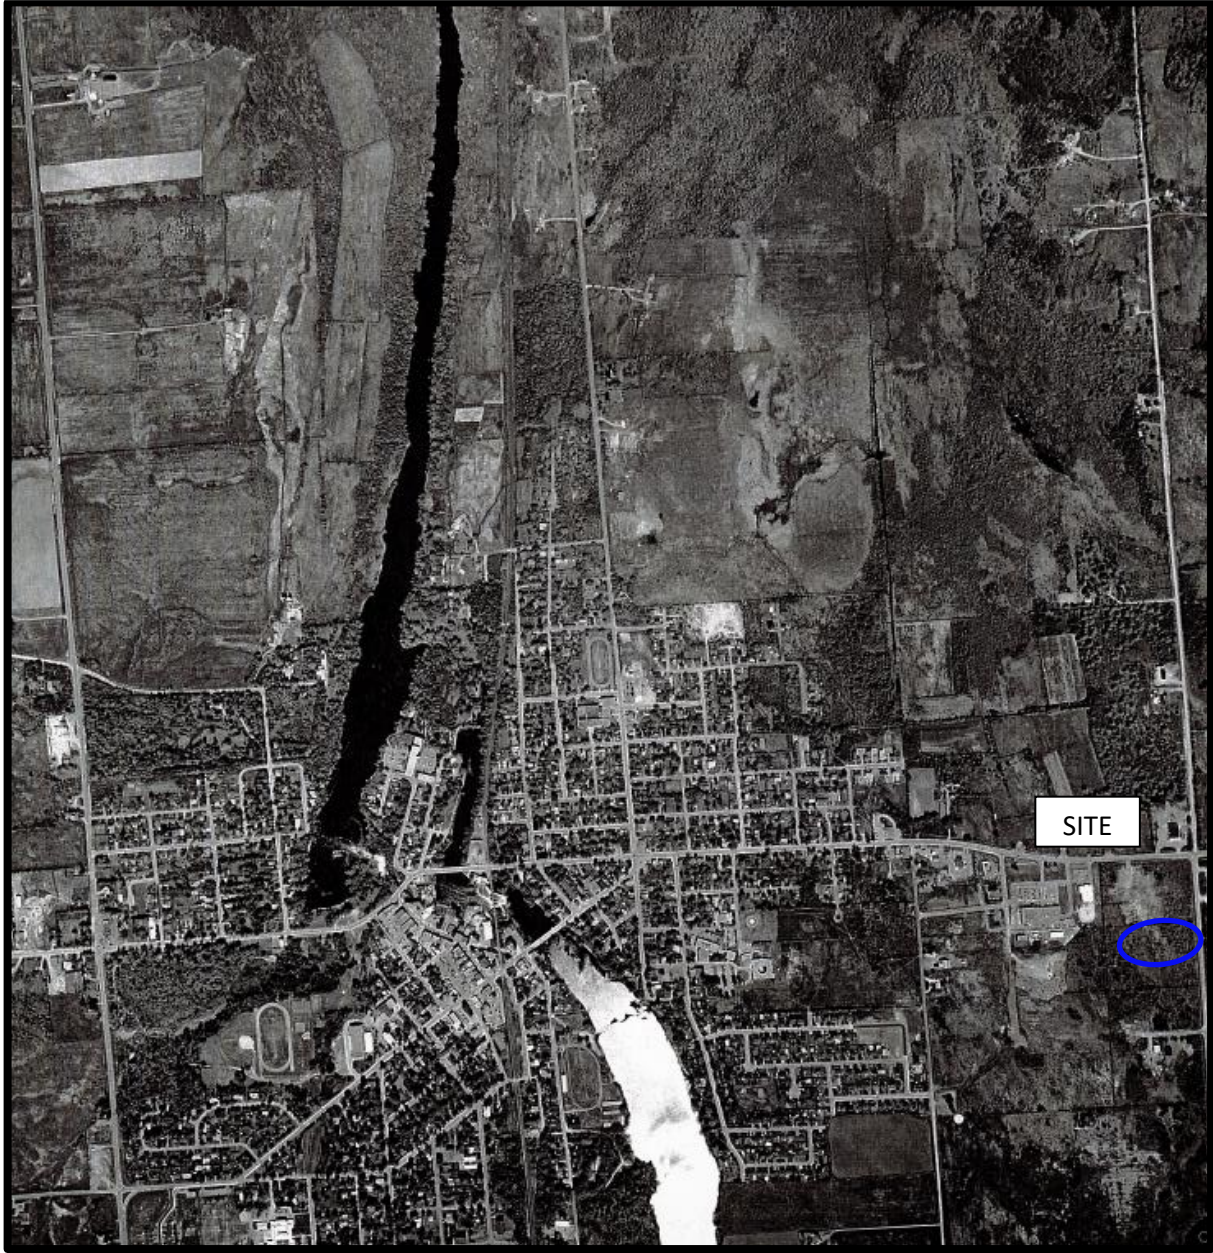
AERIAL PHOTOGRAPH
1996

- 1996 No significant changes are apparent with respect to the subject site. Part of Industrial Drive has been constructed to the southwest. No other significant changes to neighbouring land are apparent.

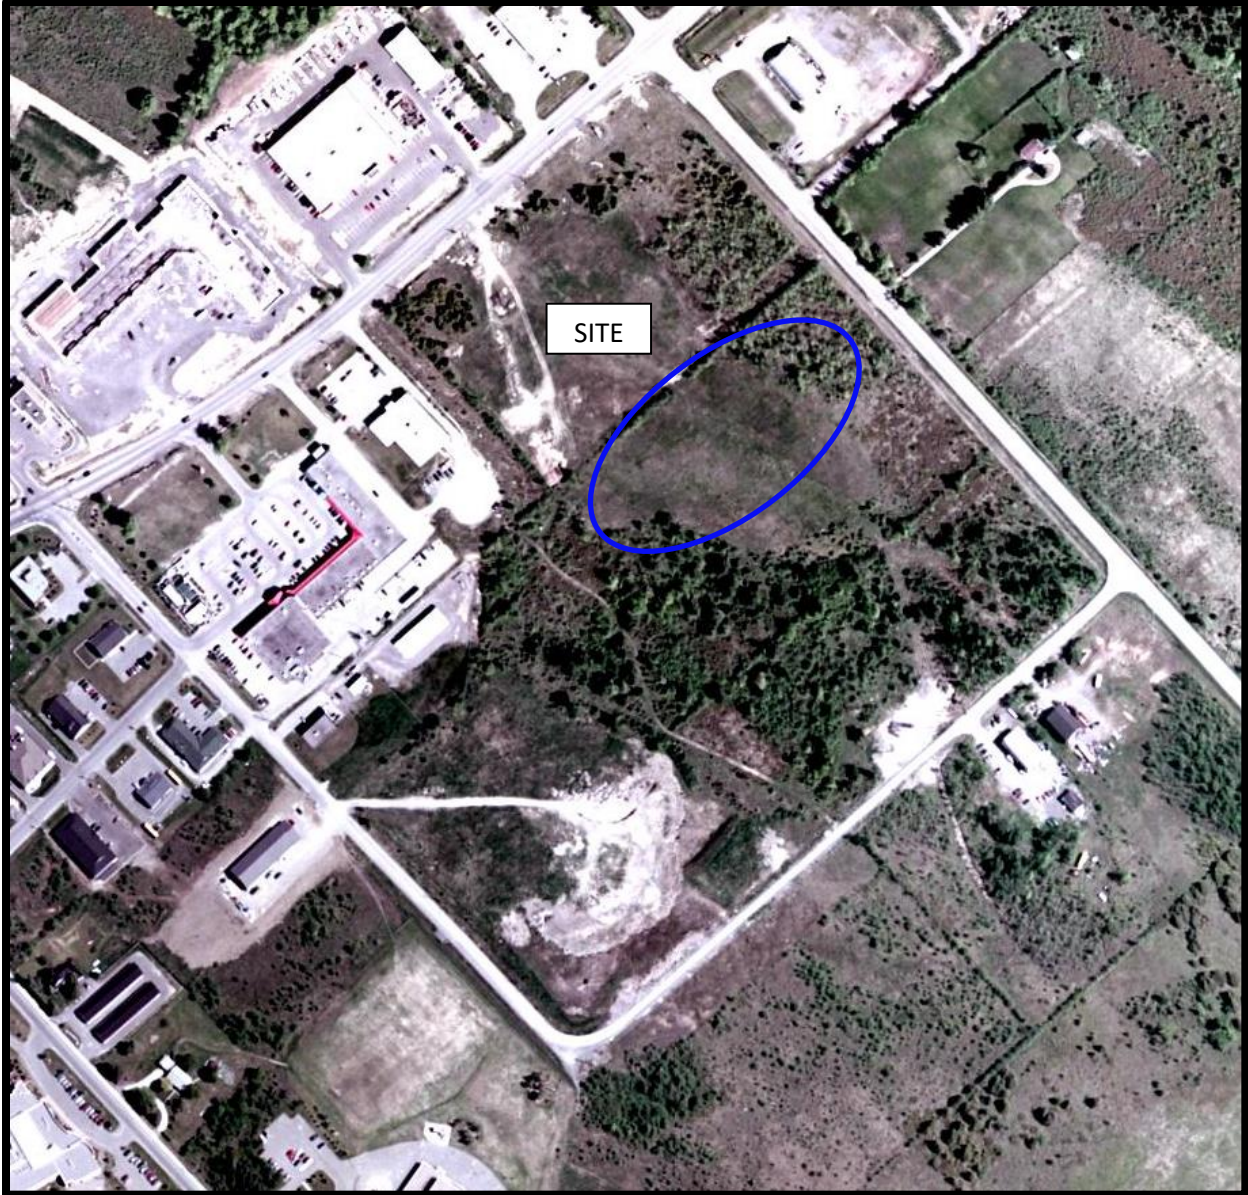
AERIAL PHOTOGRAPH
2005

- 2005 The subject site appears to be a vacant field with some trees in the northeastern corner. No significant changes are apparent with respect to the subject site. Additional commercial buildings can be seen to the north-west of the subject property. Industrial Drive appears in its current configuration.

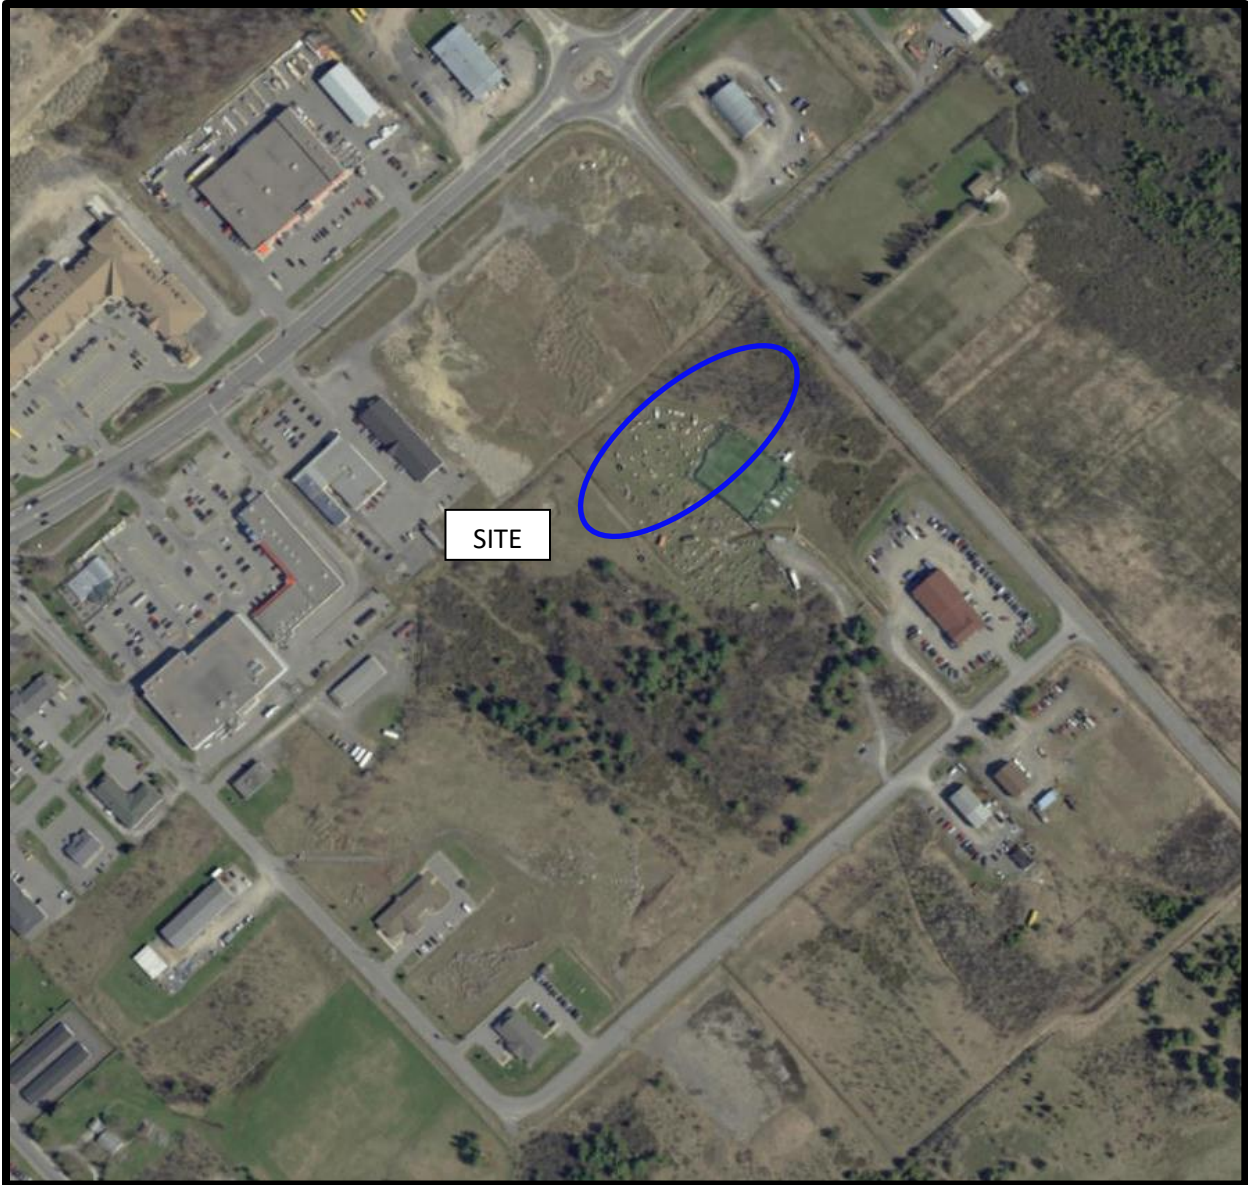
AERIAL PHOTOGRAPH
2014

- 2014 numerous items are visible distributed across the subject site. These objects are also present to the south of the subject site and are part of a paintball course that operated at that time. No other significant changes are apparent to the subject site. Several additional commercial buildings are visible to the north, southeast and west of the subject site.

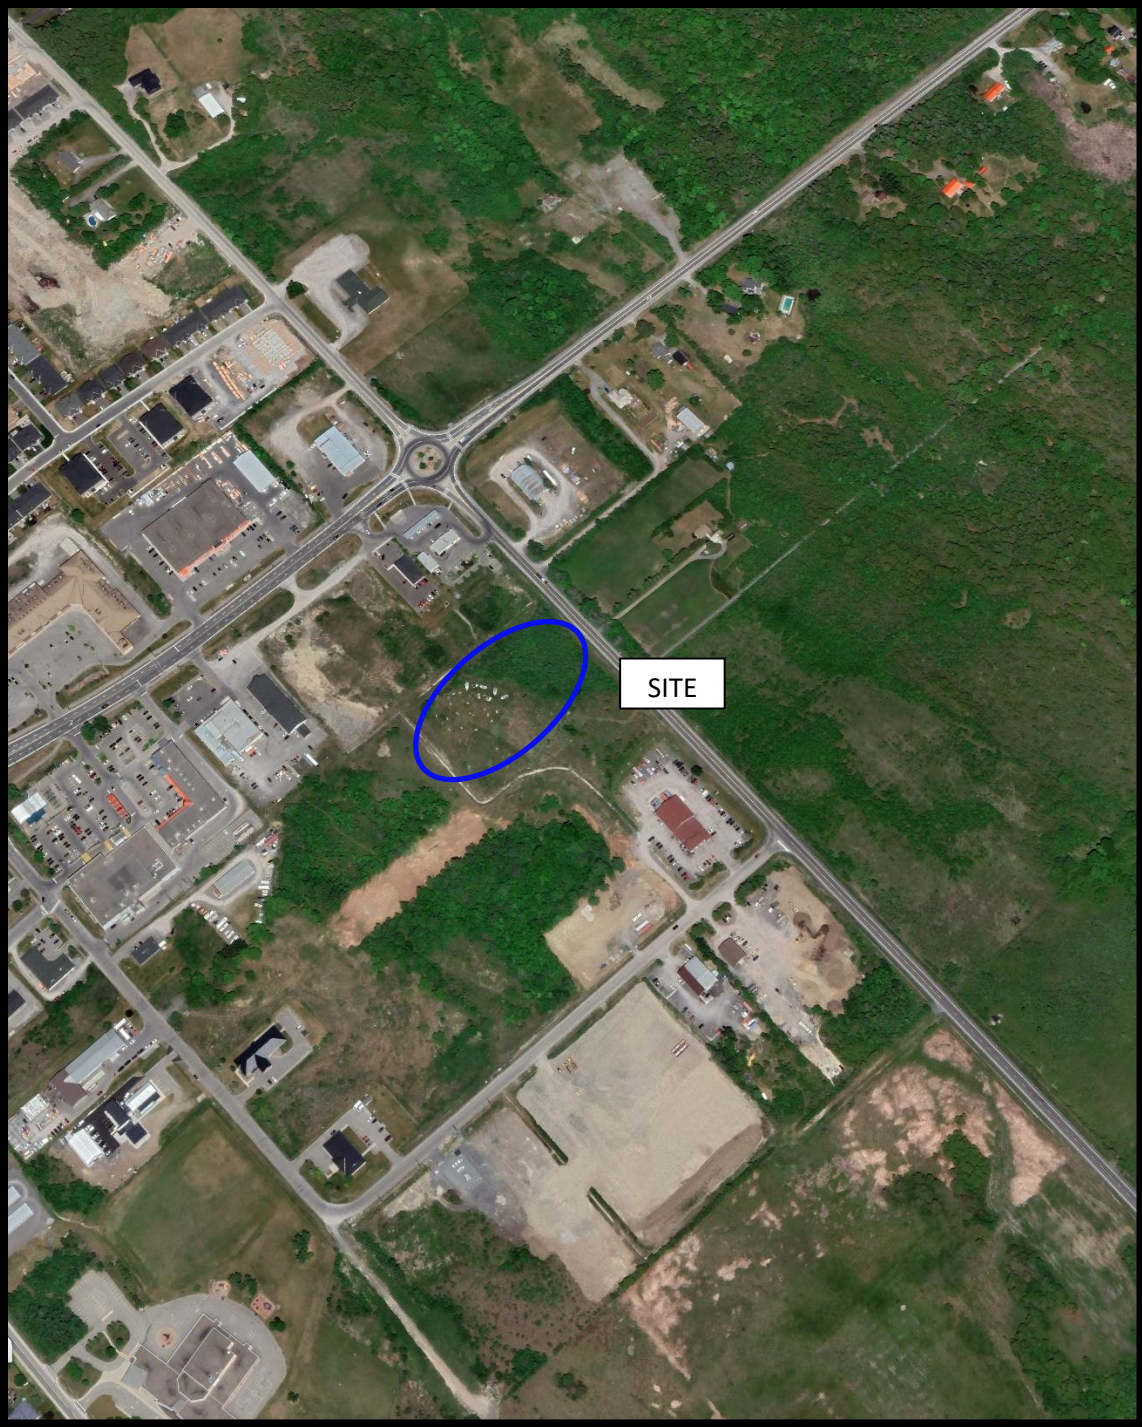
AERIAL PHOTOGRAPH
2021

- 2021 No significant changes are apparent to the subject site at this time. A retail fuel outlet (RFO) is visible to the north, additional commercial buildings are visible to the north and west of the subject site.
