REPORT ON PHASE ONE ENVIRONMENTAL SITE ASSESSMENT 430 OTTAWA STREET, ALMONTE, ONTARIO

REPORT NO.: 5559-21-EA REPORT DATE: MARCH 24, 2021

PREPARED FOR 2241497 ONTARIO LIMITED

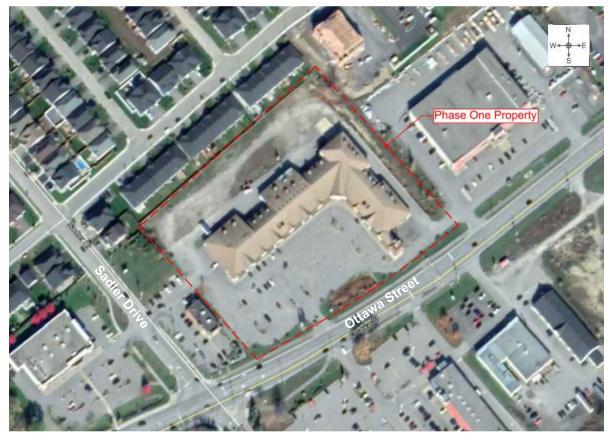
The layout of the Site is shown on Image 1, below.

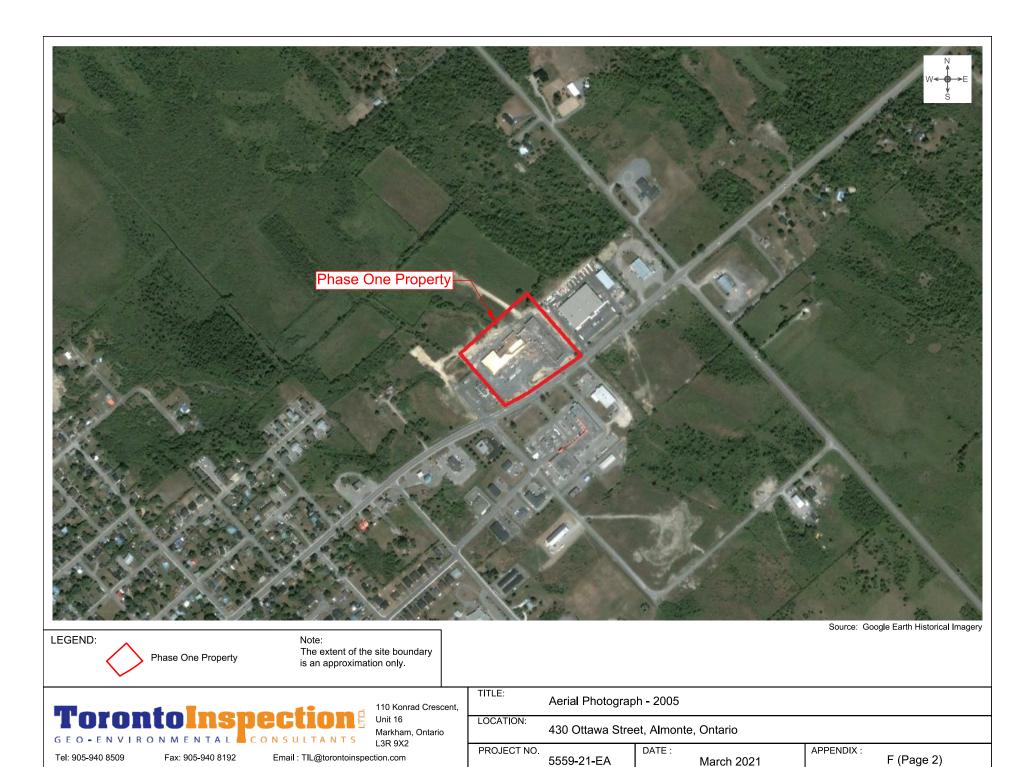
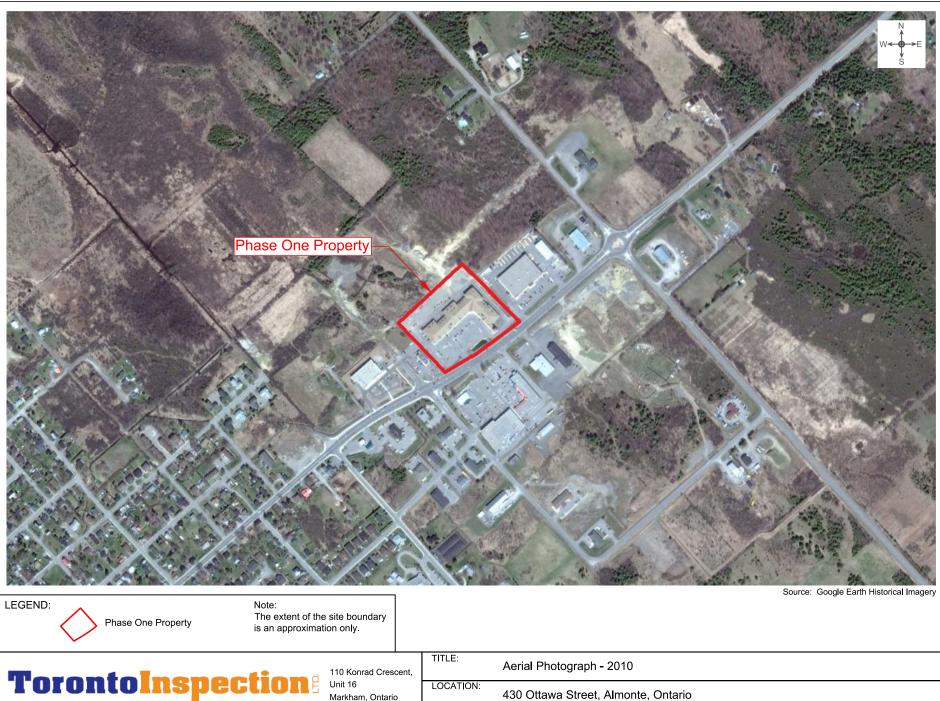
Appendix F Aerial Photographs

Year	Notable Changes or Environmental Issues
1954	 The Study Area appeared to be vacant land. Notable developments were Ottawa Street to the south and Appleton Side Road to the southwest. No evidence of development was observed for the Site.
2005	 The Site appeared to be developing with a commercial building similar to the existing structure with a parking lot on the south side of the property and a driveway along the east and north site boundaries.
	- The surrounding properties to the east, south and west appears to be developed as commercial buildings similar to the existing structures with parking areas and driveways surrounding the buildings. The surrounding area to the north remained as vacant land.

According to the1954 aerial photograph the Phase One Property was part of agricultural fields and no evidence of development was observed on Site. Reportedly, the Subject Building was developed in the mid-2000s to be used for commercial purposes.

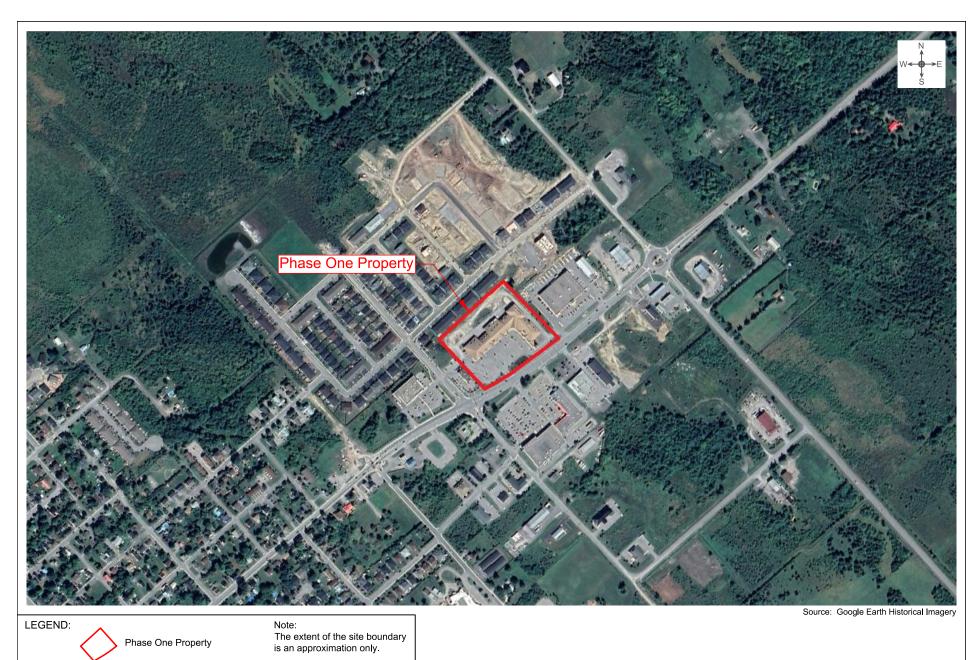
Year	Notable Changes or Environmental Issues	
2010	- No major changes were observed for the Site.	
	- The neighbouring property to the east appeared to be developed with commercial building similar to the existing structure with a parking area and driveways on the south side of the property. The parking area for the property the south was expanded and a commercial building was developed southeast of the Site. No additional major changes were observed for the Study Area.	
2018	- No major changes were observed for the Site.	
	- The surrounding areas to the north were developing with new road and residential subdivisions. No additional major changes were observed for the Study area.	
2019	- No major changes were observed for the Site and Study Area.

•								
			110 Konrad Cresce	TITLE: nt,	Aerial Photograp	h - 2018		
Toron		Dection E	Unit 16 Markham, Ontario L3R 9X2	LOCATION:	430 Ottawa Stree	et, Almonte, Ontario		
Tel: 905-940 8509	Fax: 905-940 8192	Email : TIL@torontoinspe		PROJECT NO.	5559-21-EA	DATE : March 2021	APPENDIX :	F (Page 4)

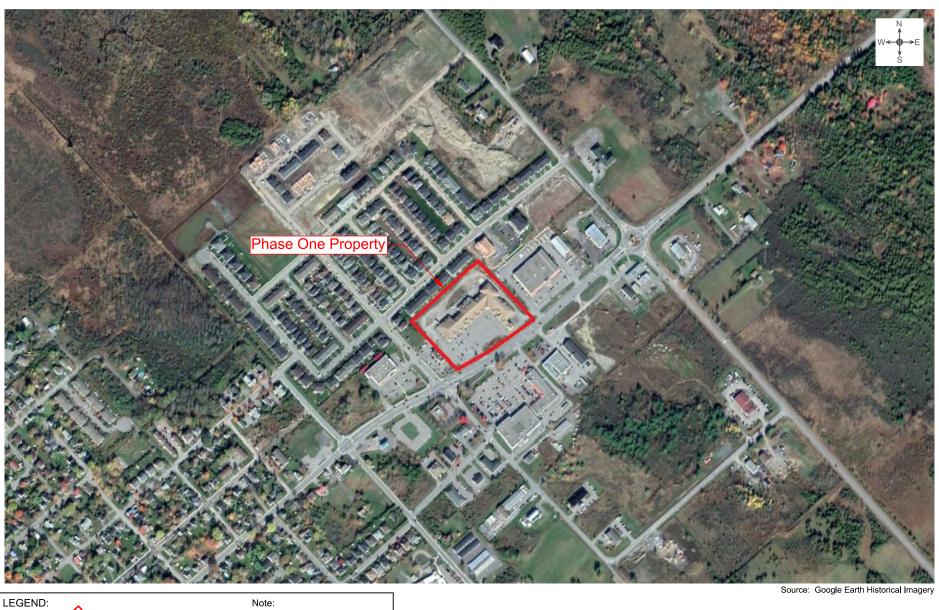
TITLE: Aerial Photograph - 2019				
Torontoinspection In the kontral cleacent, Unit 16 GEO-ENVIRONMENTAL CONSULTANTS	LOCATION: 430 Ottawa Street, Almonte, Ontario			
LJR JAZ	PENDIX : F (Page 5)
