re: Slope Stability Assessment
Proposed Residential Development
122 Old Mill Lane – Appleton, Ontario

file: PG6241-MEMO.01 Revision 1

**GEOTECHNICAL INVESTIGATION
PROPOSED RESIDENTIAL SUBDIVISION
122 OLD MILL LANE**

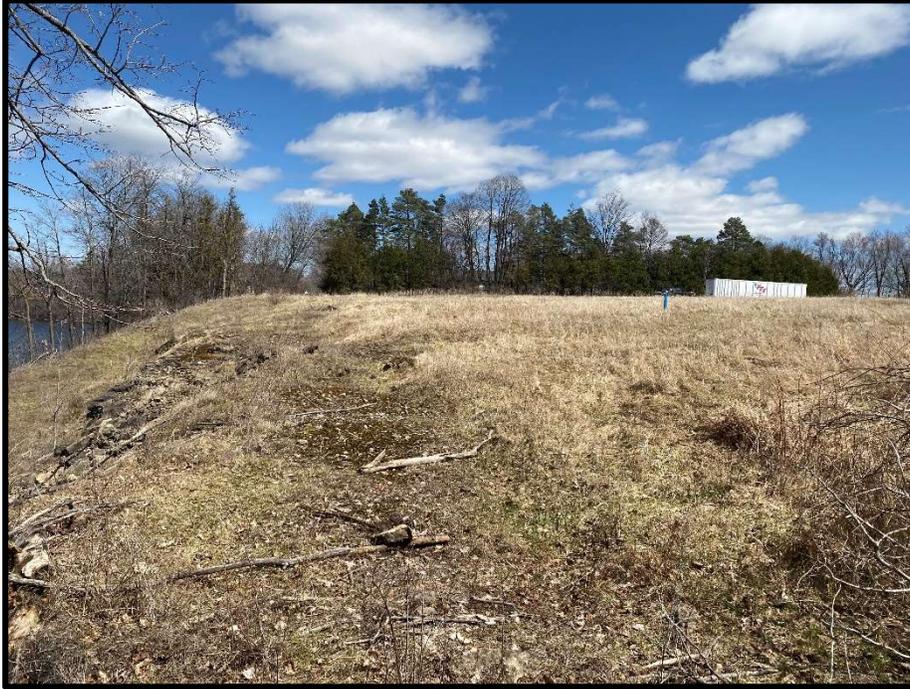
Photo 1: Photograph of area taken from top of slope looking to the east. Slope observed to be heavily covered with vegetation.

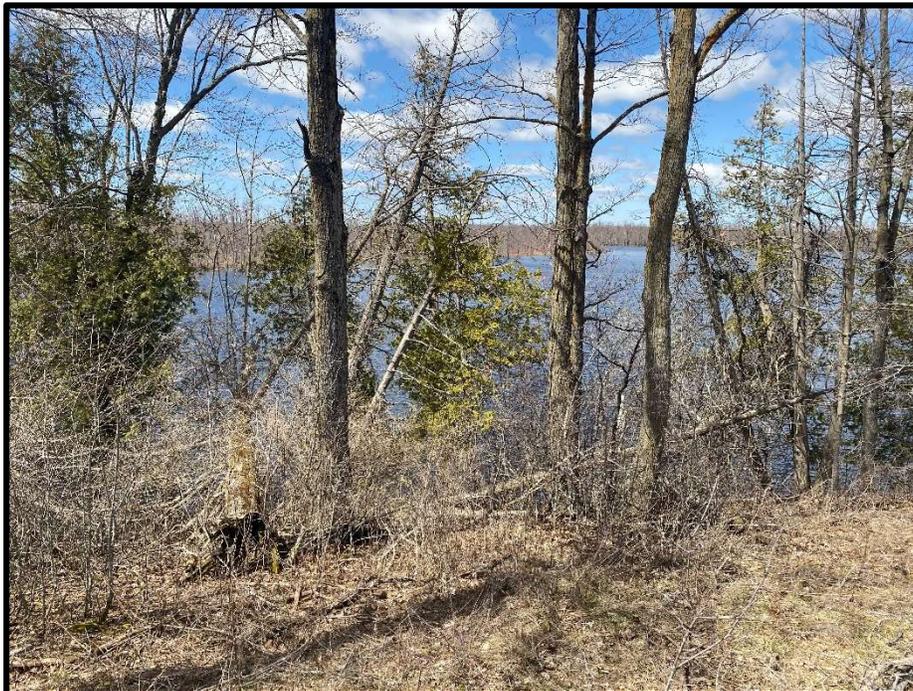
Photo 2: Photograph taken from top of slope looking to the north. Area of slope observed to be generally covered with mature vegetation such as bush, trees and grass. No signs of active erosion observed.

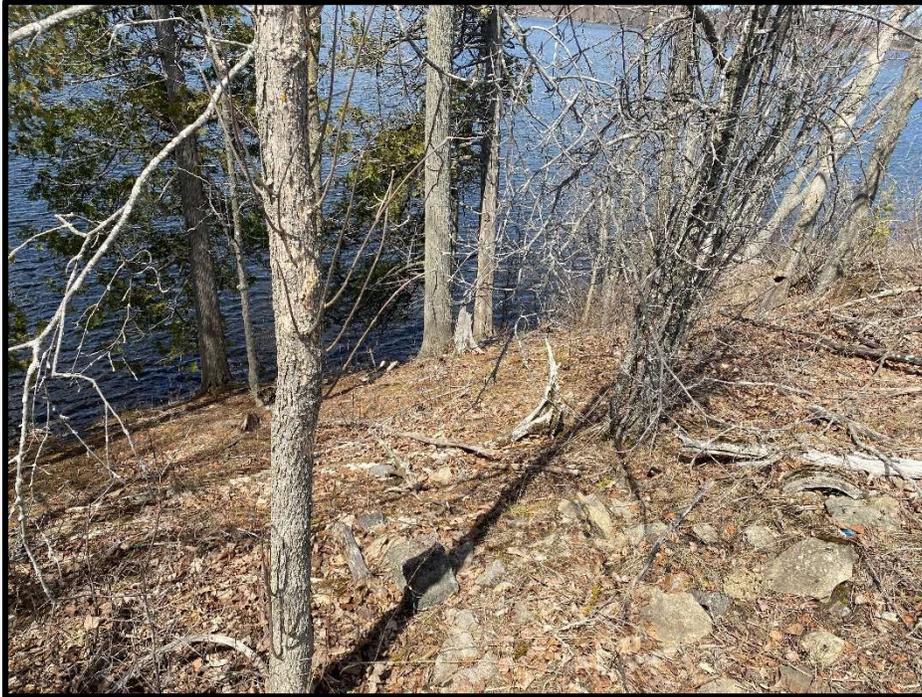
Photo 3: Photo of face of slope taken from top of slope. Face of slope observed to be generally covered with vegetation and no signs of active erosion.

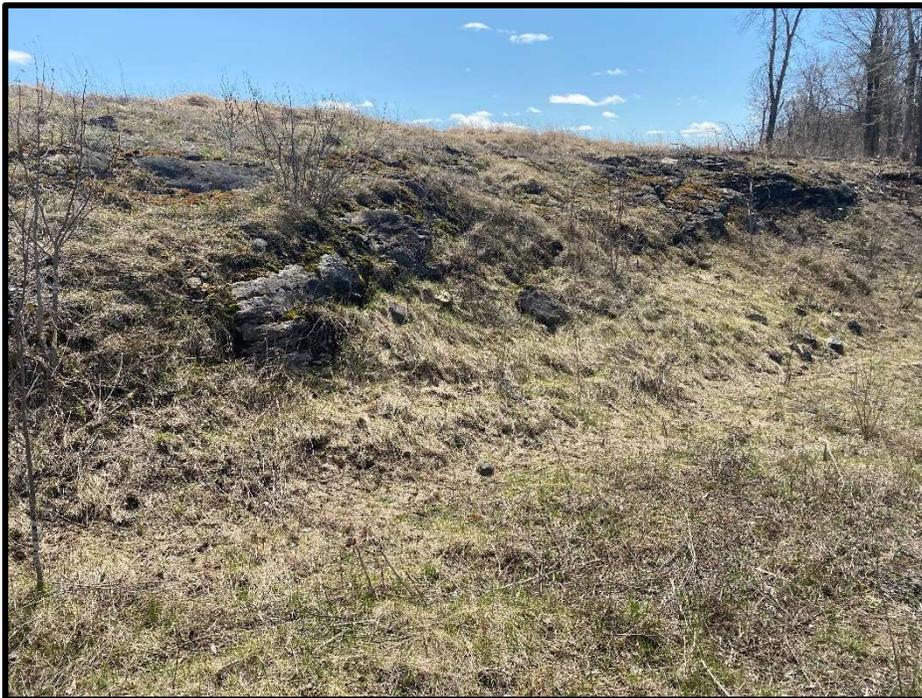
Photo 4: Photo of face of slope taken from toe of slope. Vegetation observed to be established throughout the surface. Subject site throughout left portion of photograph.

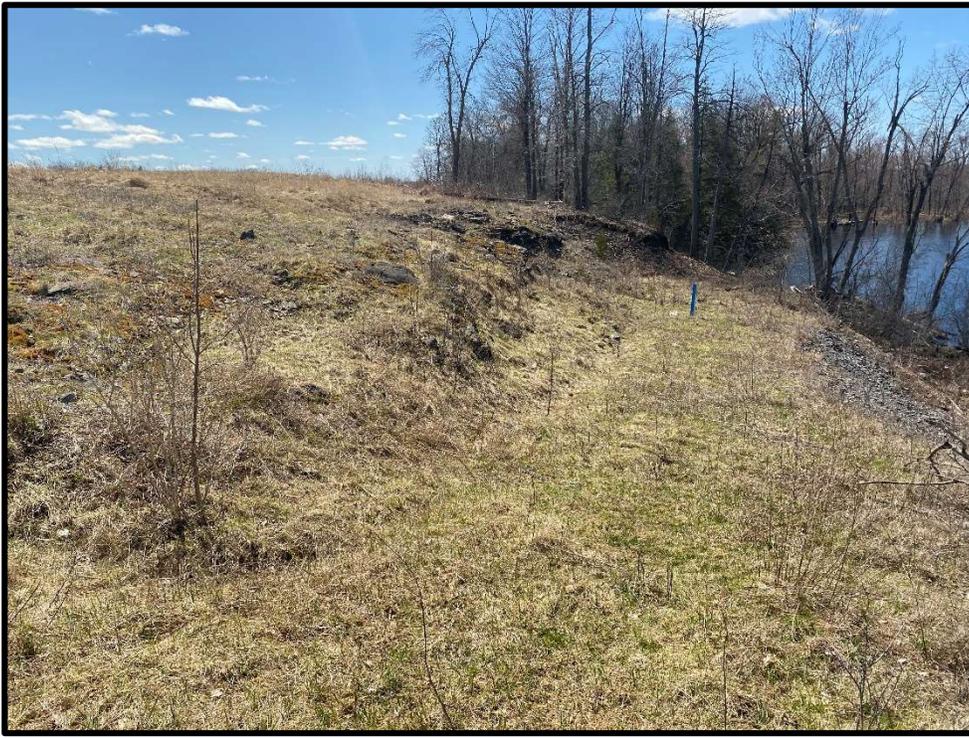
Photo 5: Photo of slope taken from top of slope. Slope observed to be covered with mature vegetation. No signs of active erosion observed

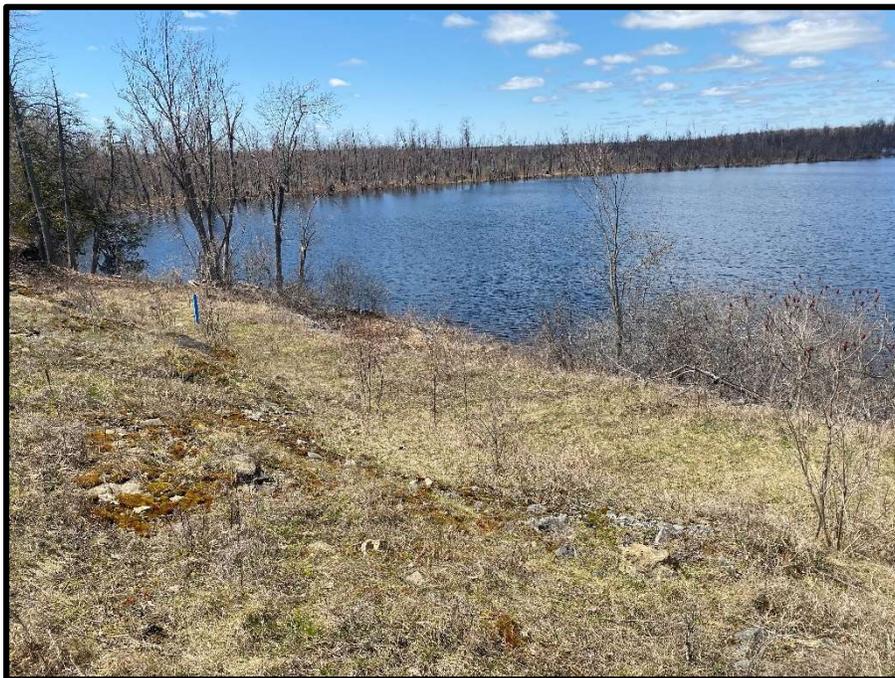
Photo 6: Photo of general area of slope taken from top of slope, looking north. No signs of erosion observed through the area.

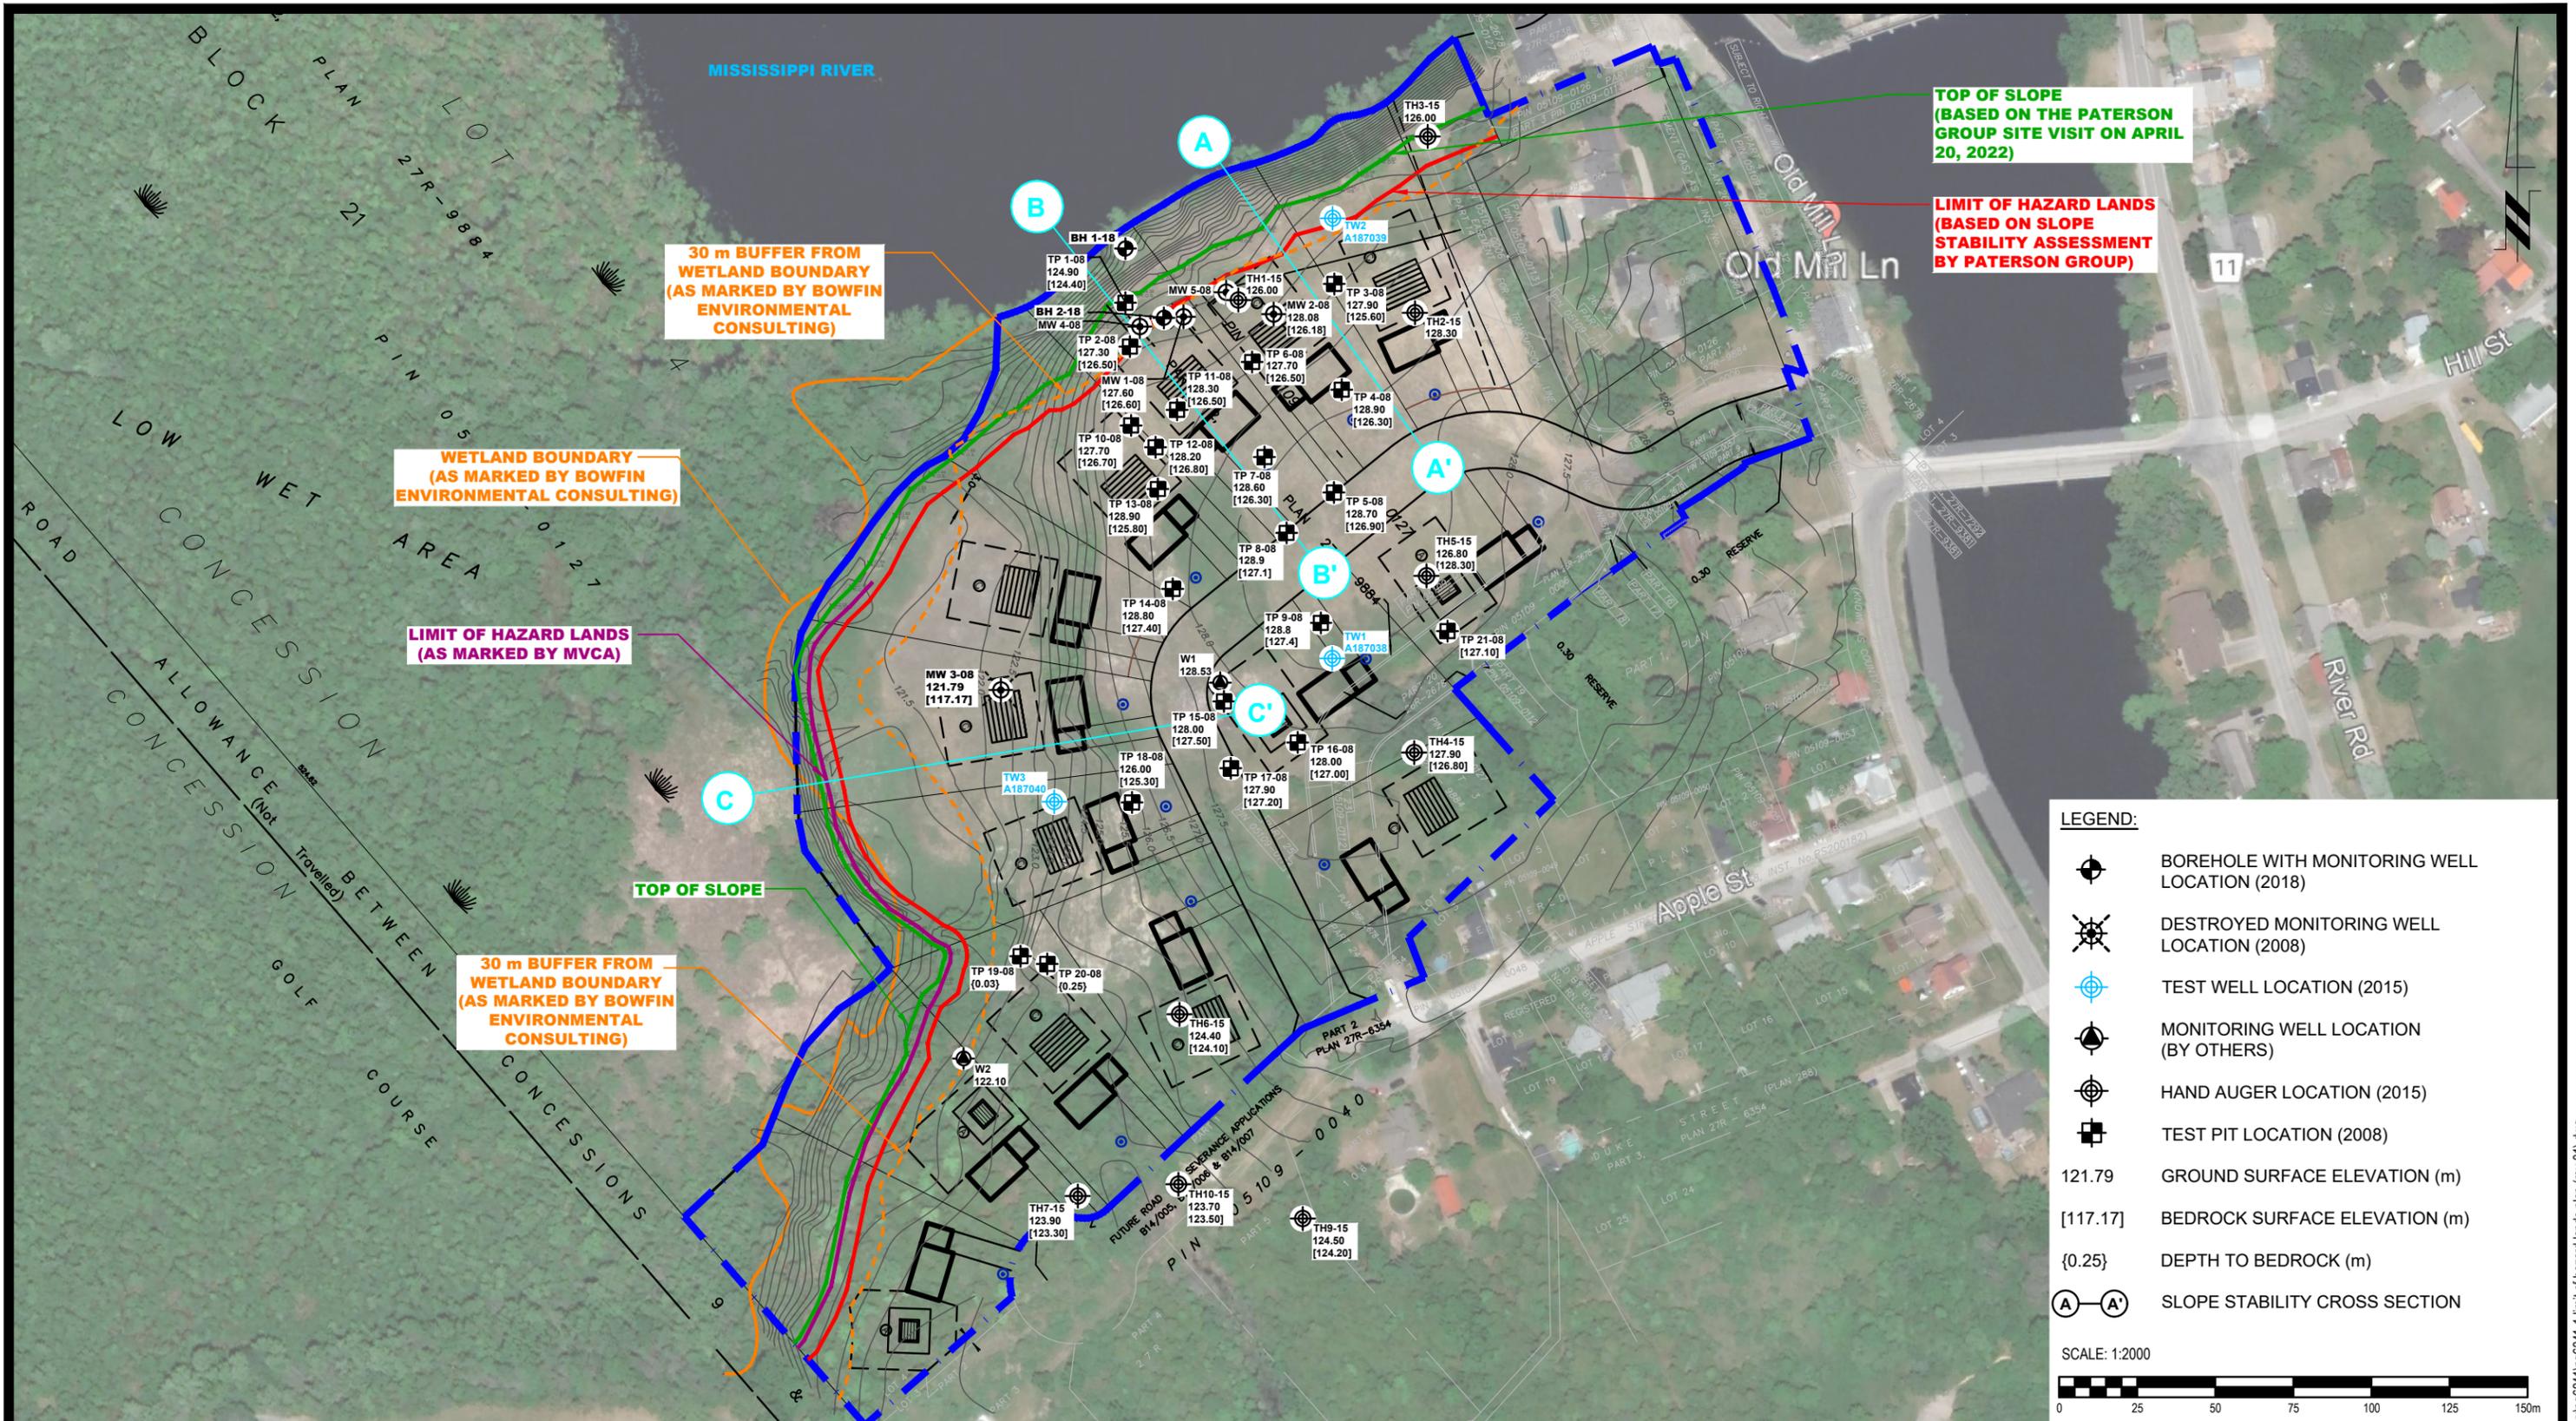
Title: LIMIT OF HAZARD LANDS PLAN

**TOP OF SLOPE
(BASED ON THE PATERSON
GROUP SITE VISIT ON APRIL
20, 2022)**

**LIMIT OF HAZARD LANDS
(BASED ON SLOPE
STABILITY ASSESSMENT
BY PATERSON GROUP)**

Typically, the Limit of Hazard Lands setback is comprised of a stable slope allowance, toe erosion, and 6 m erosion access allowance. The Limit of Hazard Lands designation line for the subject site is indicated on Drawing PG6241-1 – Limit of Hazard Lands Plan, attached to the end of this memorandum.

The results of the slope stability assessment indicate that Limit of Hazard Lands setbacks of 10, 14, and 7 m as measured from the top of the slope, should be provided for any proposed structures at the subject site in the areas of Section A-A, B-B, and C-C respectively, in order to provide a suitable factor of safety of 1.5 under static conditions and 1.1 under seismic conditions.

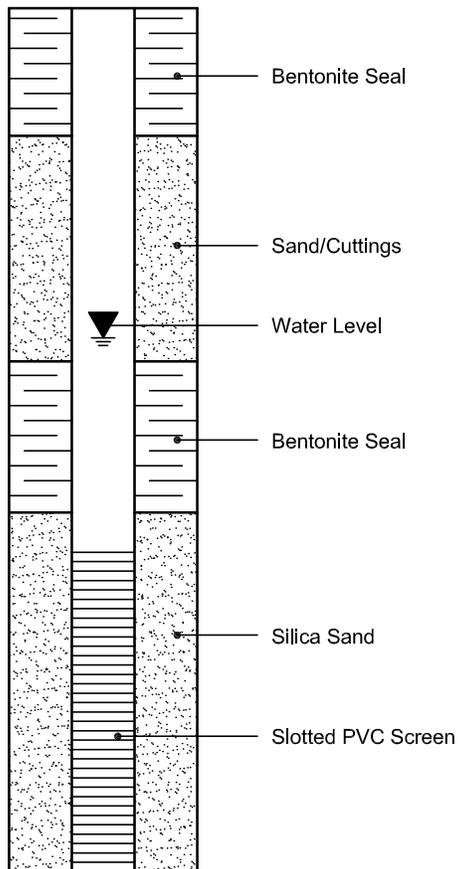
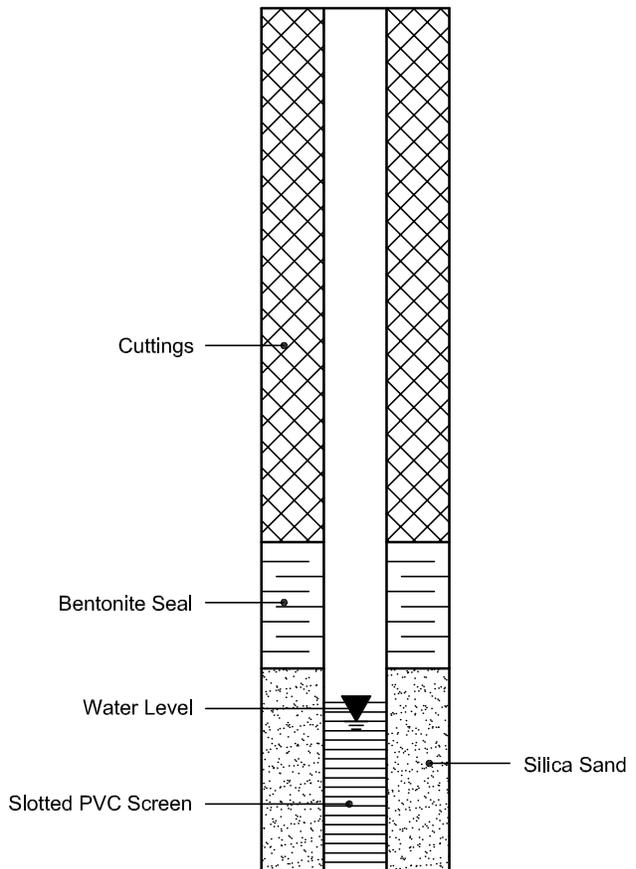
MONITORING WELL AND PIEZOMETER CONSTRUCTION

MONITORING WELL CONSTRUCTION

PIEZOMETER CONSTRUCTION

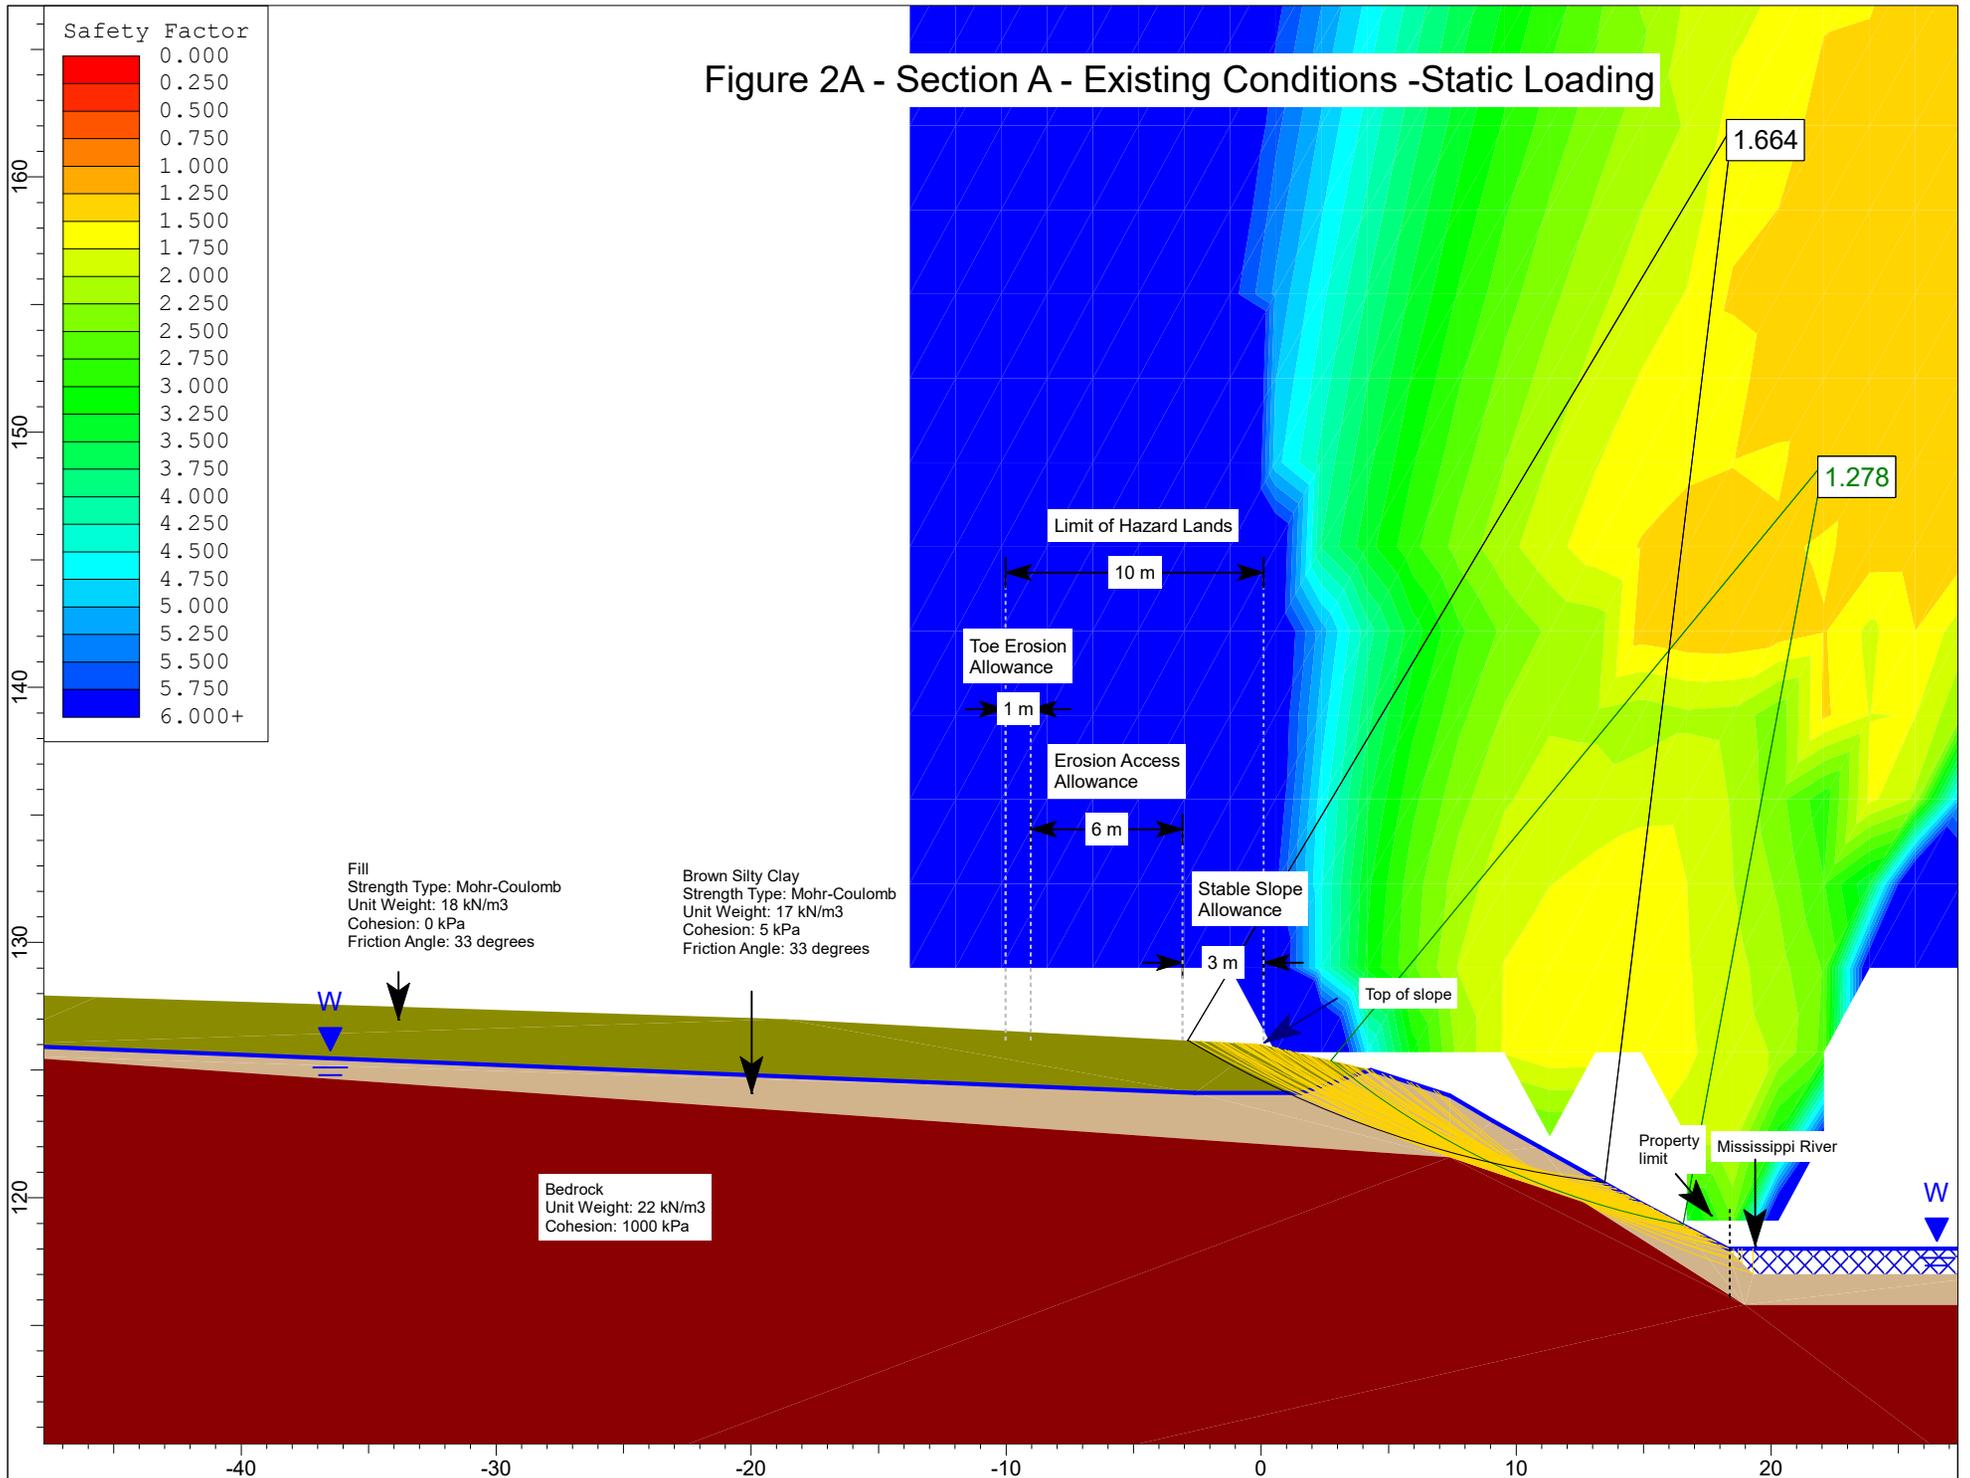
Figure 2A - Section A - Existing Conditions -Static Loading

The results for the slope stability analyses under static conditions at Sections A-A, B-B, and C-C are shown on Figures 2A, 3A, and 4A, attached to the present memorandum. The factors of safety were found to be 1.2 and 0.9 at Section A-A and B-B under static conditions, respectively. Therefore, stable slope setback allowances from the top of slope have been provided to obtain a factor of safety greater than or equal to 1.5.

Based on the analysis results, stable slope setbacks of 3 and 7 m at the locations of Sections A-A and B-B, respectively, are required for the slope to be stable under static and seismic conditions.

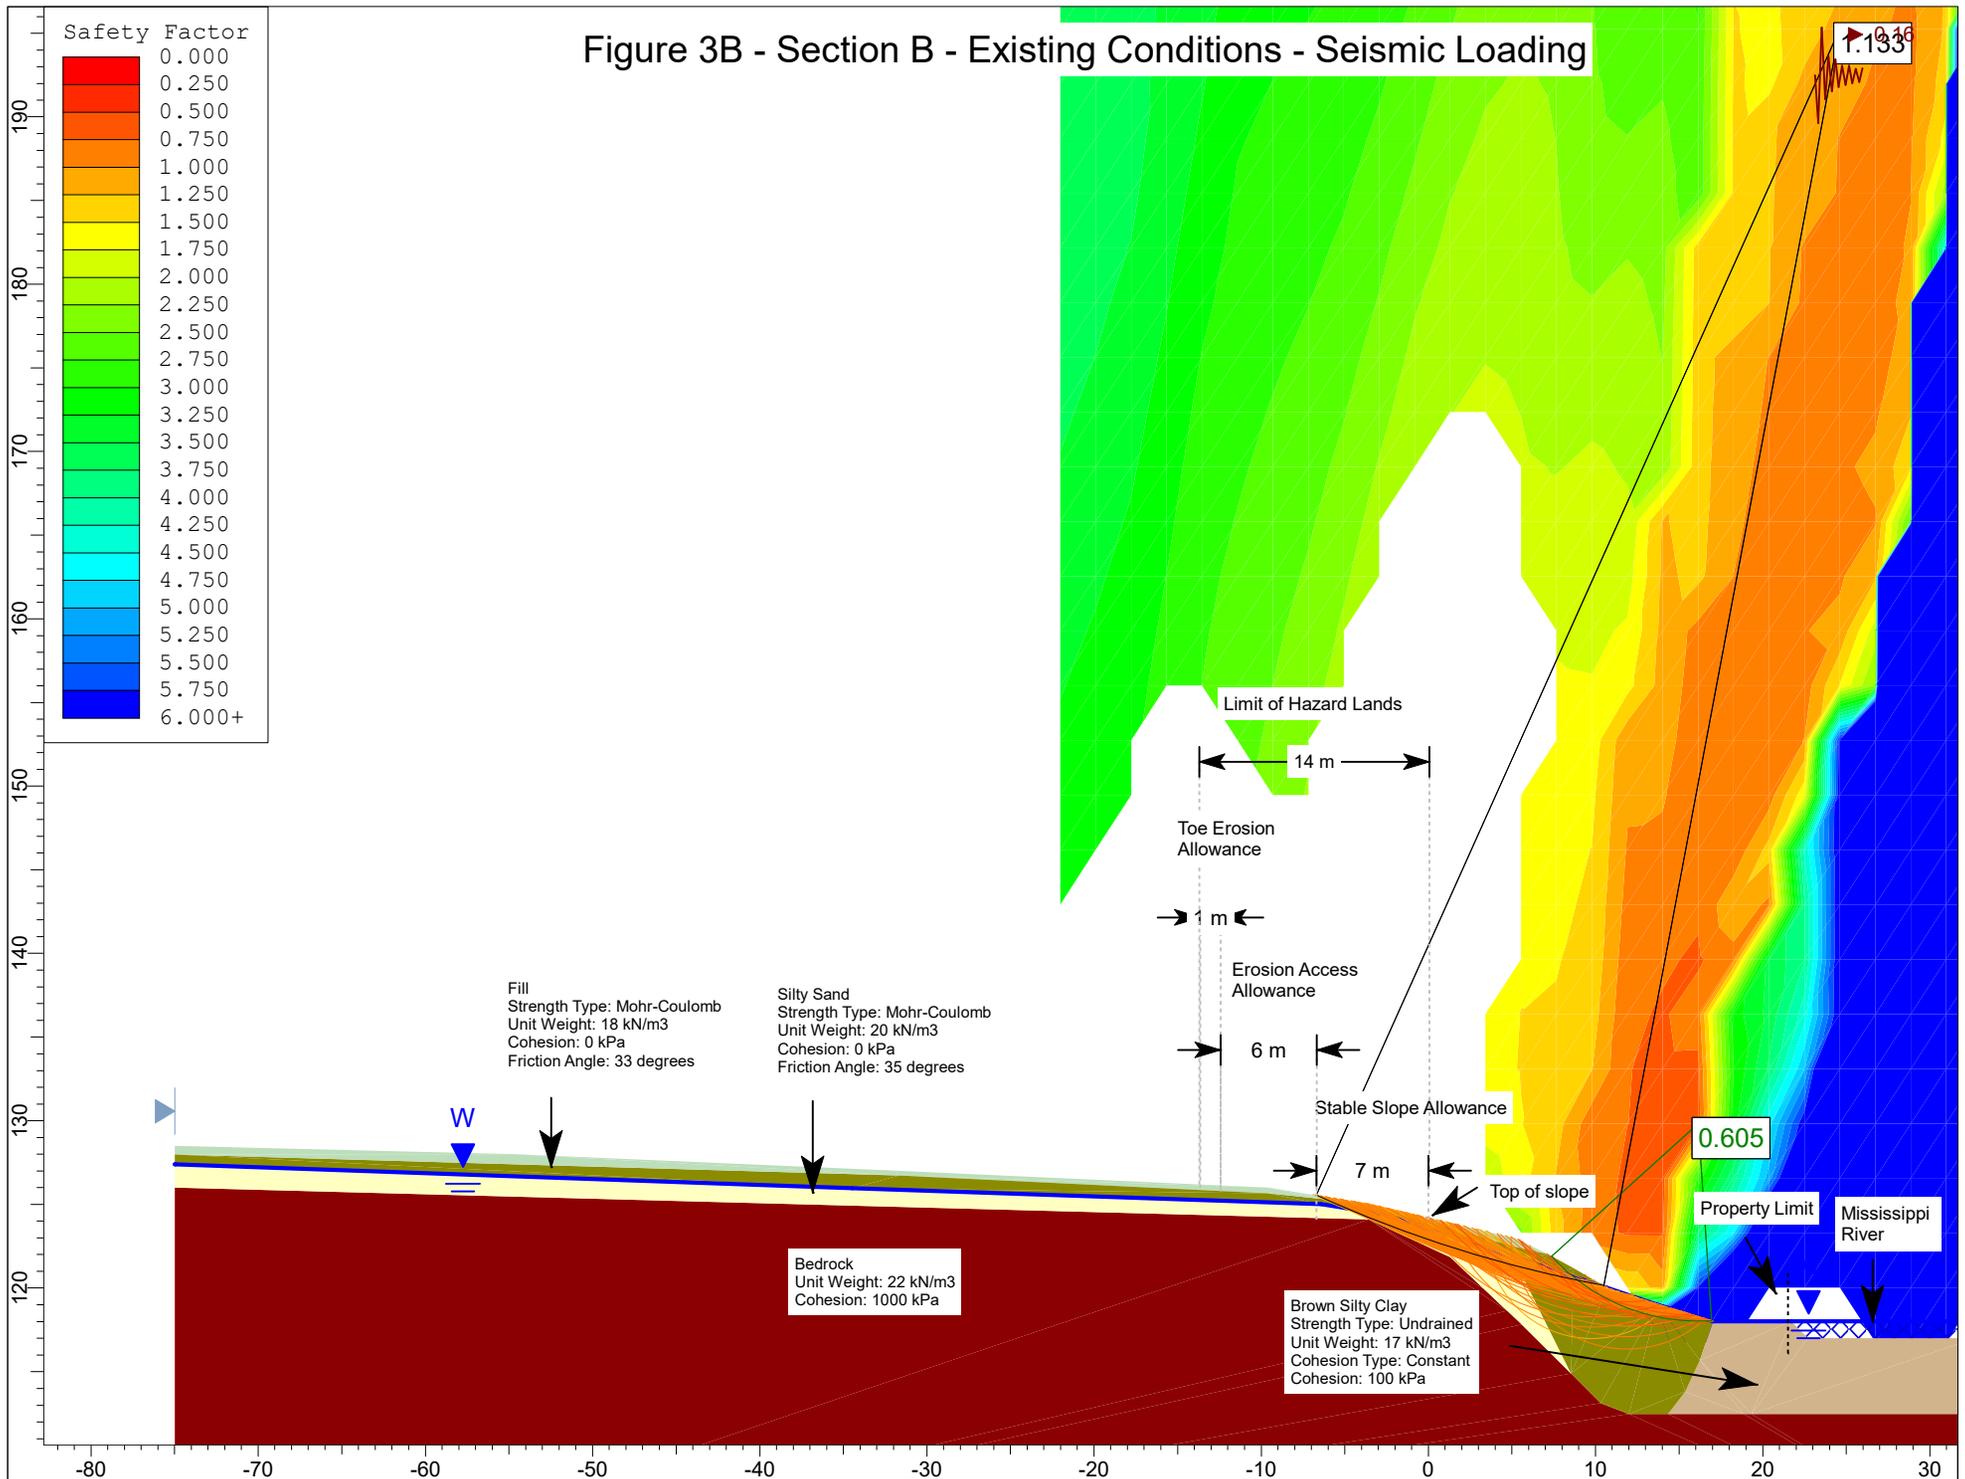
Figure 3B - Section B - Existing Conditions - Seismic Loading

However, the results indicate a factor of safety less than 1.1 beyond the top of slope for Section B-B. Based on these results, a stable slope setback of 7 m from the top of slope is required to achieve a factor of safety of at least 1.1 in the area of Section B-B. It should be noted that the stable slope setback associated with the seismic loading analysis governs the required stable slope setback over the static analysis for Section B-B.

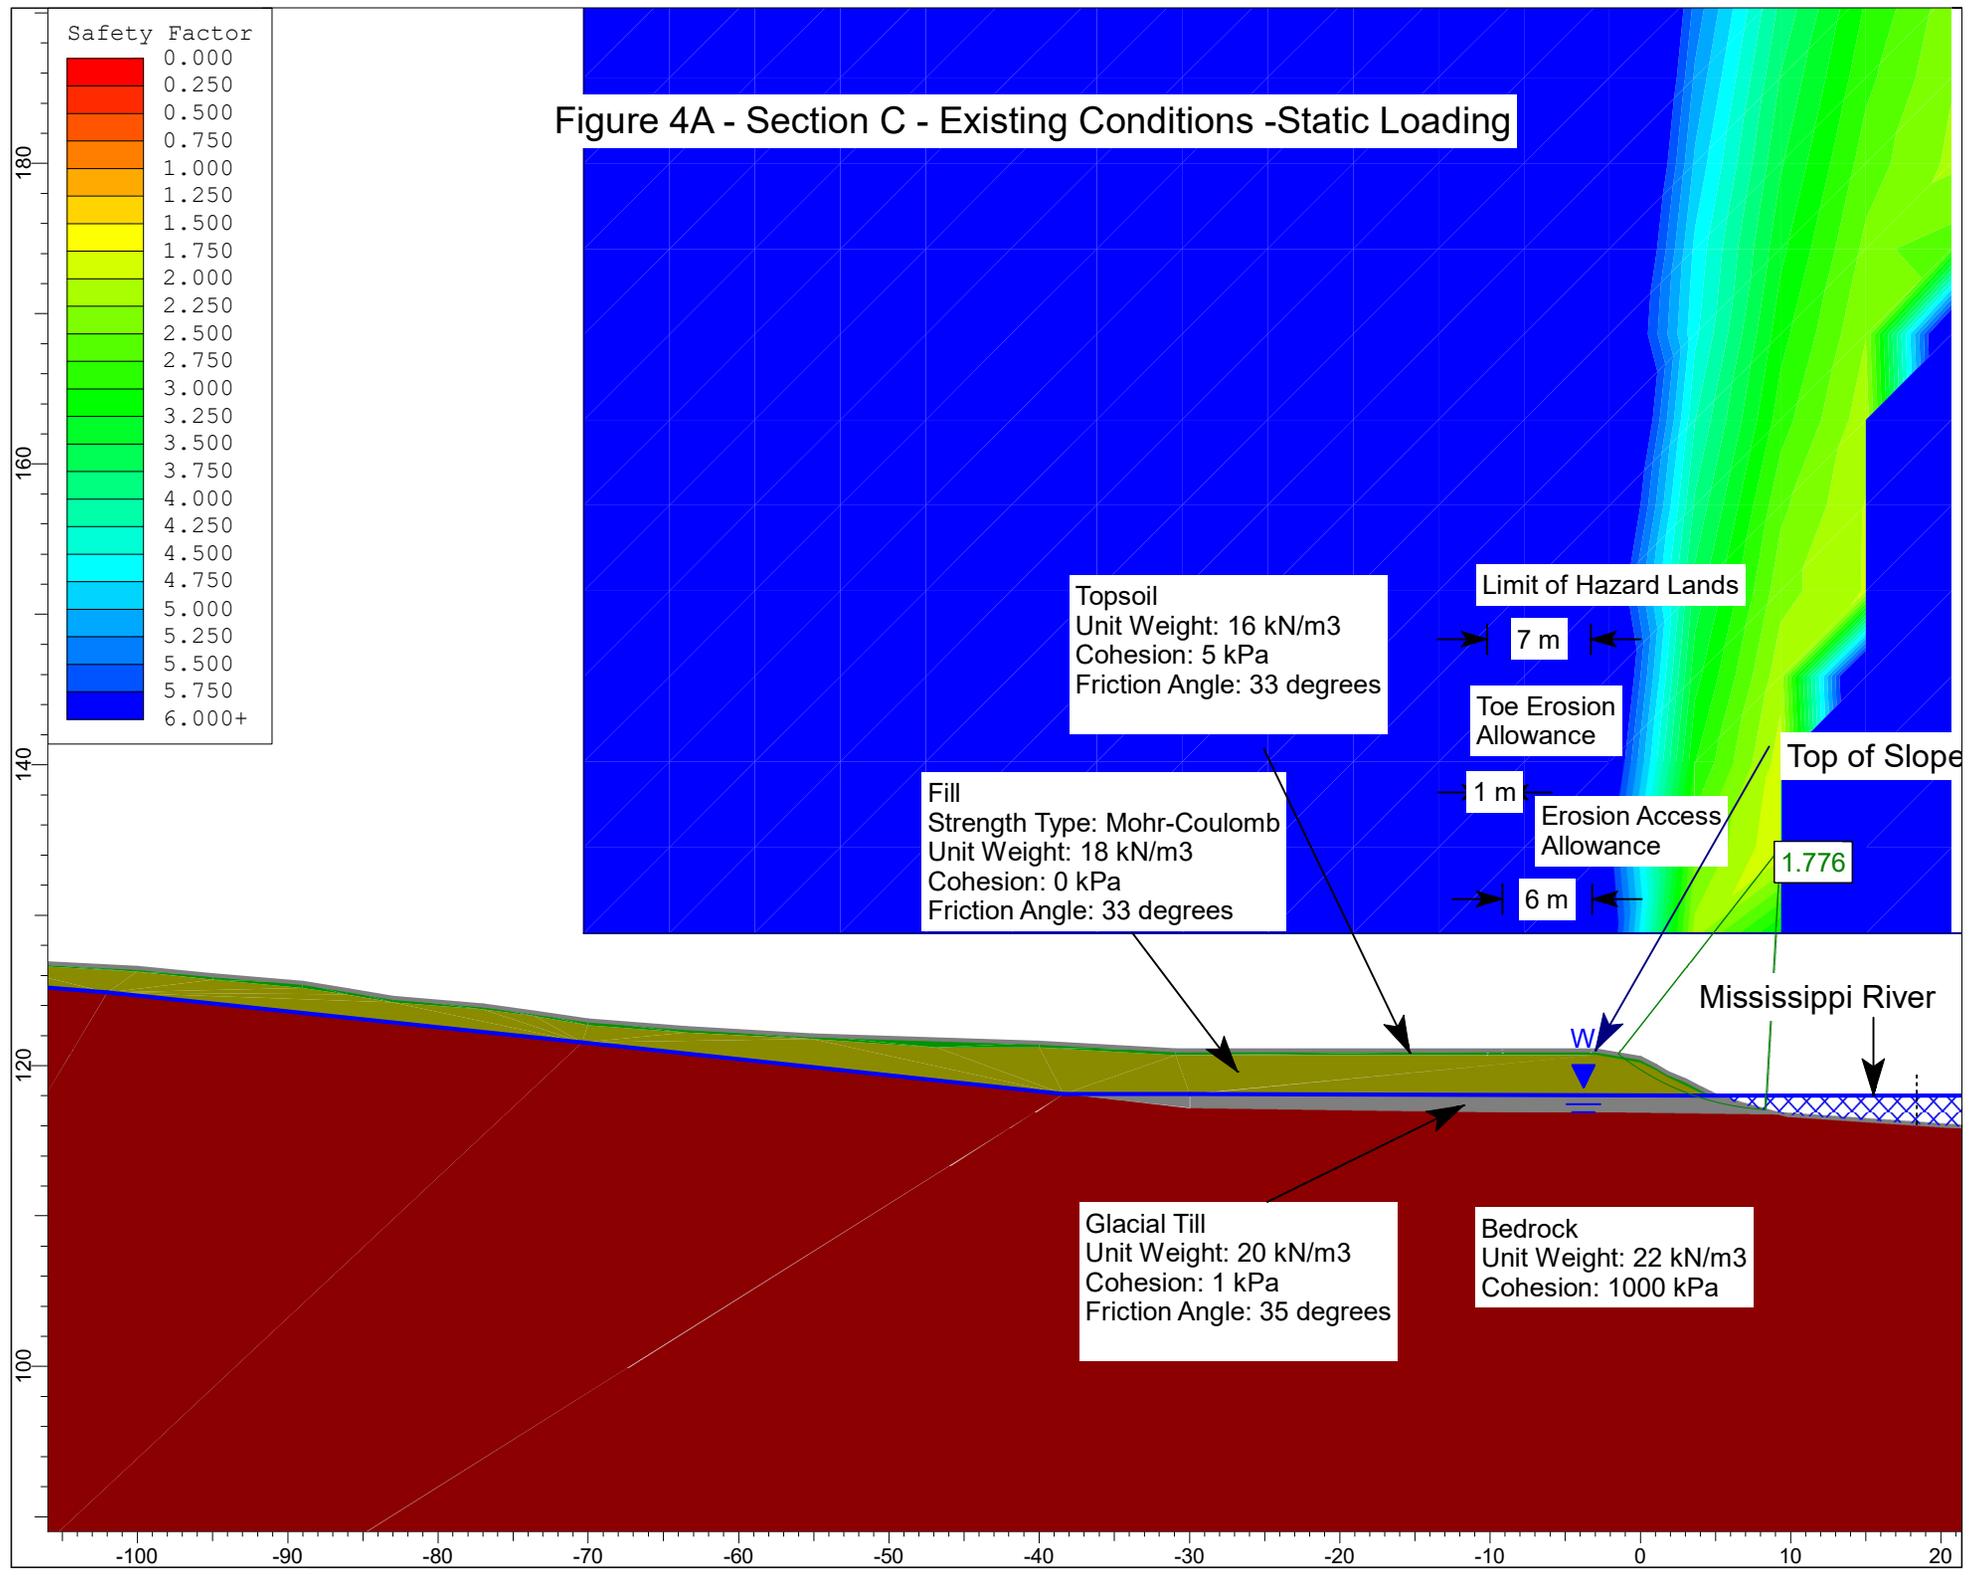
Figure 4A - Section C - Existing Conditions -Static Loading

At Section C-C, the factor of safety was calculated to be 1.78, therefore a stable slope allowance is not required in this area.
