## Cultural Heritage Evaluation Report

Address: Black Watch Building,  
Date: 2026

Prepared by: Sally Coutts, Heritage Consultant

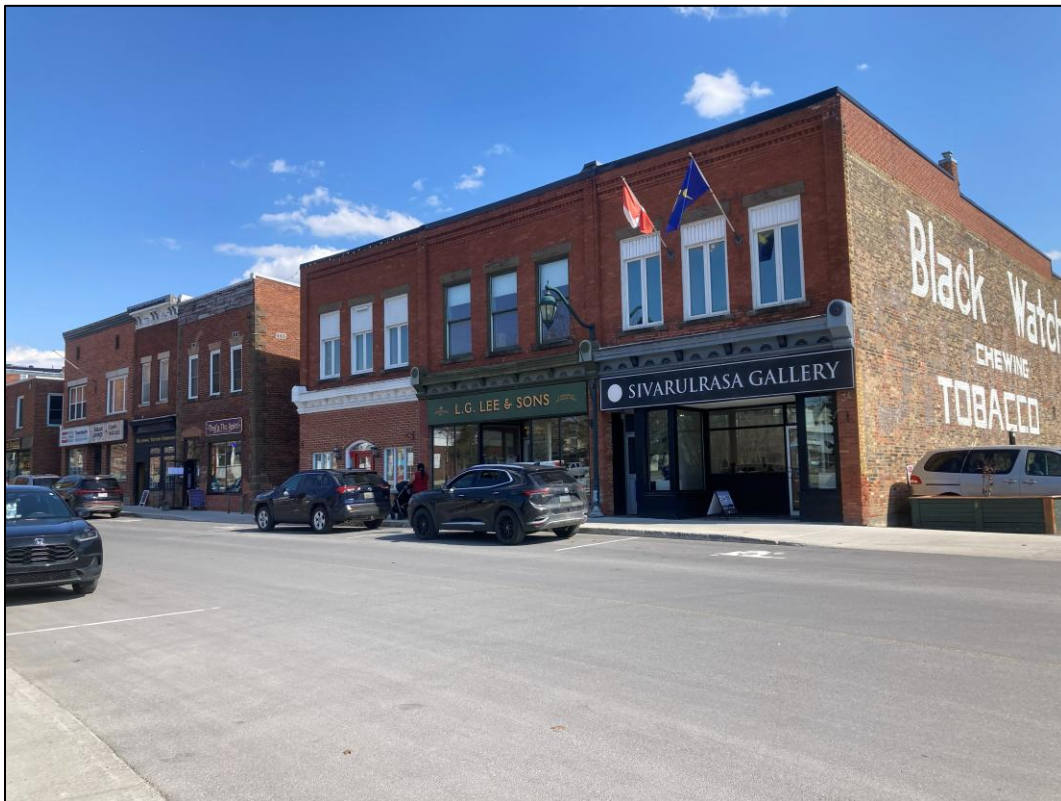
The building has undergone changes since its construction, including the construction of a brick storefront at 38 Mill Street, the replacement of the second floor sash windows at 34 and 38 with undersized windows and minor changes to the storefronts at 34 and 36.

The Black Watch Building, located on lower Mill Street next to an empty lot, is part of a commercial street wall with buildings set flush against the sidewalk running east to Bridge Street. The flat-roofed, two-storey structure is divided into three storefronts, each with a ground-level entrance and three large second-floor windows featuring stone sills and lintels. Brick pilasters separate the building sections, while decorative coursing defines the cornice. A pressed metal secondary cornice separates the first and second stories. The west wall is painted with a large advertisement for “Black Watch CHEWING TOBACCO “A Man’s Chew’.”

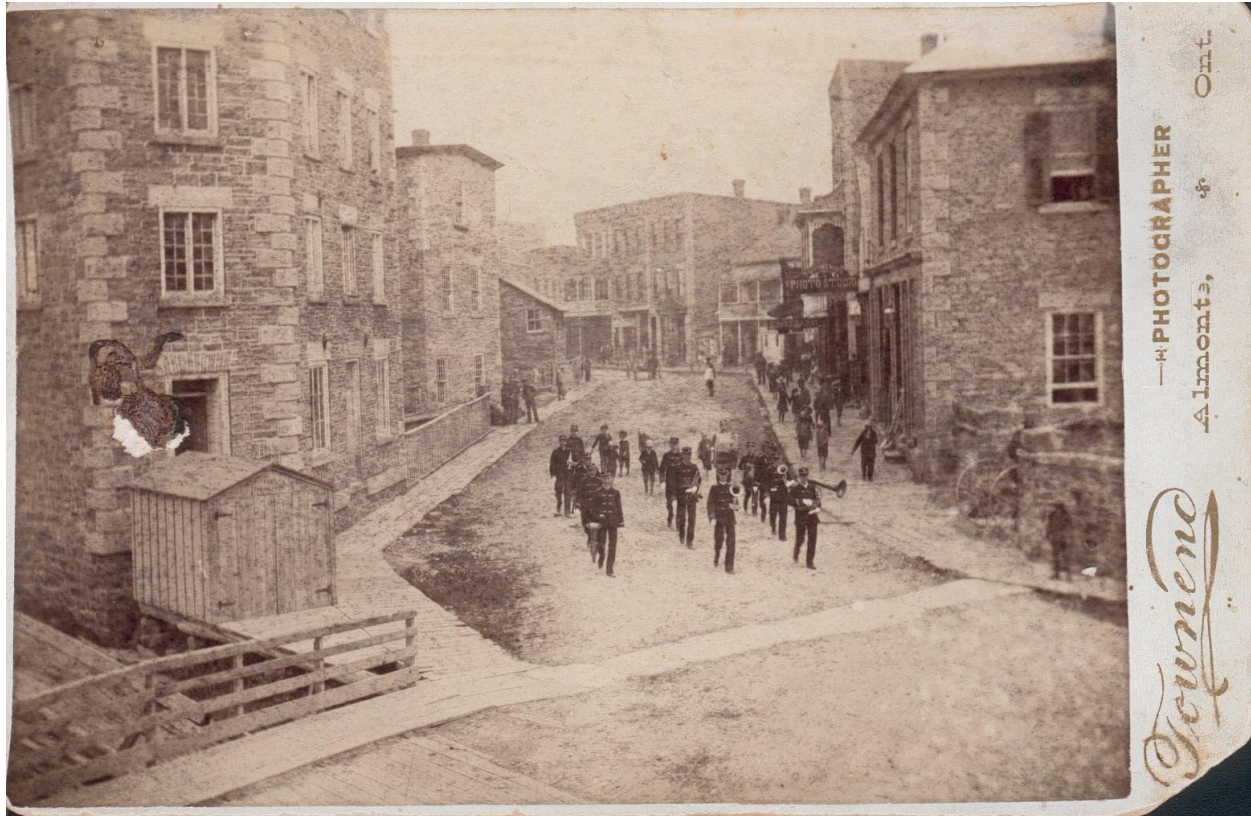
Caption: This photograph from the late 19th century shows the varied rooflines constructed as part of Mill Street's initial development.

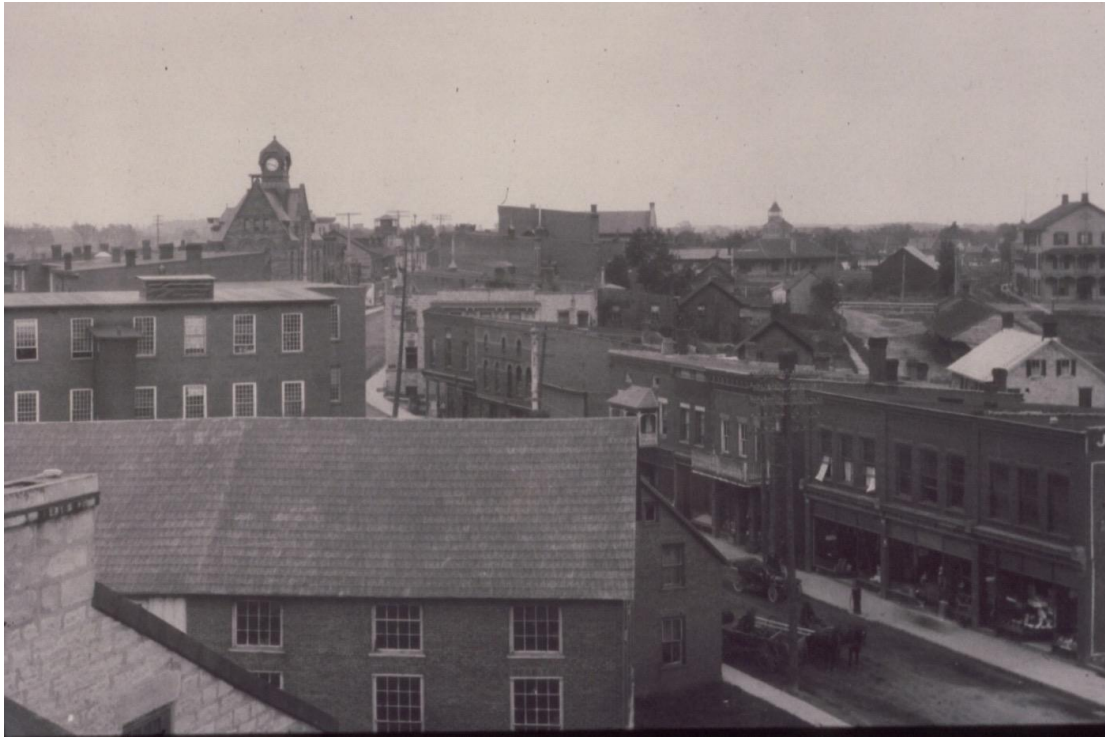
Photo Credit: <https://almonte.com/historic-photo-archive/>

After the 1909 fire, the 1877 commercial structure at 32-36 Mill Street was replaced by the current structure. Like its predecessor, it featured a flat roof, retail at grade, plate glass windows and a recessed front door, decorative brick work at the roofline and regularly spaced rectangular windows, although it was two storeys in height, not three. The continuation of the building type on the lot indicates the ongoing popularity of the building type for small scale commercial enterprises.

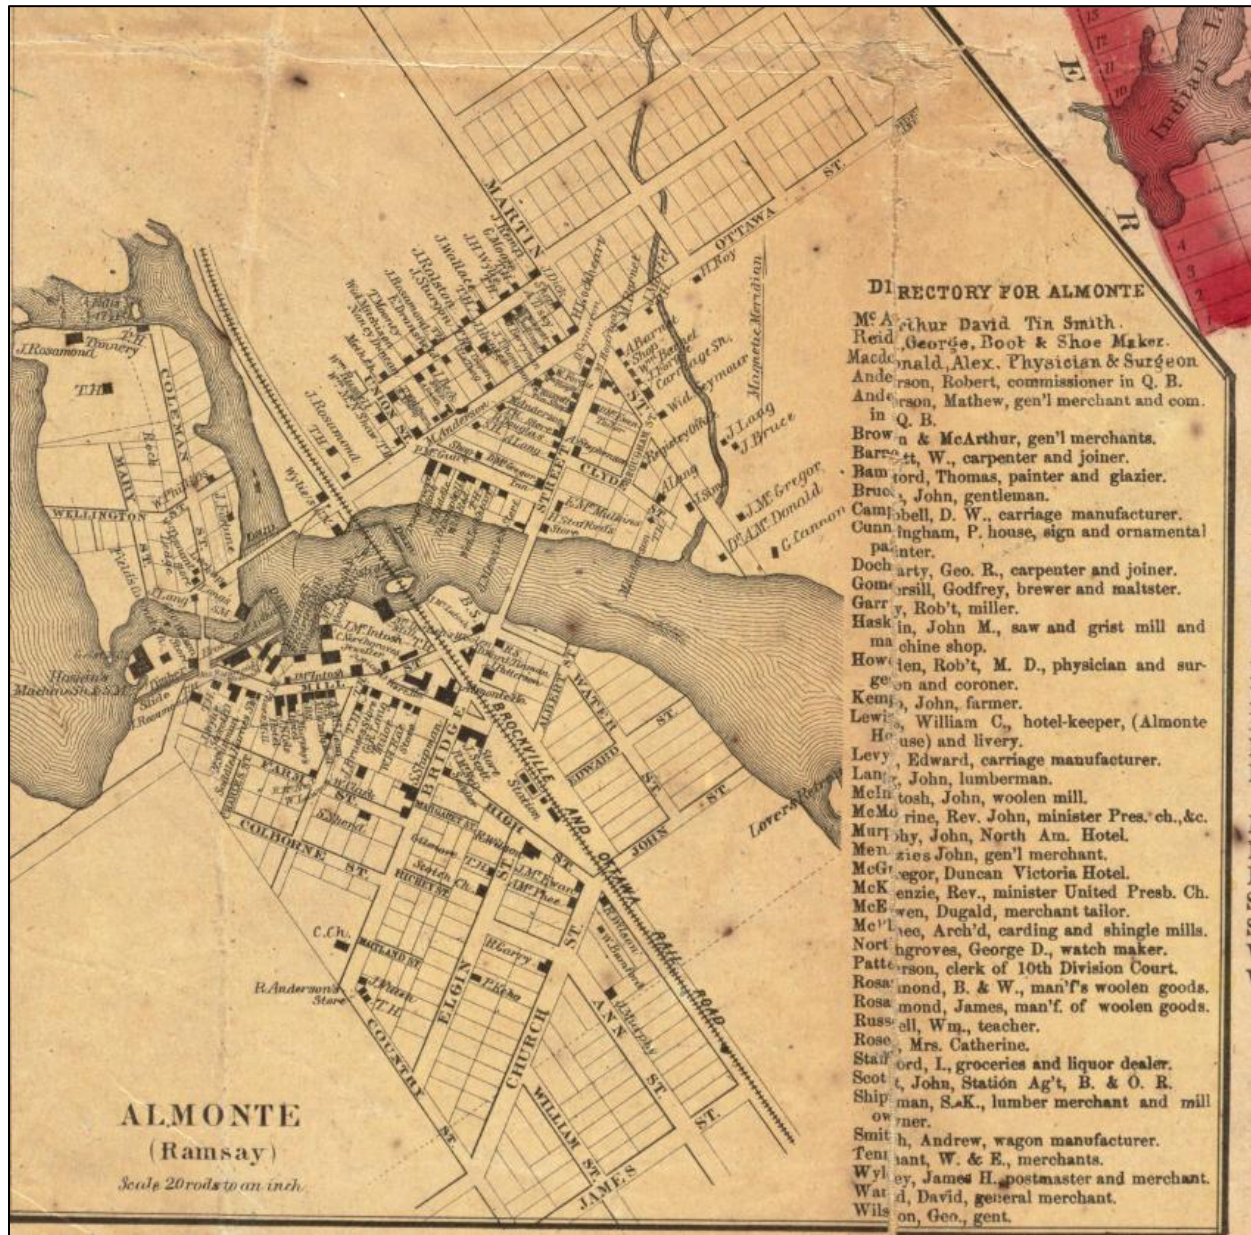
Wallings Map of Almonte's commercial core in 1863.

When the map above was completed, the familiar flat-roofed two and three storey form was not fully established and some of the earliest buildings, including the first building

Murphy's Hotel, the original building on the site, is noted on the map above, but had burned down by 1877.<sup>6</sup> It was replaced by a three storey structure that burnt down along with its neighbours in 1909 and was replaced by the current two storey structure.<sup>7</sup> This pattern of incremental change and loss and replacement of buildings because of fire or the aspirations of individual property owners contributes to the richly textured character of Mill Street.

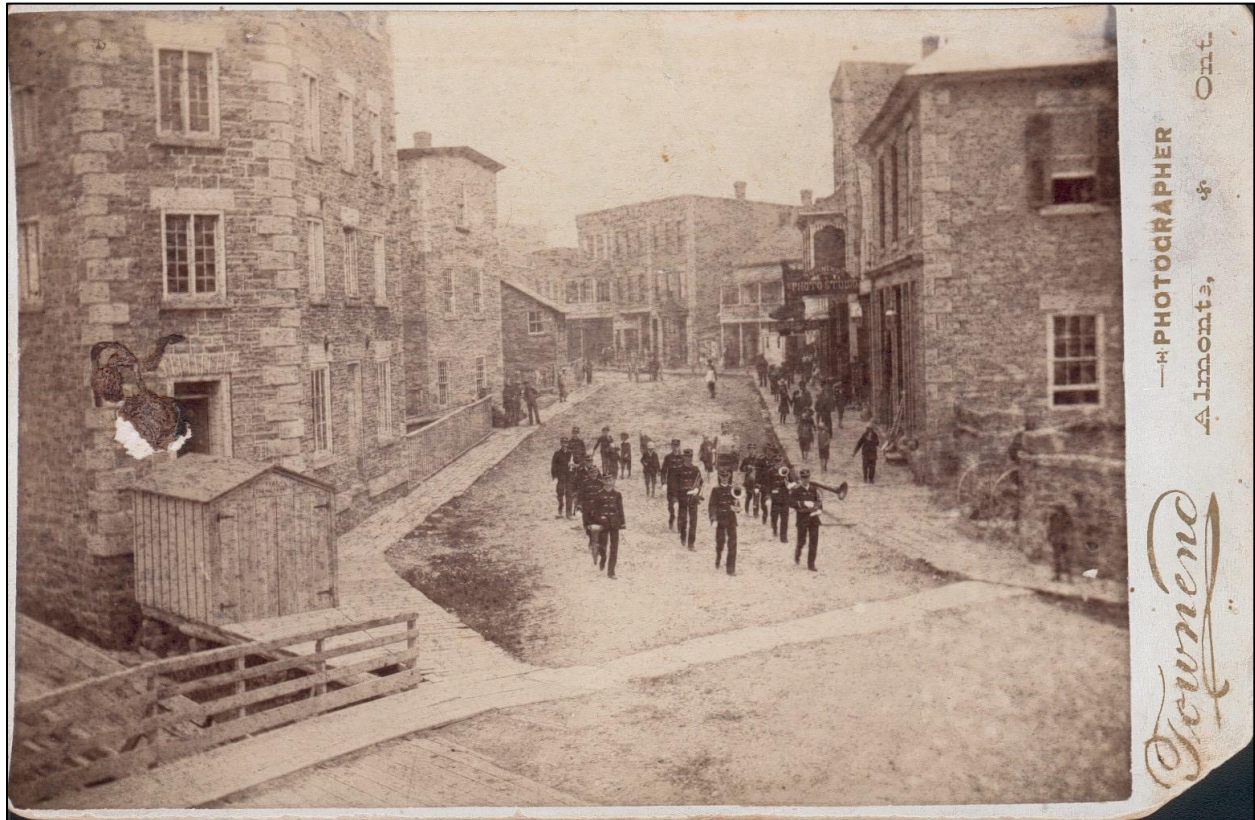
Photo Credit: <https://almonte.com/historic-photo-archive/>

on the 32, 34, 36 Mill Street lot that burned down in 1877, had side-gabled roofs. The photo below shows a variety of rooflines.

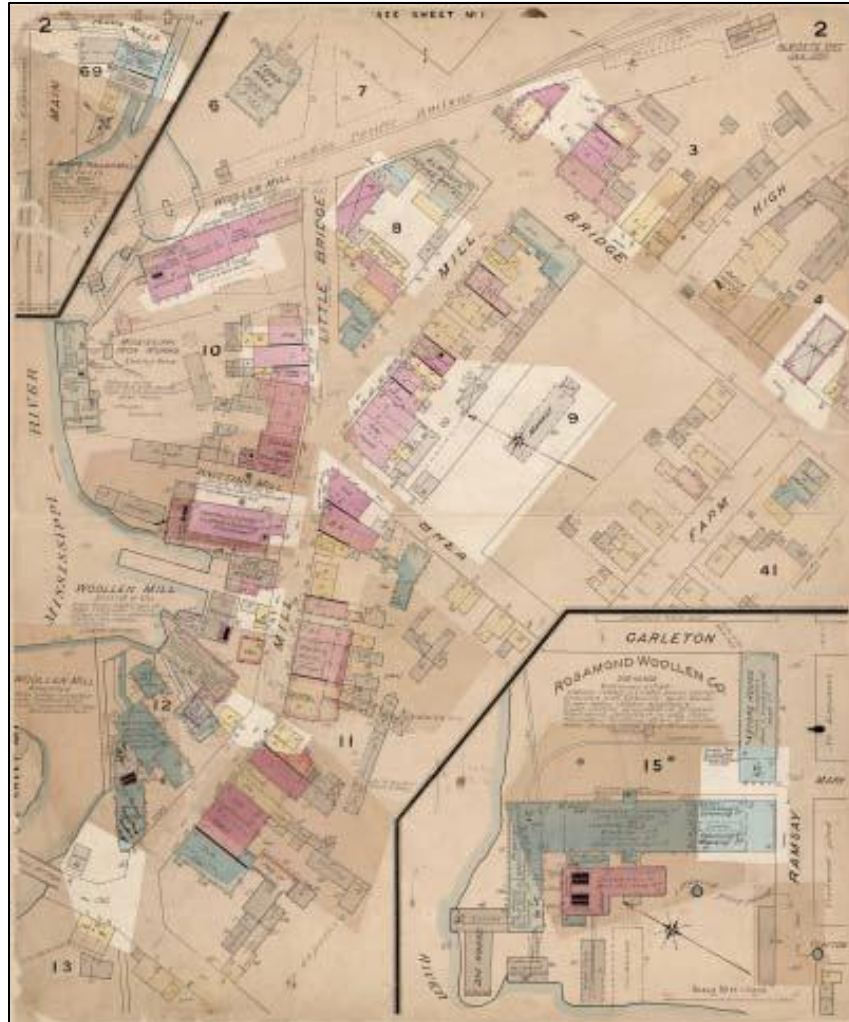
Fire Insurance Plan, 1889 Source; Library and Archives Canada, C.E. Goad Insurance Plan, Almonte, Sheet 2.

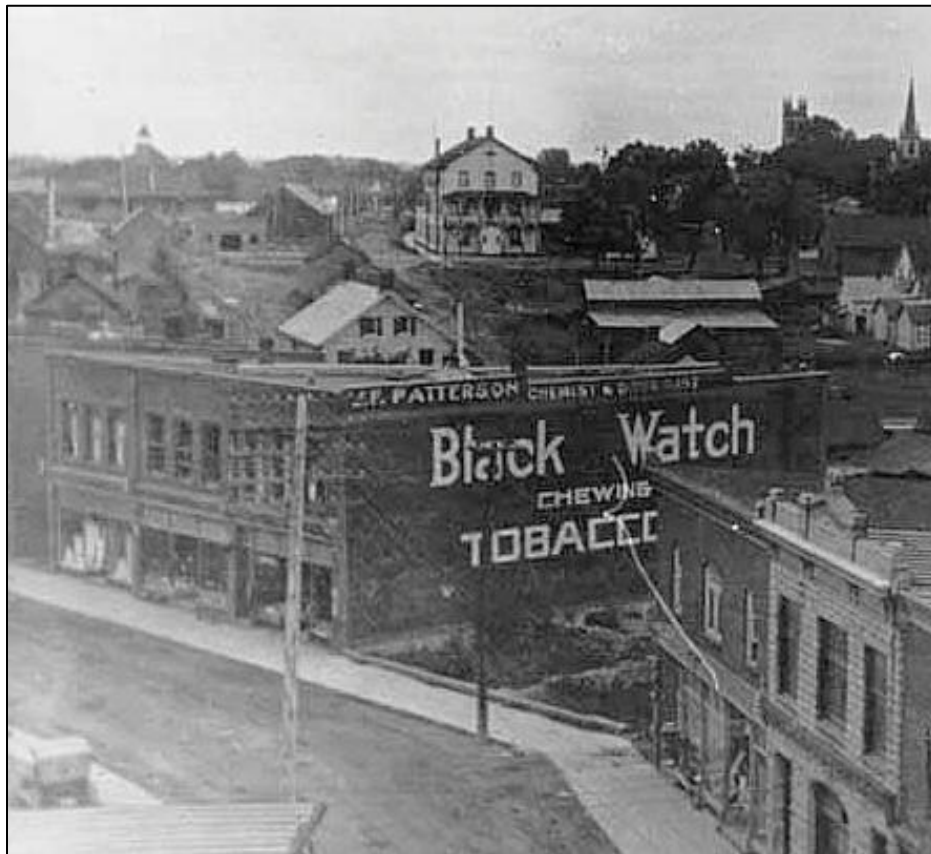
The west wall of the Black Watch building has been exposed since the building was constructed, making it a suitable place for advertising. Historic photographs show that advertisements appeared on the wall soon after completion, and a faint ghost sign with the word “Shamrock Woolens” can still be seen beneath the current Black Watch sign.
