# **Geotechnical Investigation**

## **Proposed Residential Development**

Brown Lands - County Road No. 29 and Strathburn Street  
Almonte, Ontario

Report PG6260 – 2 Rev. 3 dated September 20, 2024

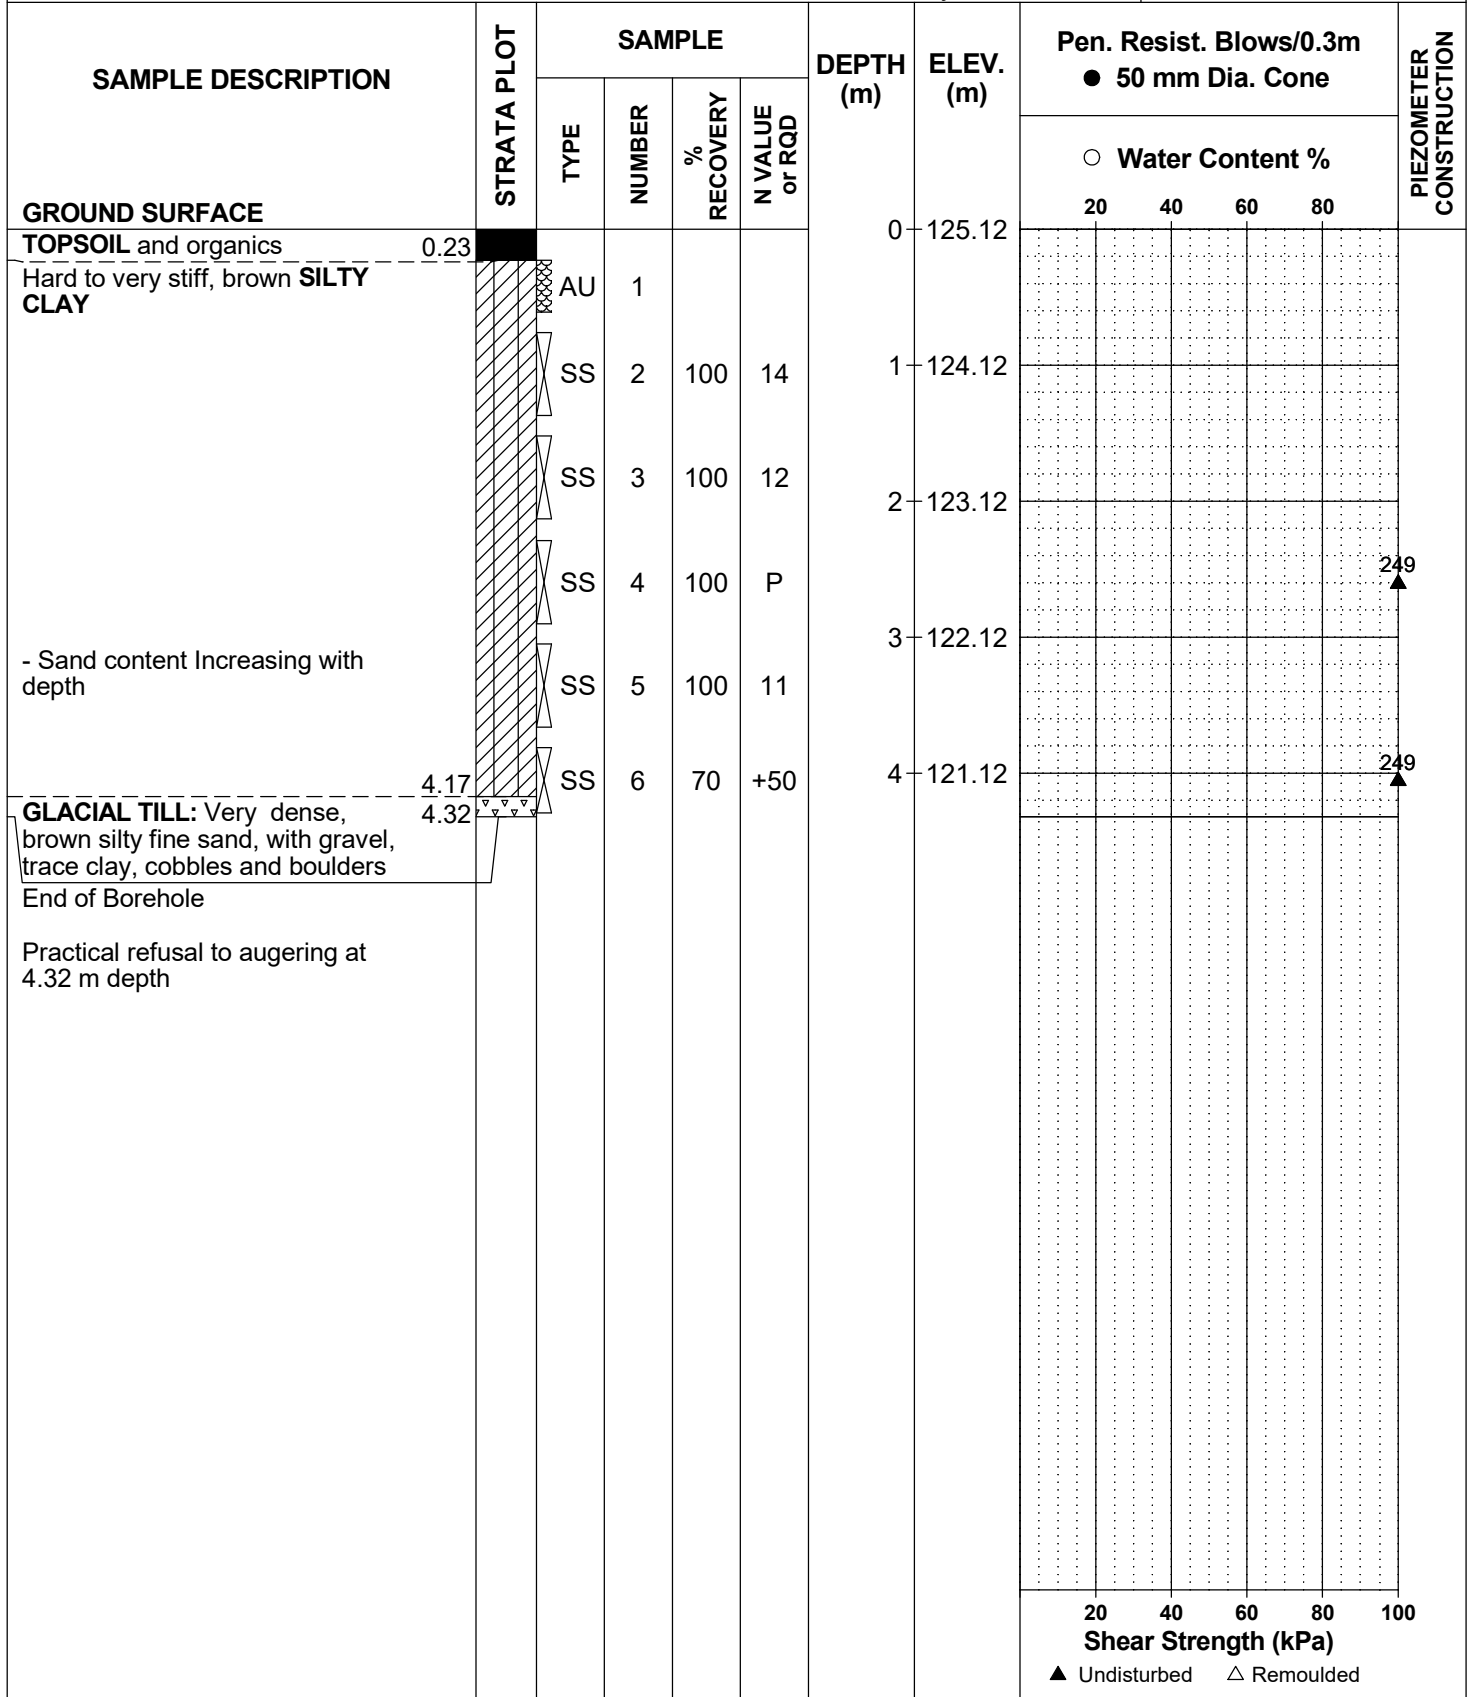
FILE NO. **PG6260**  
HOLE NO. **BH 2-24**

EASTING: 327457.7    NORTHING: 5009587.872    ELEVATION: 125.119  
DATUM: Geodetic  
REMARKS:  
BORINGS BY: CME-55 Low Clearance Drill    DATE: 2024 July 17

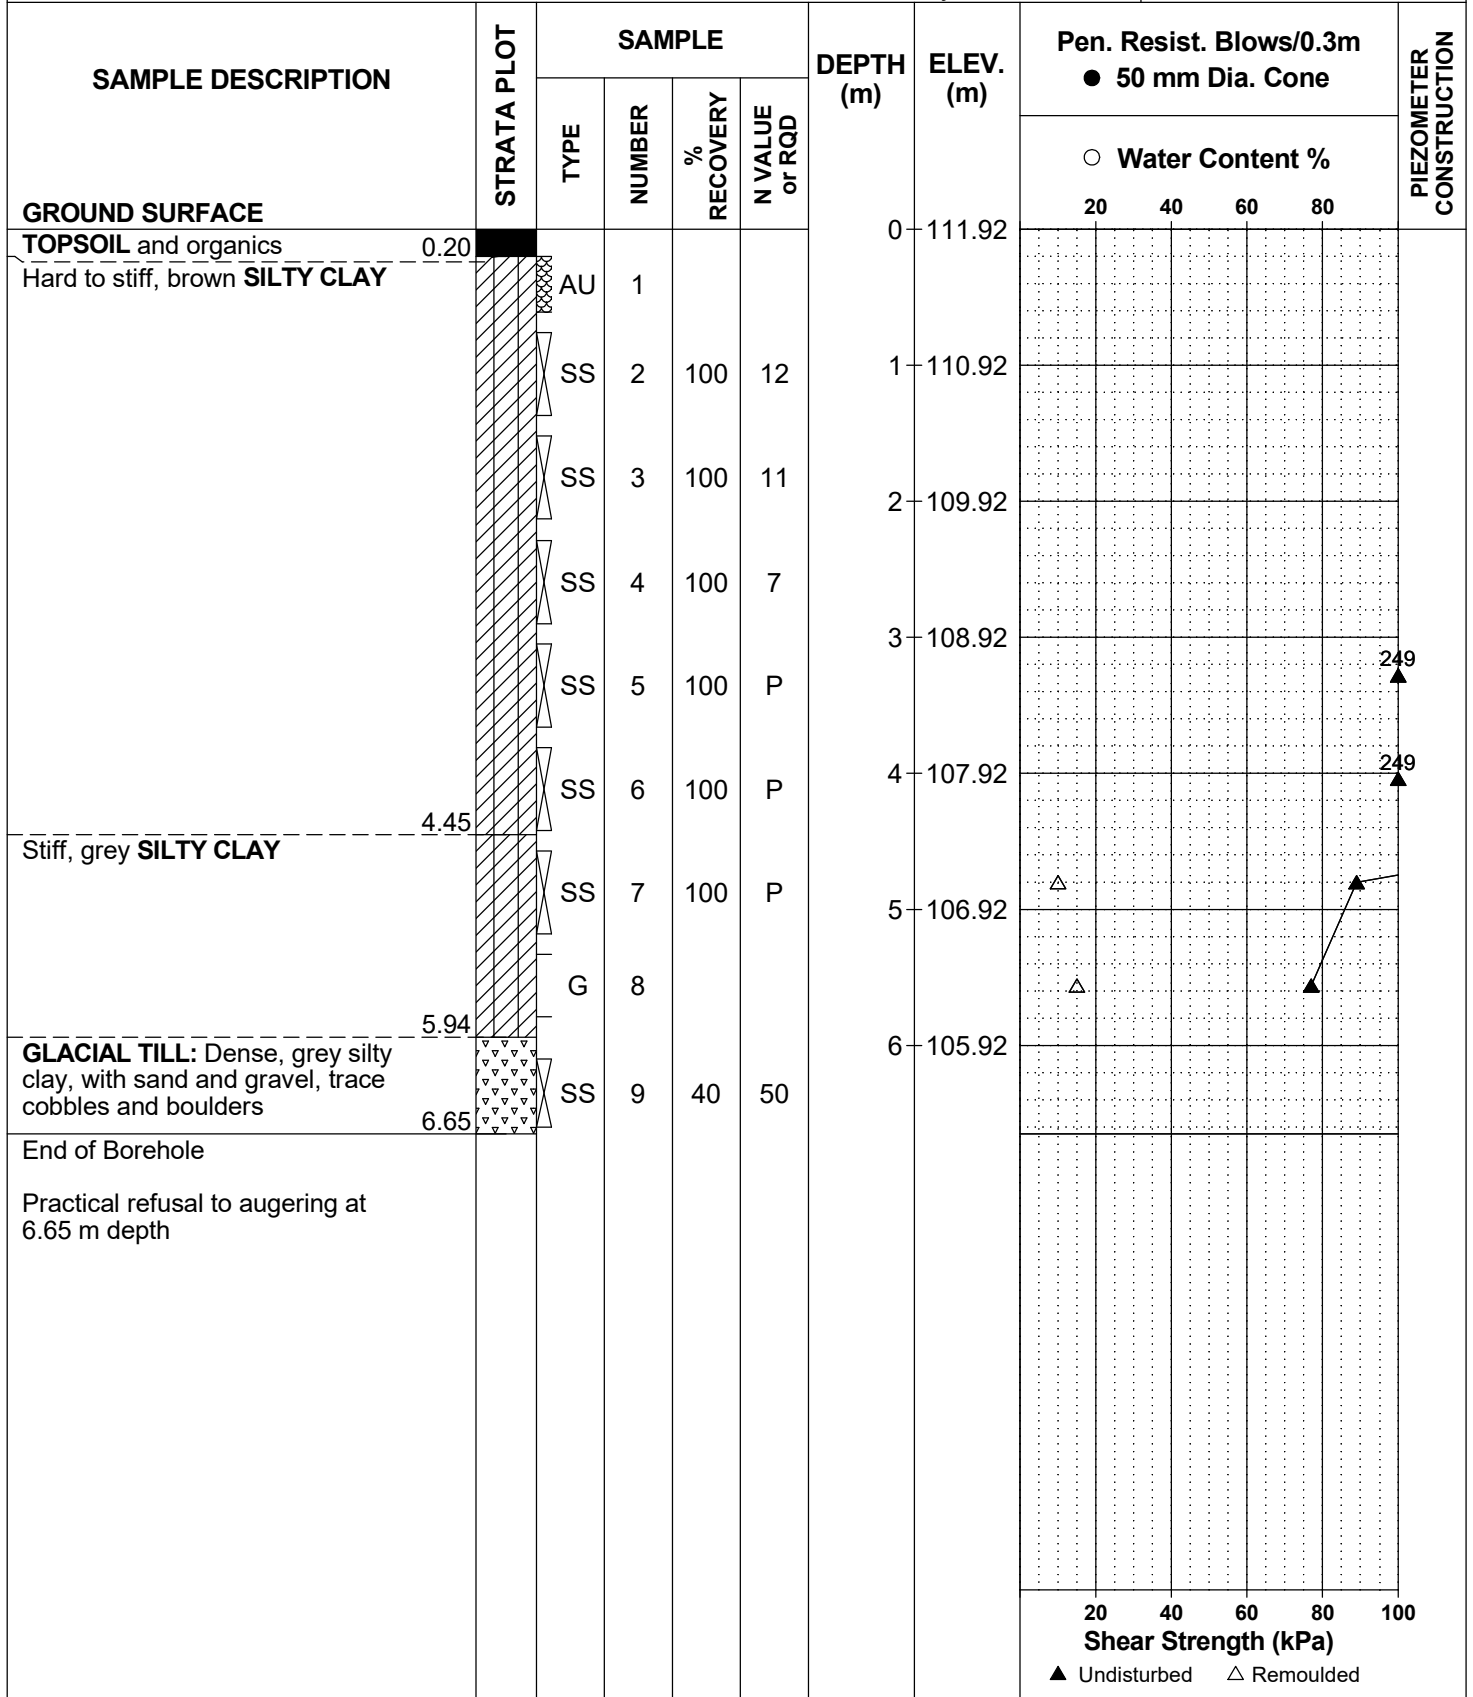
FILE NO. **PG6260**  
HOLE NO. **BH 5-24**

EASTING: 327788.525    NORTHING: 5009910.772    ELEVATION: 111.922  
DATUM: Geodetic  
REMARKS:  
BORINGS BY: CME-55 Low Clearance Drill    DATE: 2024 July 17

Groundwater monitoring wells were installed in boreholes BH 1-22, BH 7-22, BH 5-24 and BH 10-24, and flexible standpipe piezometers were installed in all other boreholes to permit monitoring of the groundwater levels subsequent to the completion of the sampling program. All groundwater observations are noted on the Soil Profile and Test Data sheets presented in Appendix 1.

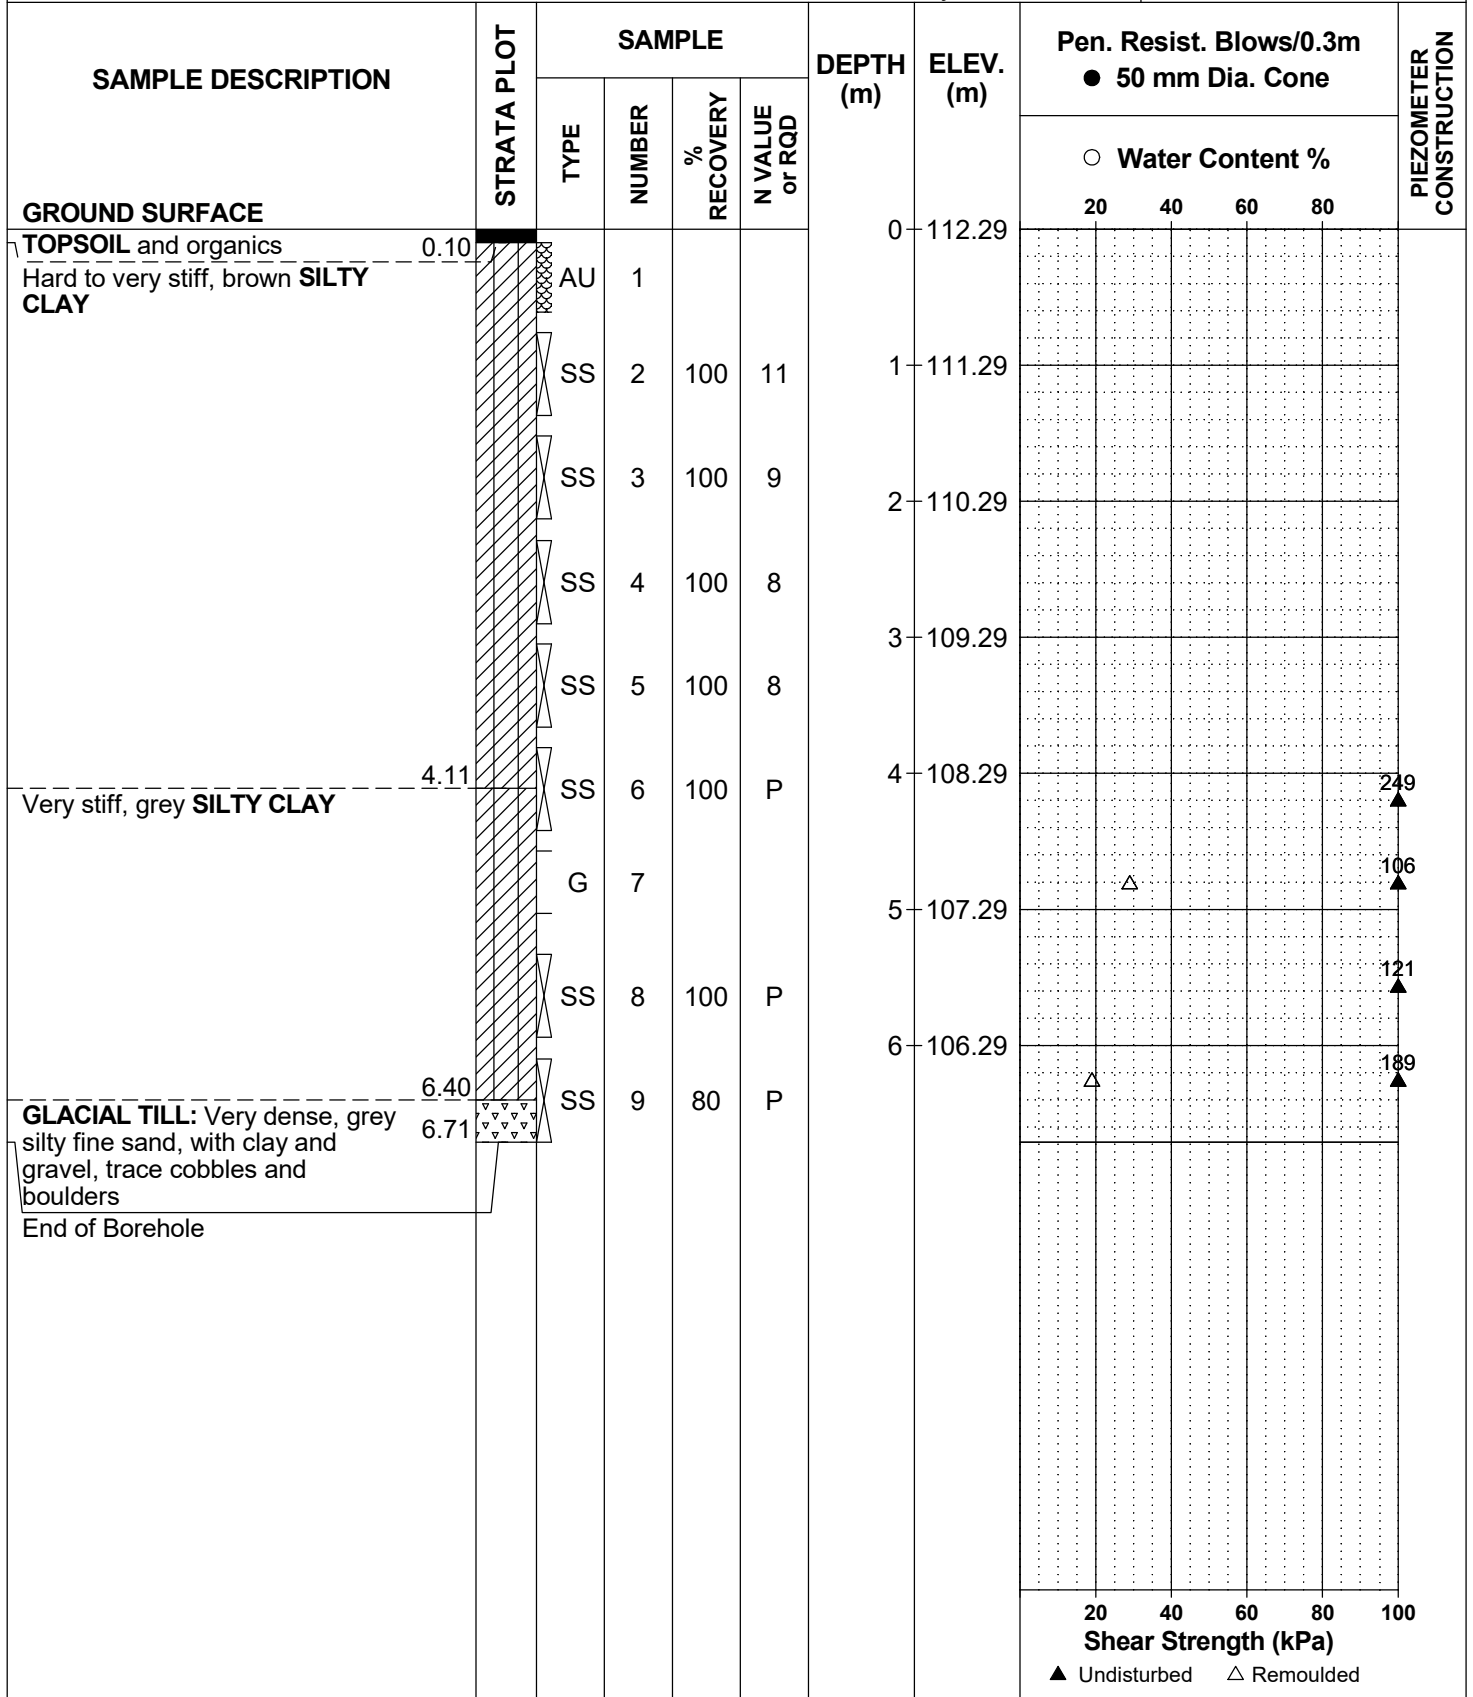
FILE NO. **PG6260**  
HOLE NO. **BH 6-24**

EASTING: 327796.663    NORTHING: 5009856.008    ELEVATION: 112.289  
DATUM: Geodetic  
REMARKS:  
BORINGS BY: CME-55 Low Clearance Drill    DATE: 2024 July 17

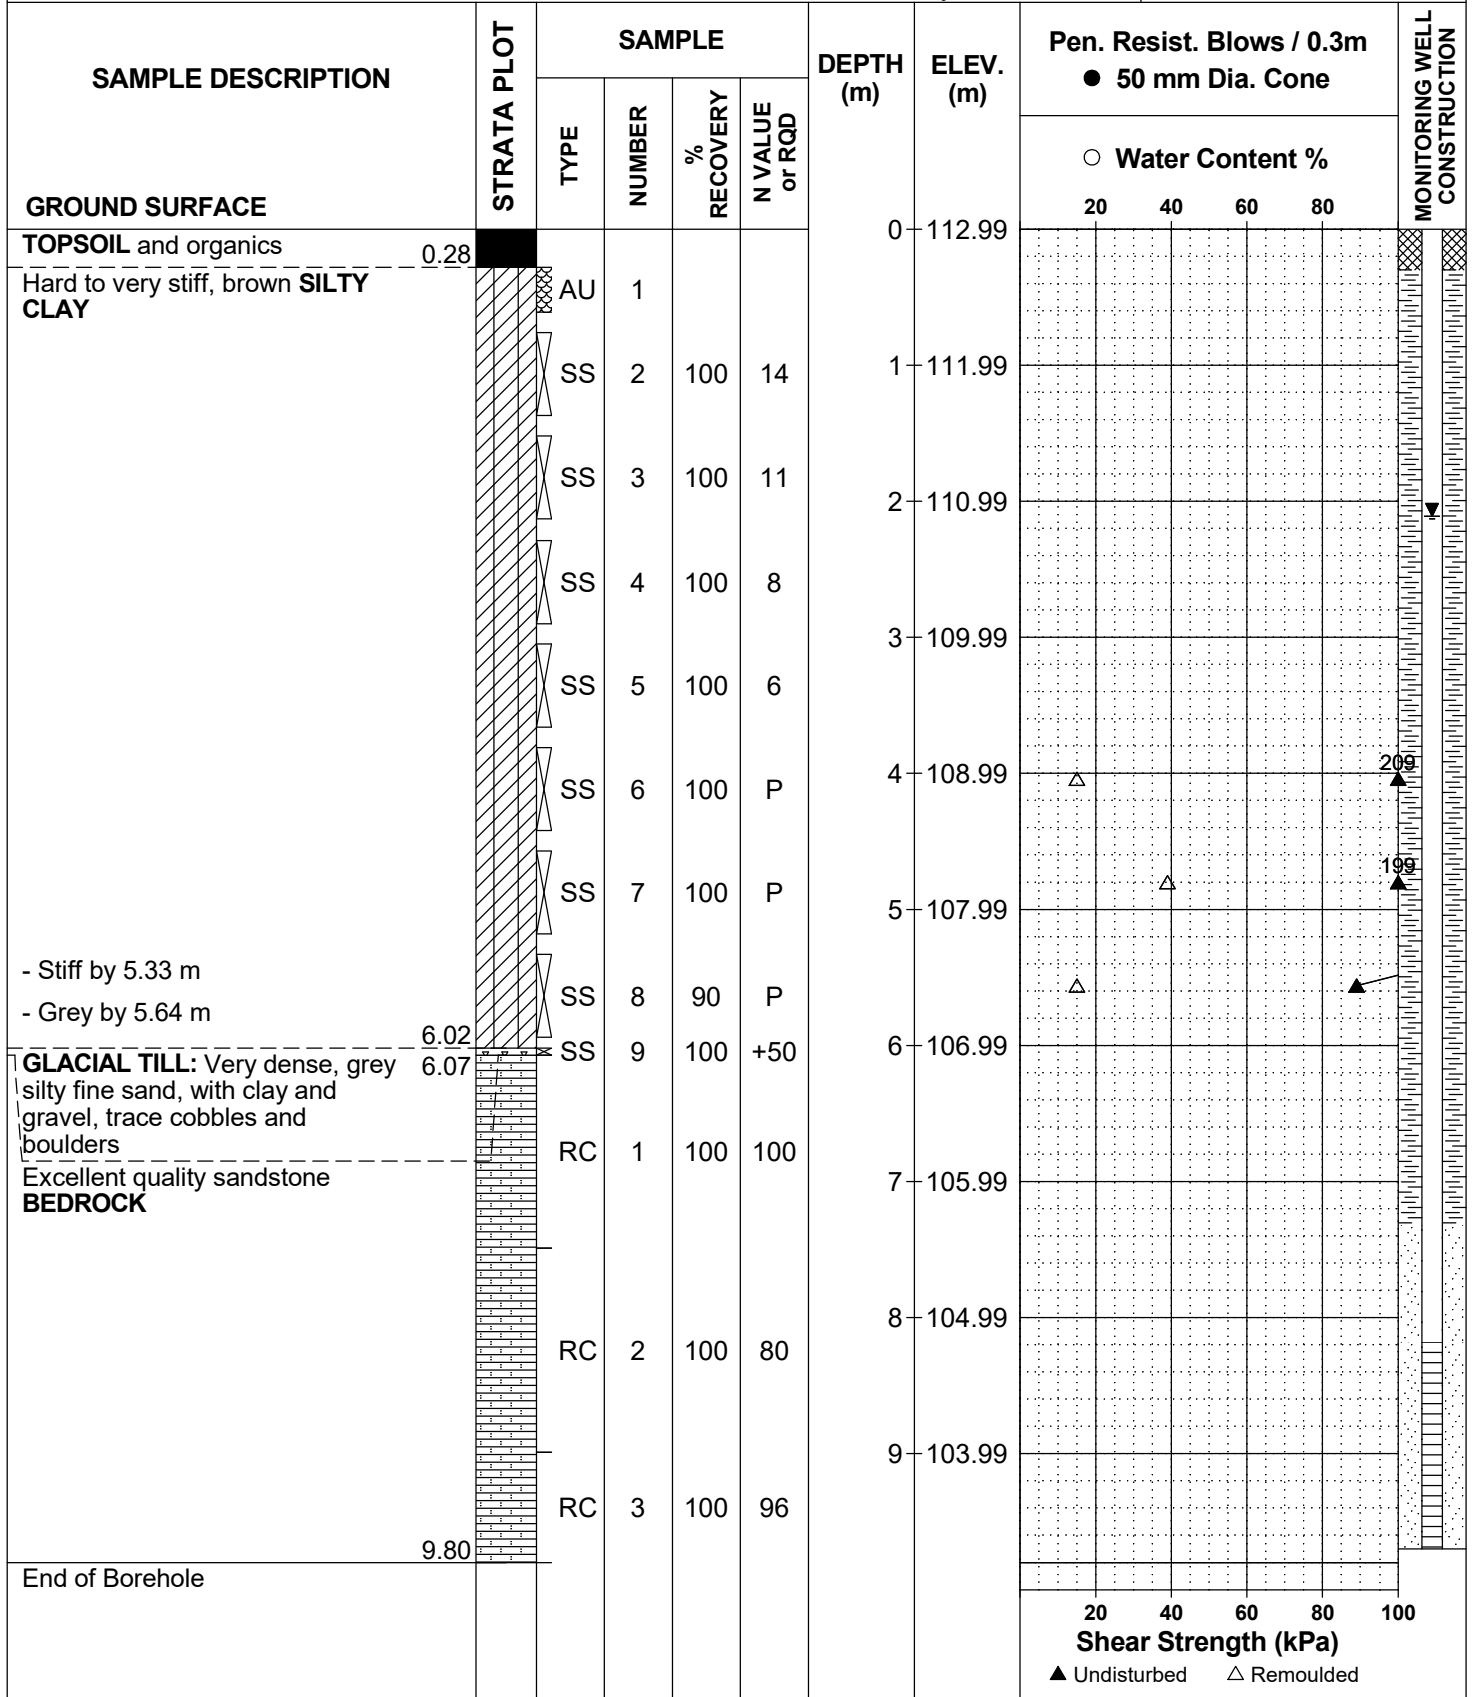
FILE NO. **PG6260**  
 HOLE NO. **BH 10-24**

EASTING: 327746.356    NORTHING: 5009717.302    ELEVATION: 112.988  
 DATUM: Geodetic  
 REMARKS:  
 BORINGS BY: CME-55 Low Clearance Drill    DATE: 2024 July 19

At boreholes BH 7-22 and BH 10-24, where bedrock was cored with the drilling equipment, the bedrock was observed to consist of good to excellent, light brown to grey sandstone.

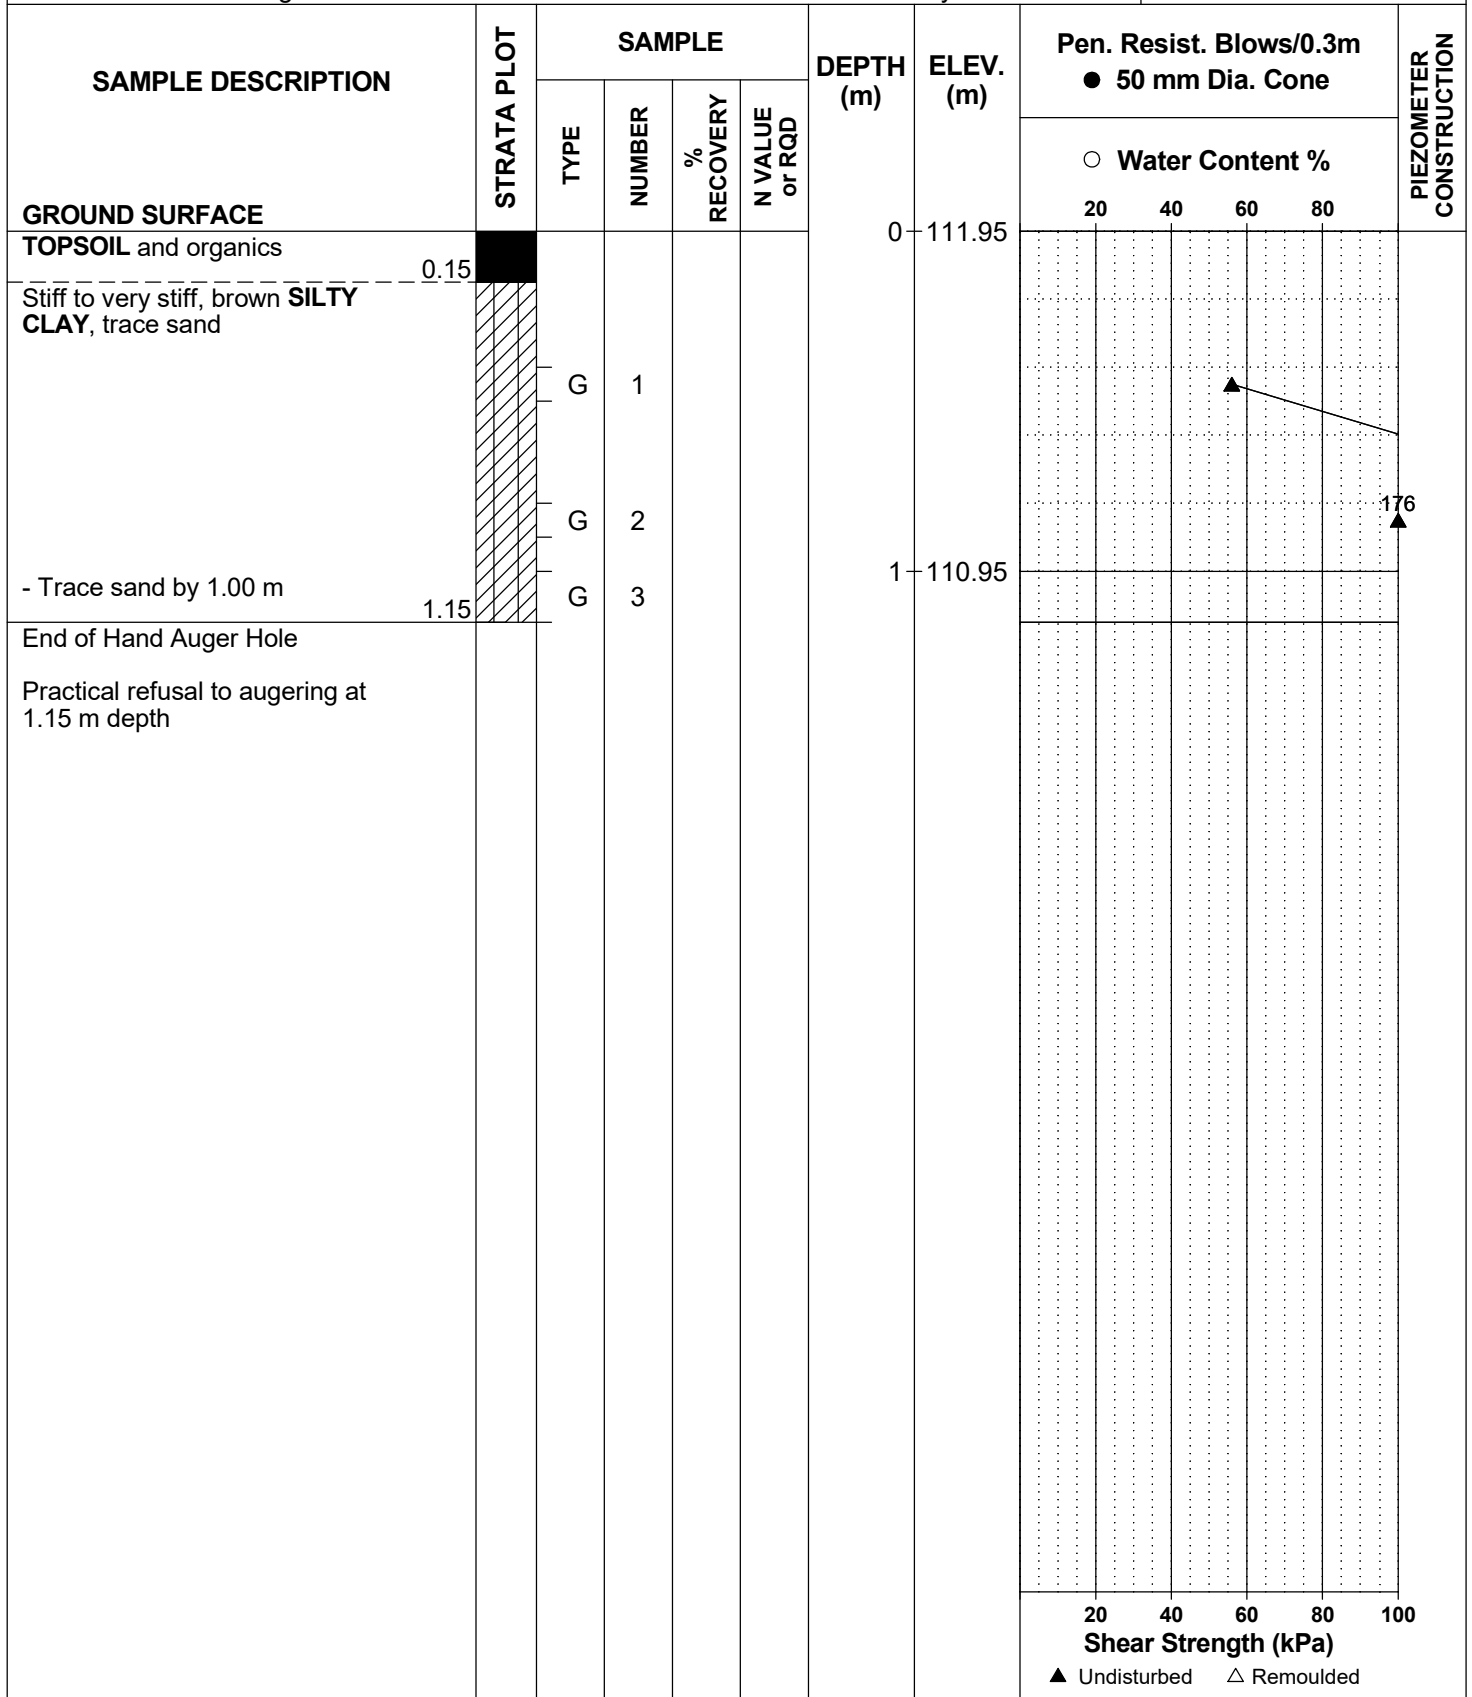
FILE NO. **PG6260**  
 HOLE NO. **HA 1-24**

EASTING: 327821.402    NORTHING: 5009932.198    ELEVATION: 111.954  
 DATUM: Geodetic  
 REMARKS:  
 BORINGS BY: Hand Auger    DATE: 2024 July 19

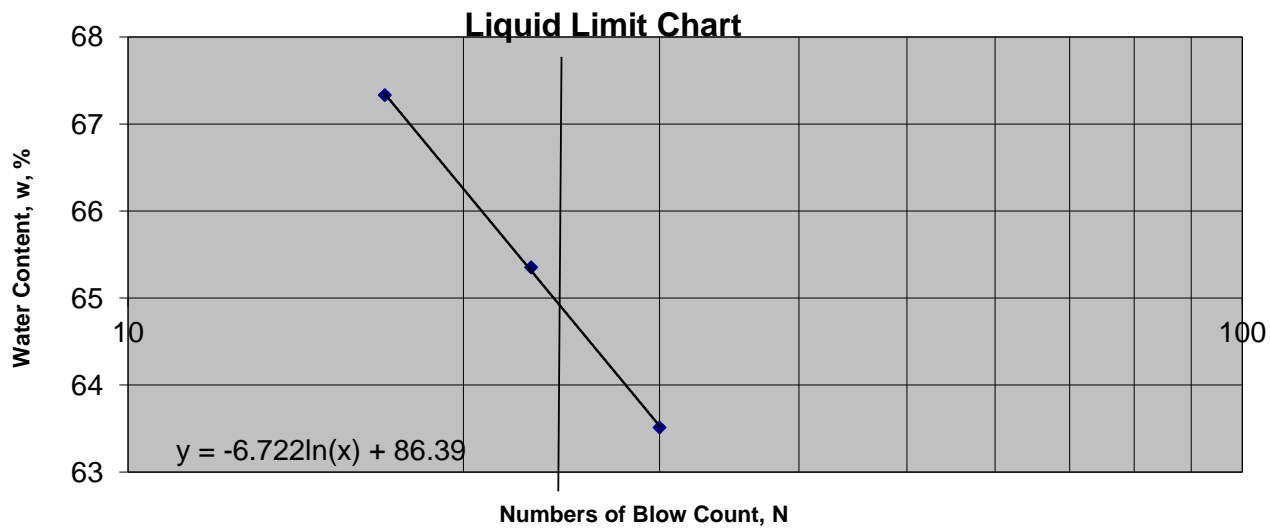
RESULTS	
LIQUID LIMIT	<b>65</b>
PLASTIC LIMIT	<b>35</b>
PLASTICITY INDEX	<b>30</b>

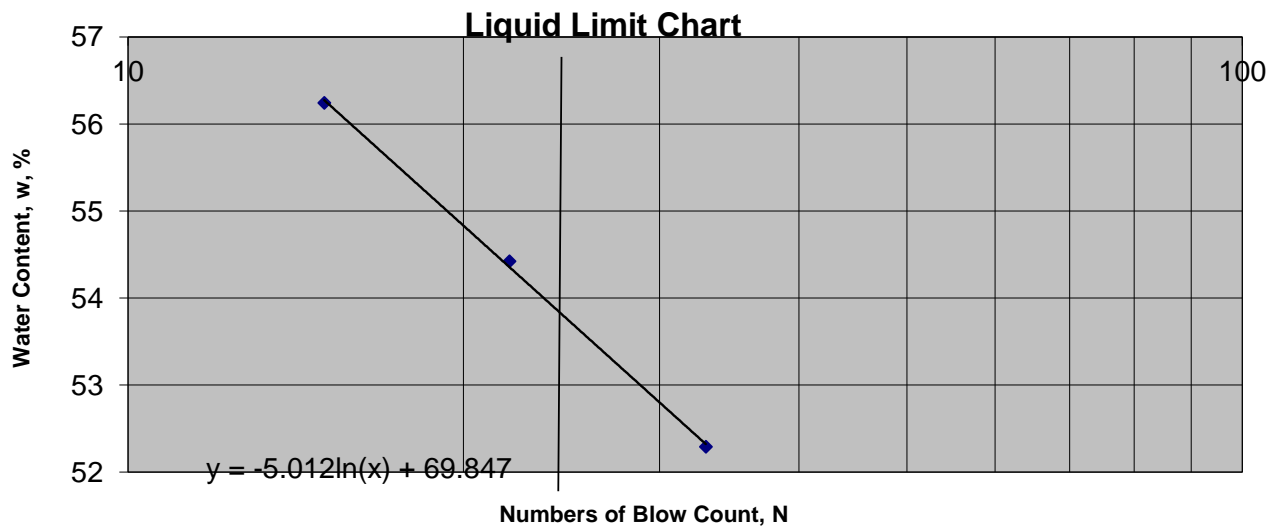
RESULTS	
LIQUID LIMIT	<b>54</b>
PLASTIC LIMIT	<b>28</b>
PLASTICITY INDEX	<b>26</b>

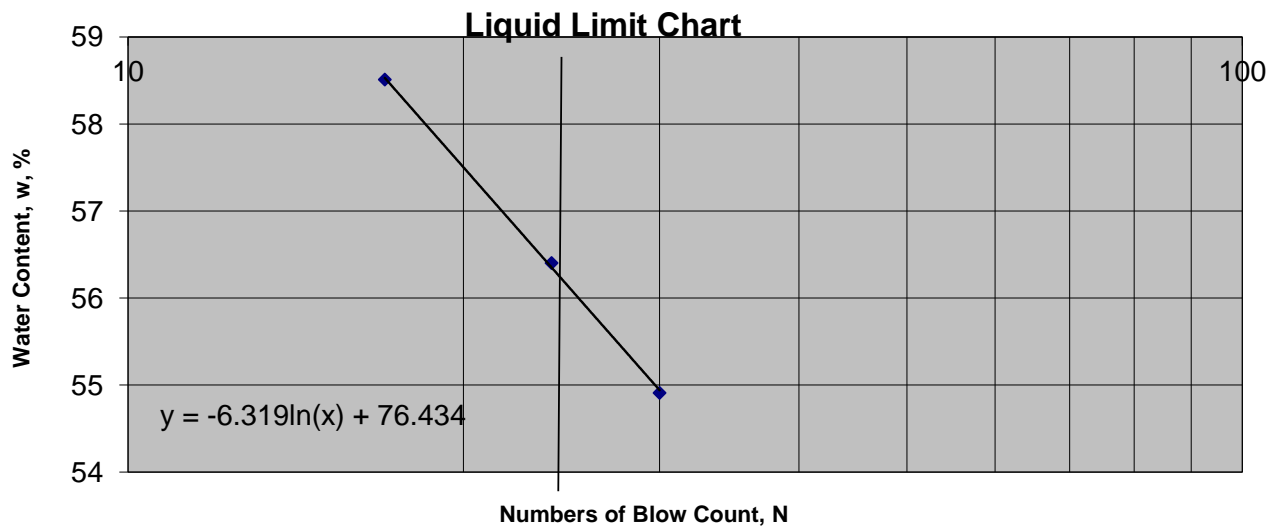
RESULTS	
LIQUID LIMIT	<b>57</b>
PLASTIC LIMIT	<b>28</b>
PLASTICITY INDEX	<b>29</b>

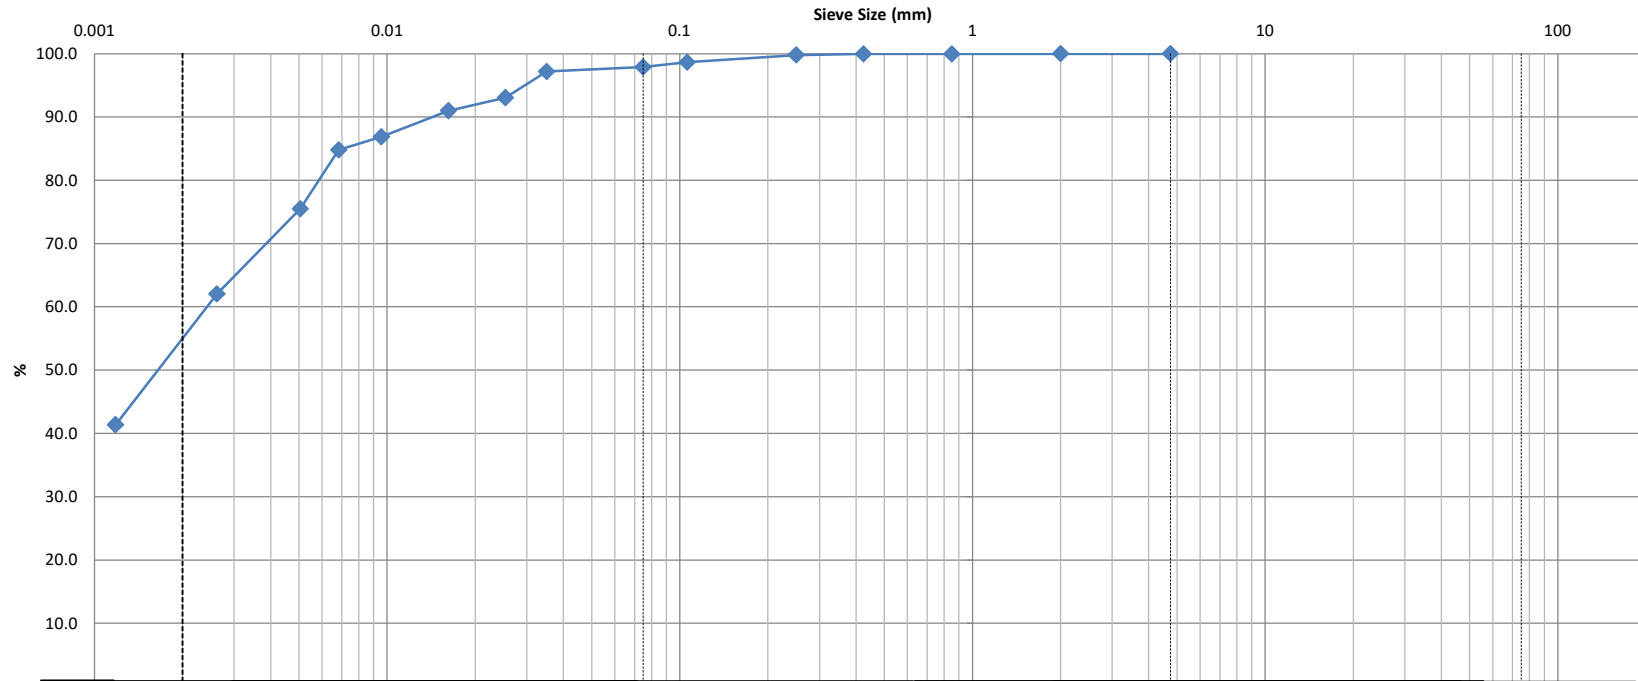
**SIEVE ANALYSIS  
ASTM C136**

CLIENT:	Regional Group (Novatech)	DEPTH:	5.0' - 7.0'	FILE NO:	PG6260
CONTRACT NO.:		BH OR TP No.:	BH13-22 SS3	LAB NO:	41375
PROJECT:	County Road 29 & Strathbury Street			DATE RECEIVED:	1-Dec-22
DATE SAMPLED:	Nov 28-29			DATE TESTED:	6-Dec-22
SAMPLED BY:	JP			DATE REPORTED:	13-Dec-22
				TESTED BY:	DK/CS

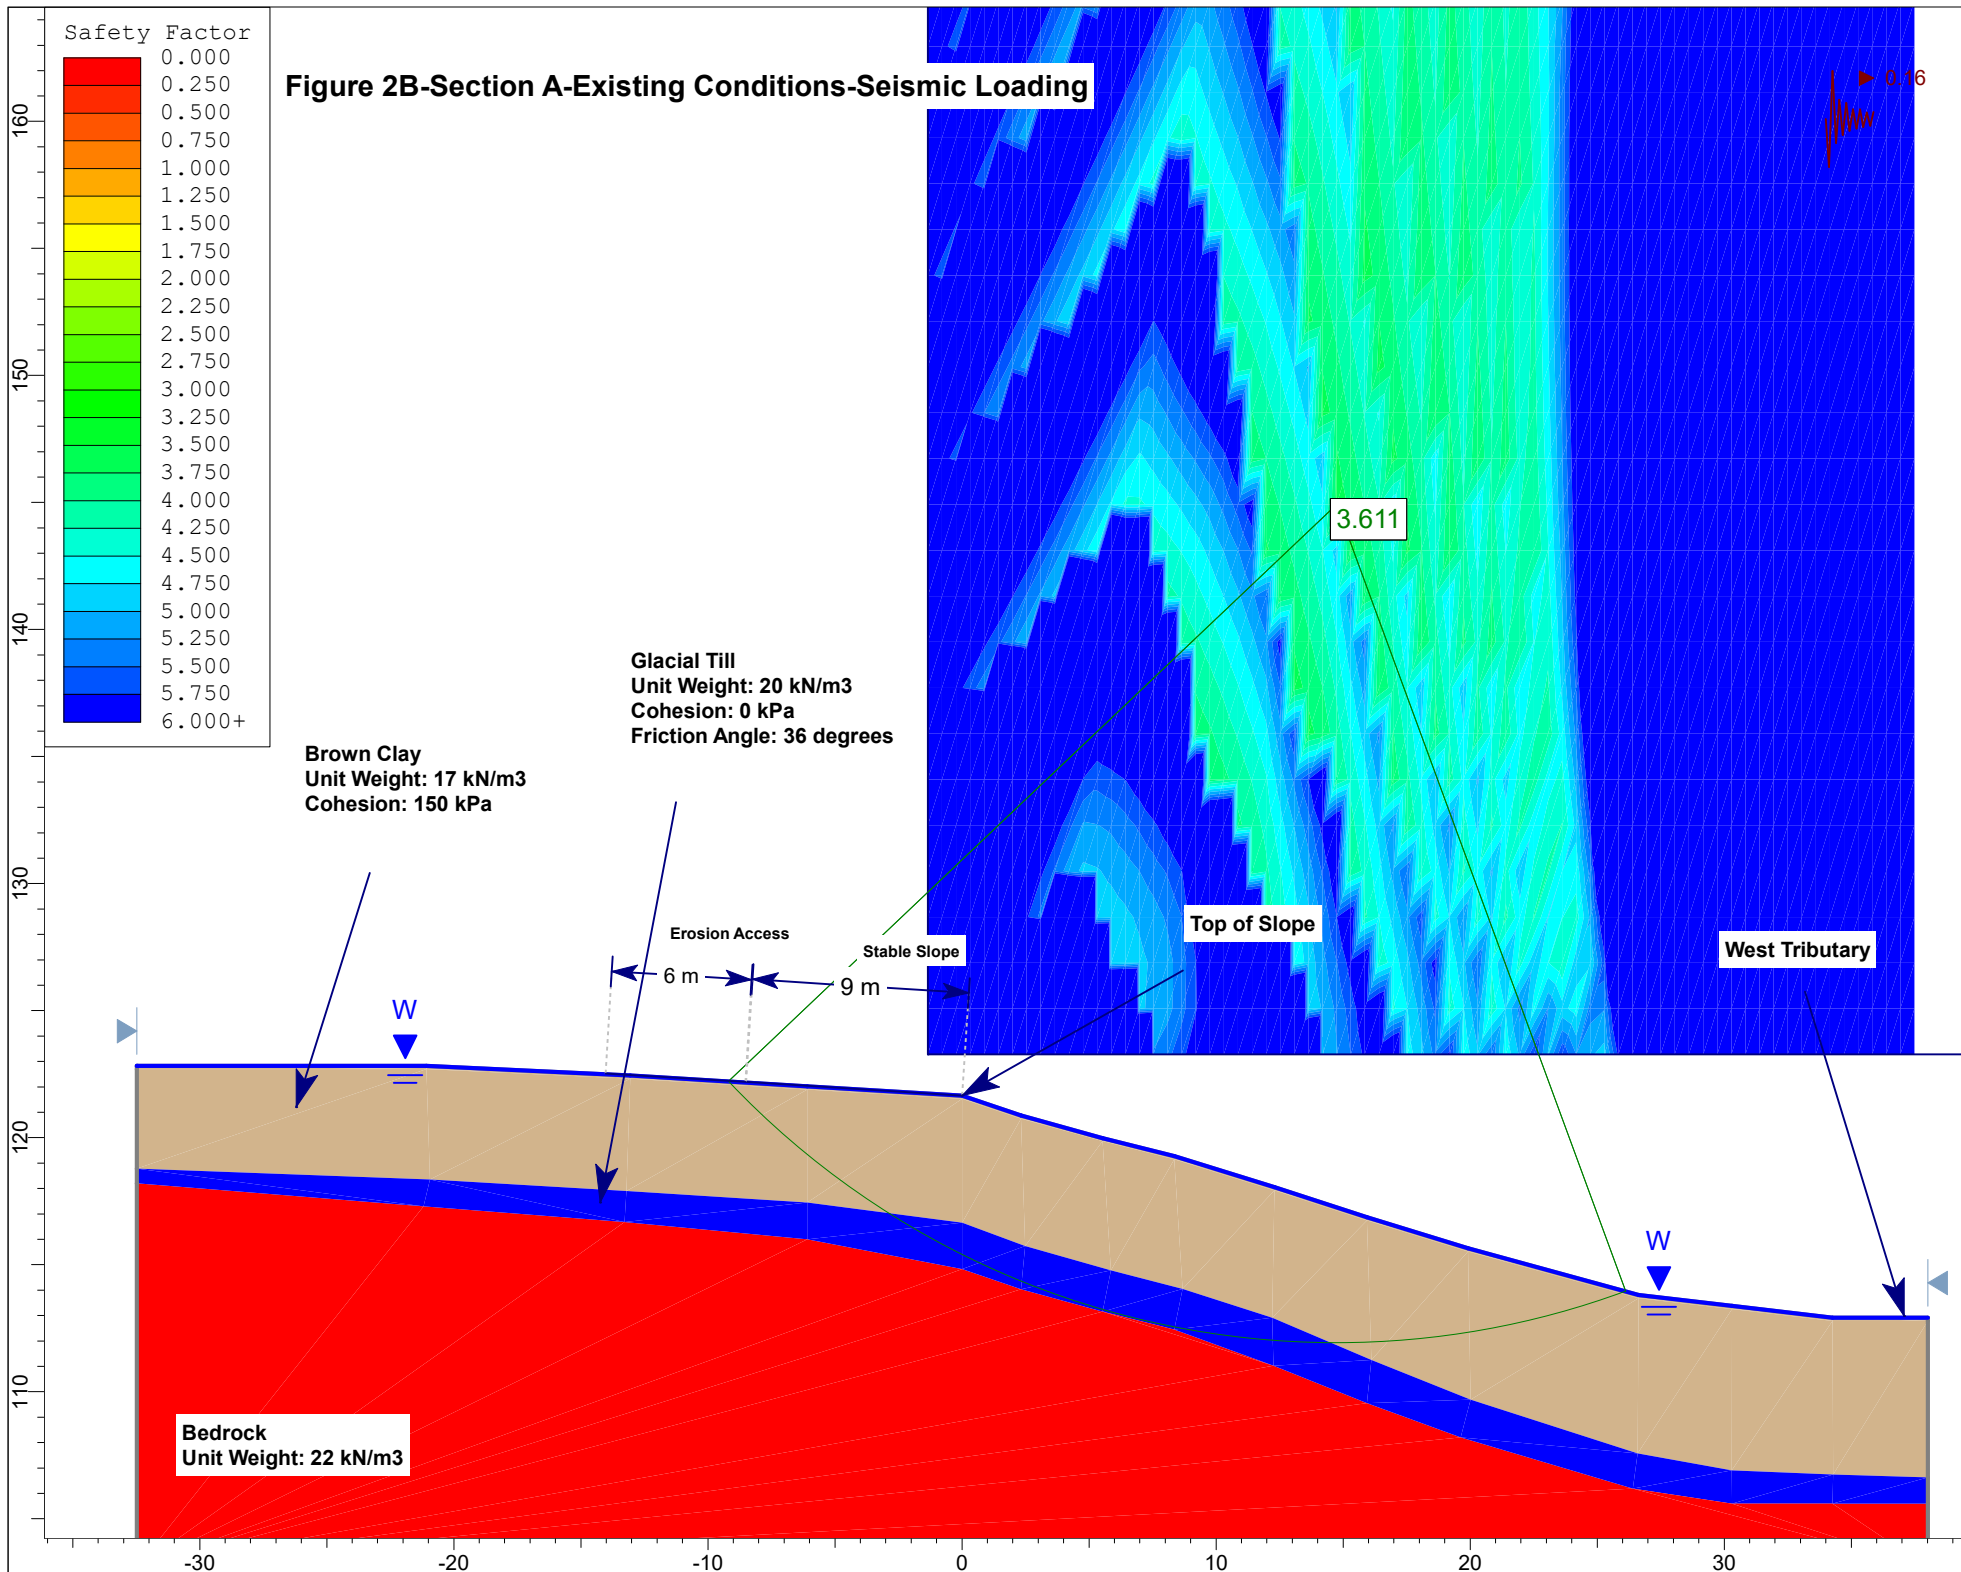
The static analysis results for slope cross-sections A-A, and B-B are presented in Figures 2A and 3A, respectively, provided in Appendix 2. The factors of safety for the slopes was greater than 1.5 for slope cross-section B-B. A factor of safety less than 1.5 was noted for slope cross-section A-A, therefore, a slope stability setback would be required, if the existing slope was not re-graded as part of the proposed development. A stable slope setback of 9 m, for slope cross-section A-A, would be required if the existing slope is not modified.
