# **Geotechnical Investigation**

## **Proposed Residential Development**

Brown Lands - County Road No. 29 and Strathburn Street  
Almonte, Ontario

Report PG6260 – 2 Rev. 3 dated September 20, 2024

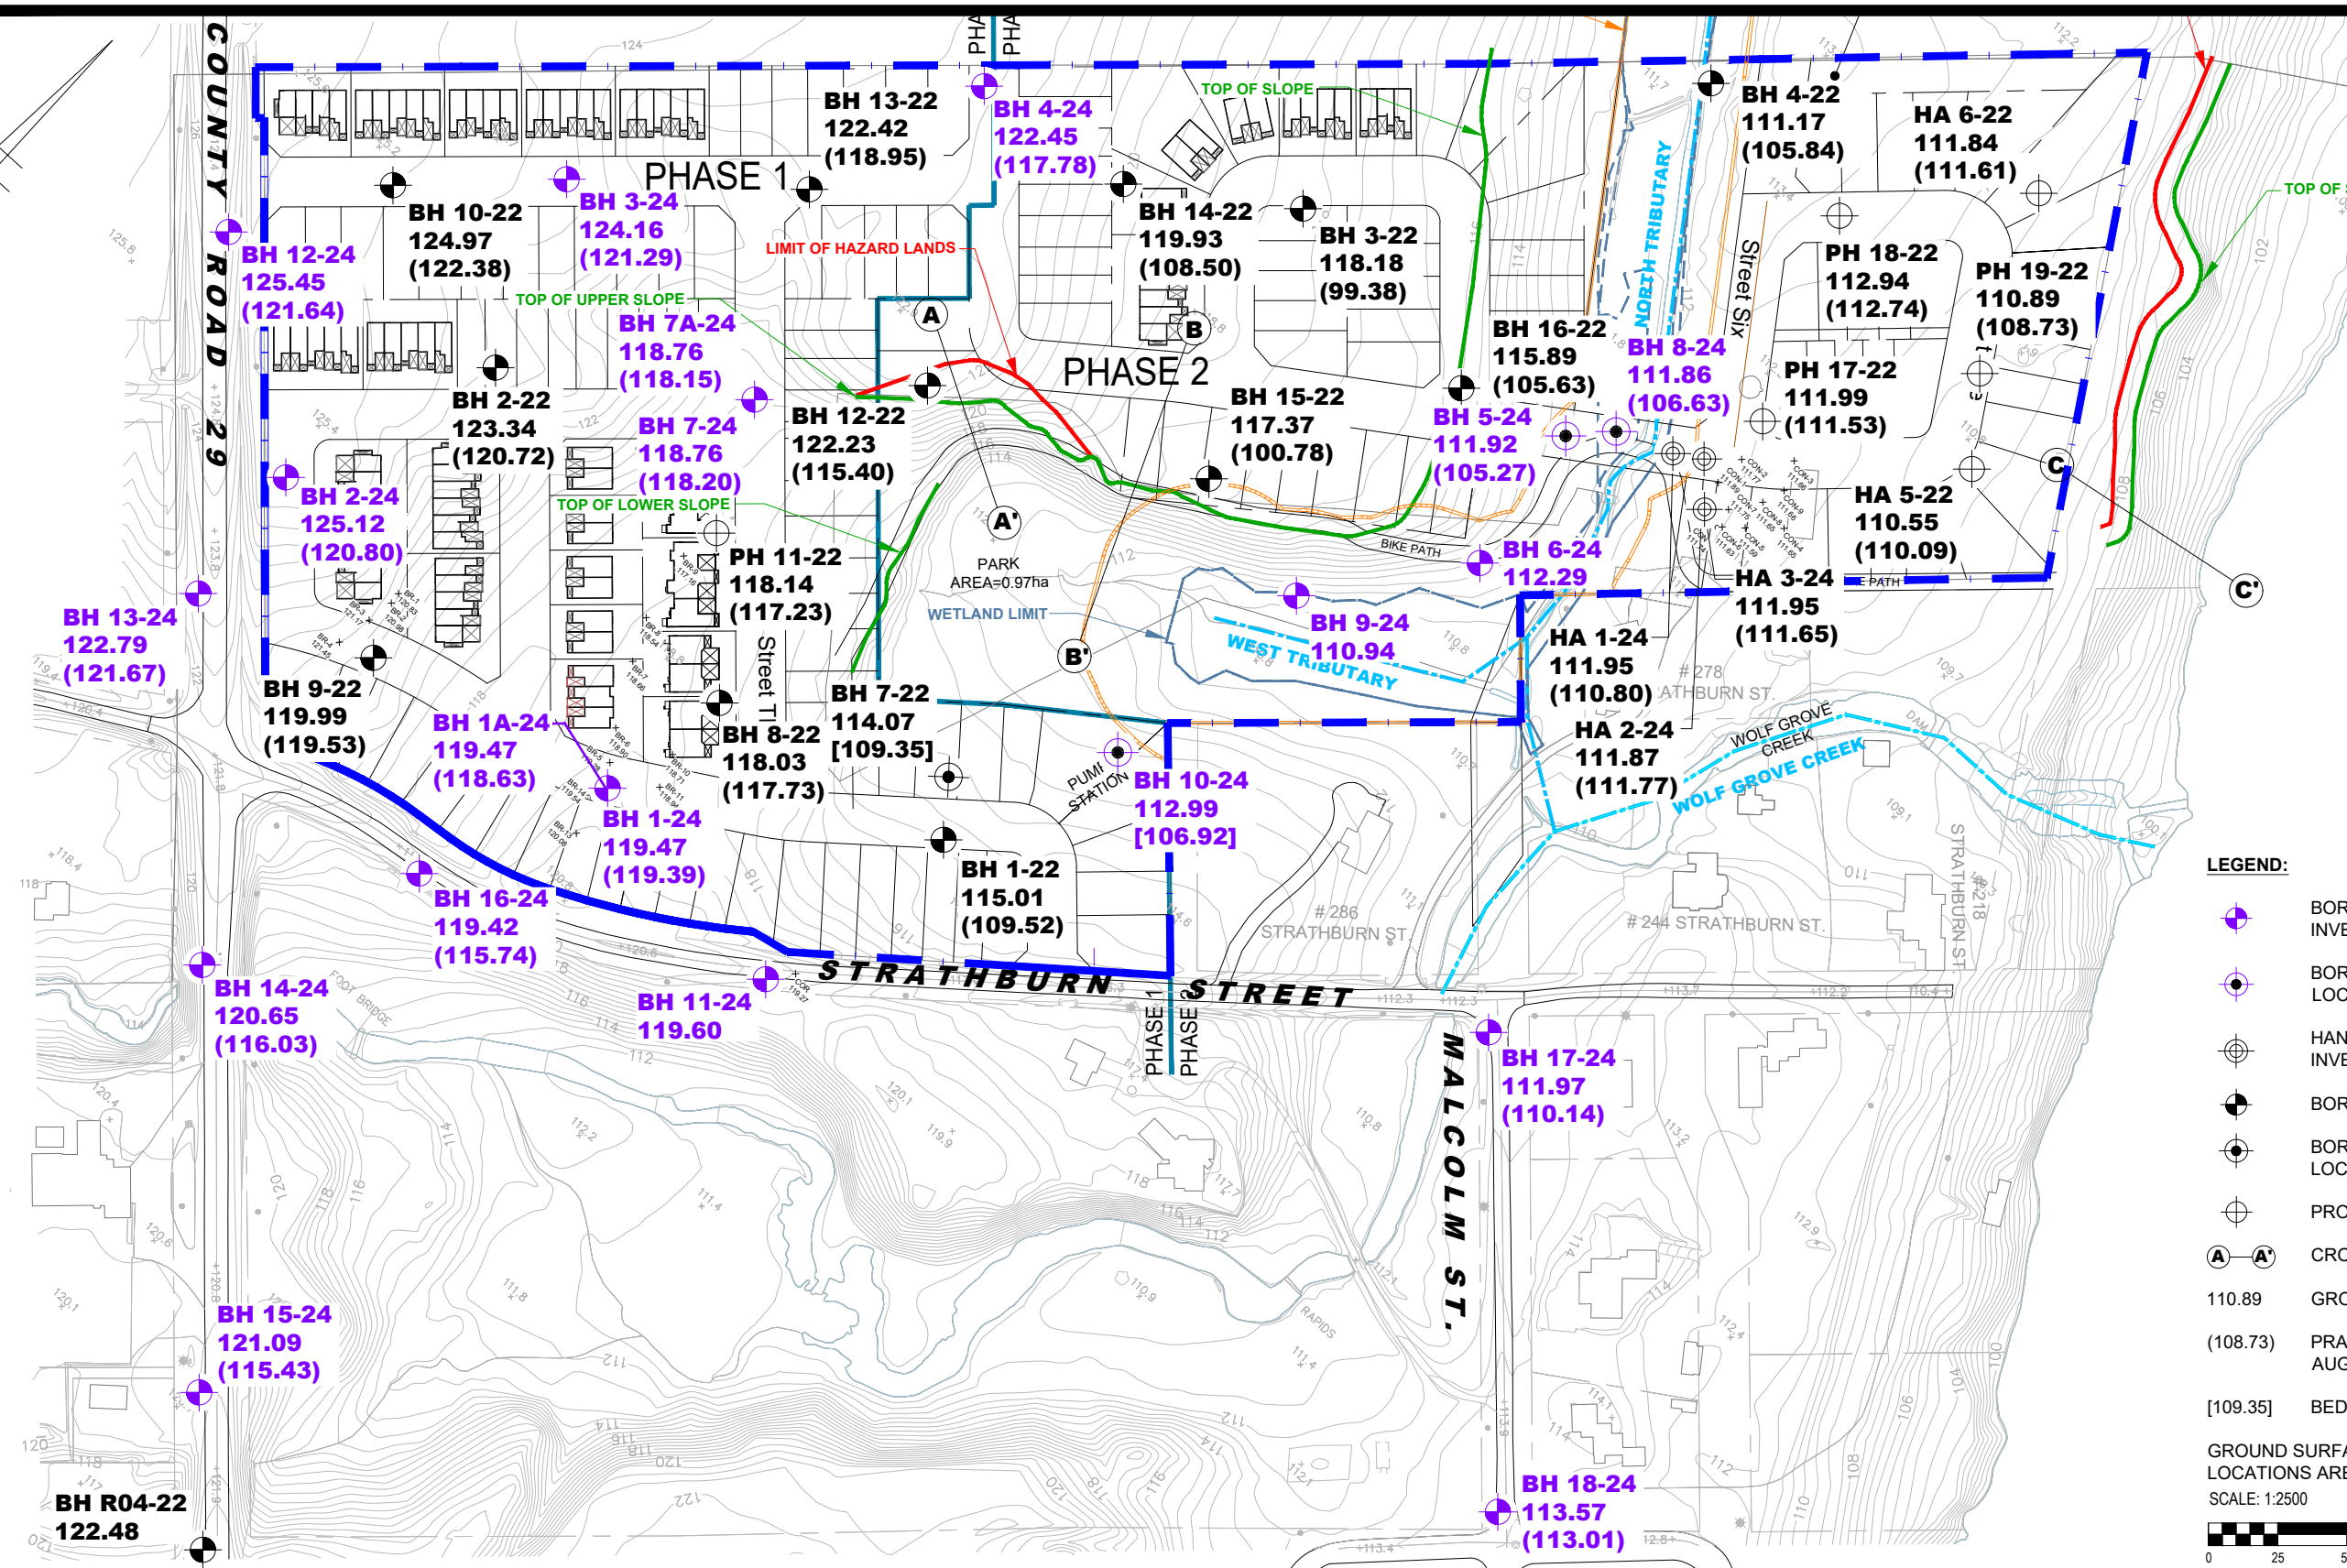
Scale:	1:2500	Date:	01/2023
Drawn by:	JM	Report No.:	PG6260-1
Checked by:	NS	Dwg. No.:	<b>PG6260-1</b>
Approved by:	DP	Revision No.:	4

Three (3) slope cross-sections (Sections A, B, and C) were studied as the worst case scenarios. The cross section locations are presented on Drawing PG6260-1 – Test Hole Location Plan in Appendix 2. It should be noted that details of the slope height and slope angle at the cross-section locations are presented in Figures 2A through 4B in Appendix 2, based on the topographic data obtained during the field investigation, as well as the available topographic survey plan for the site.

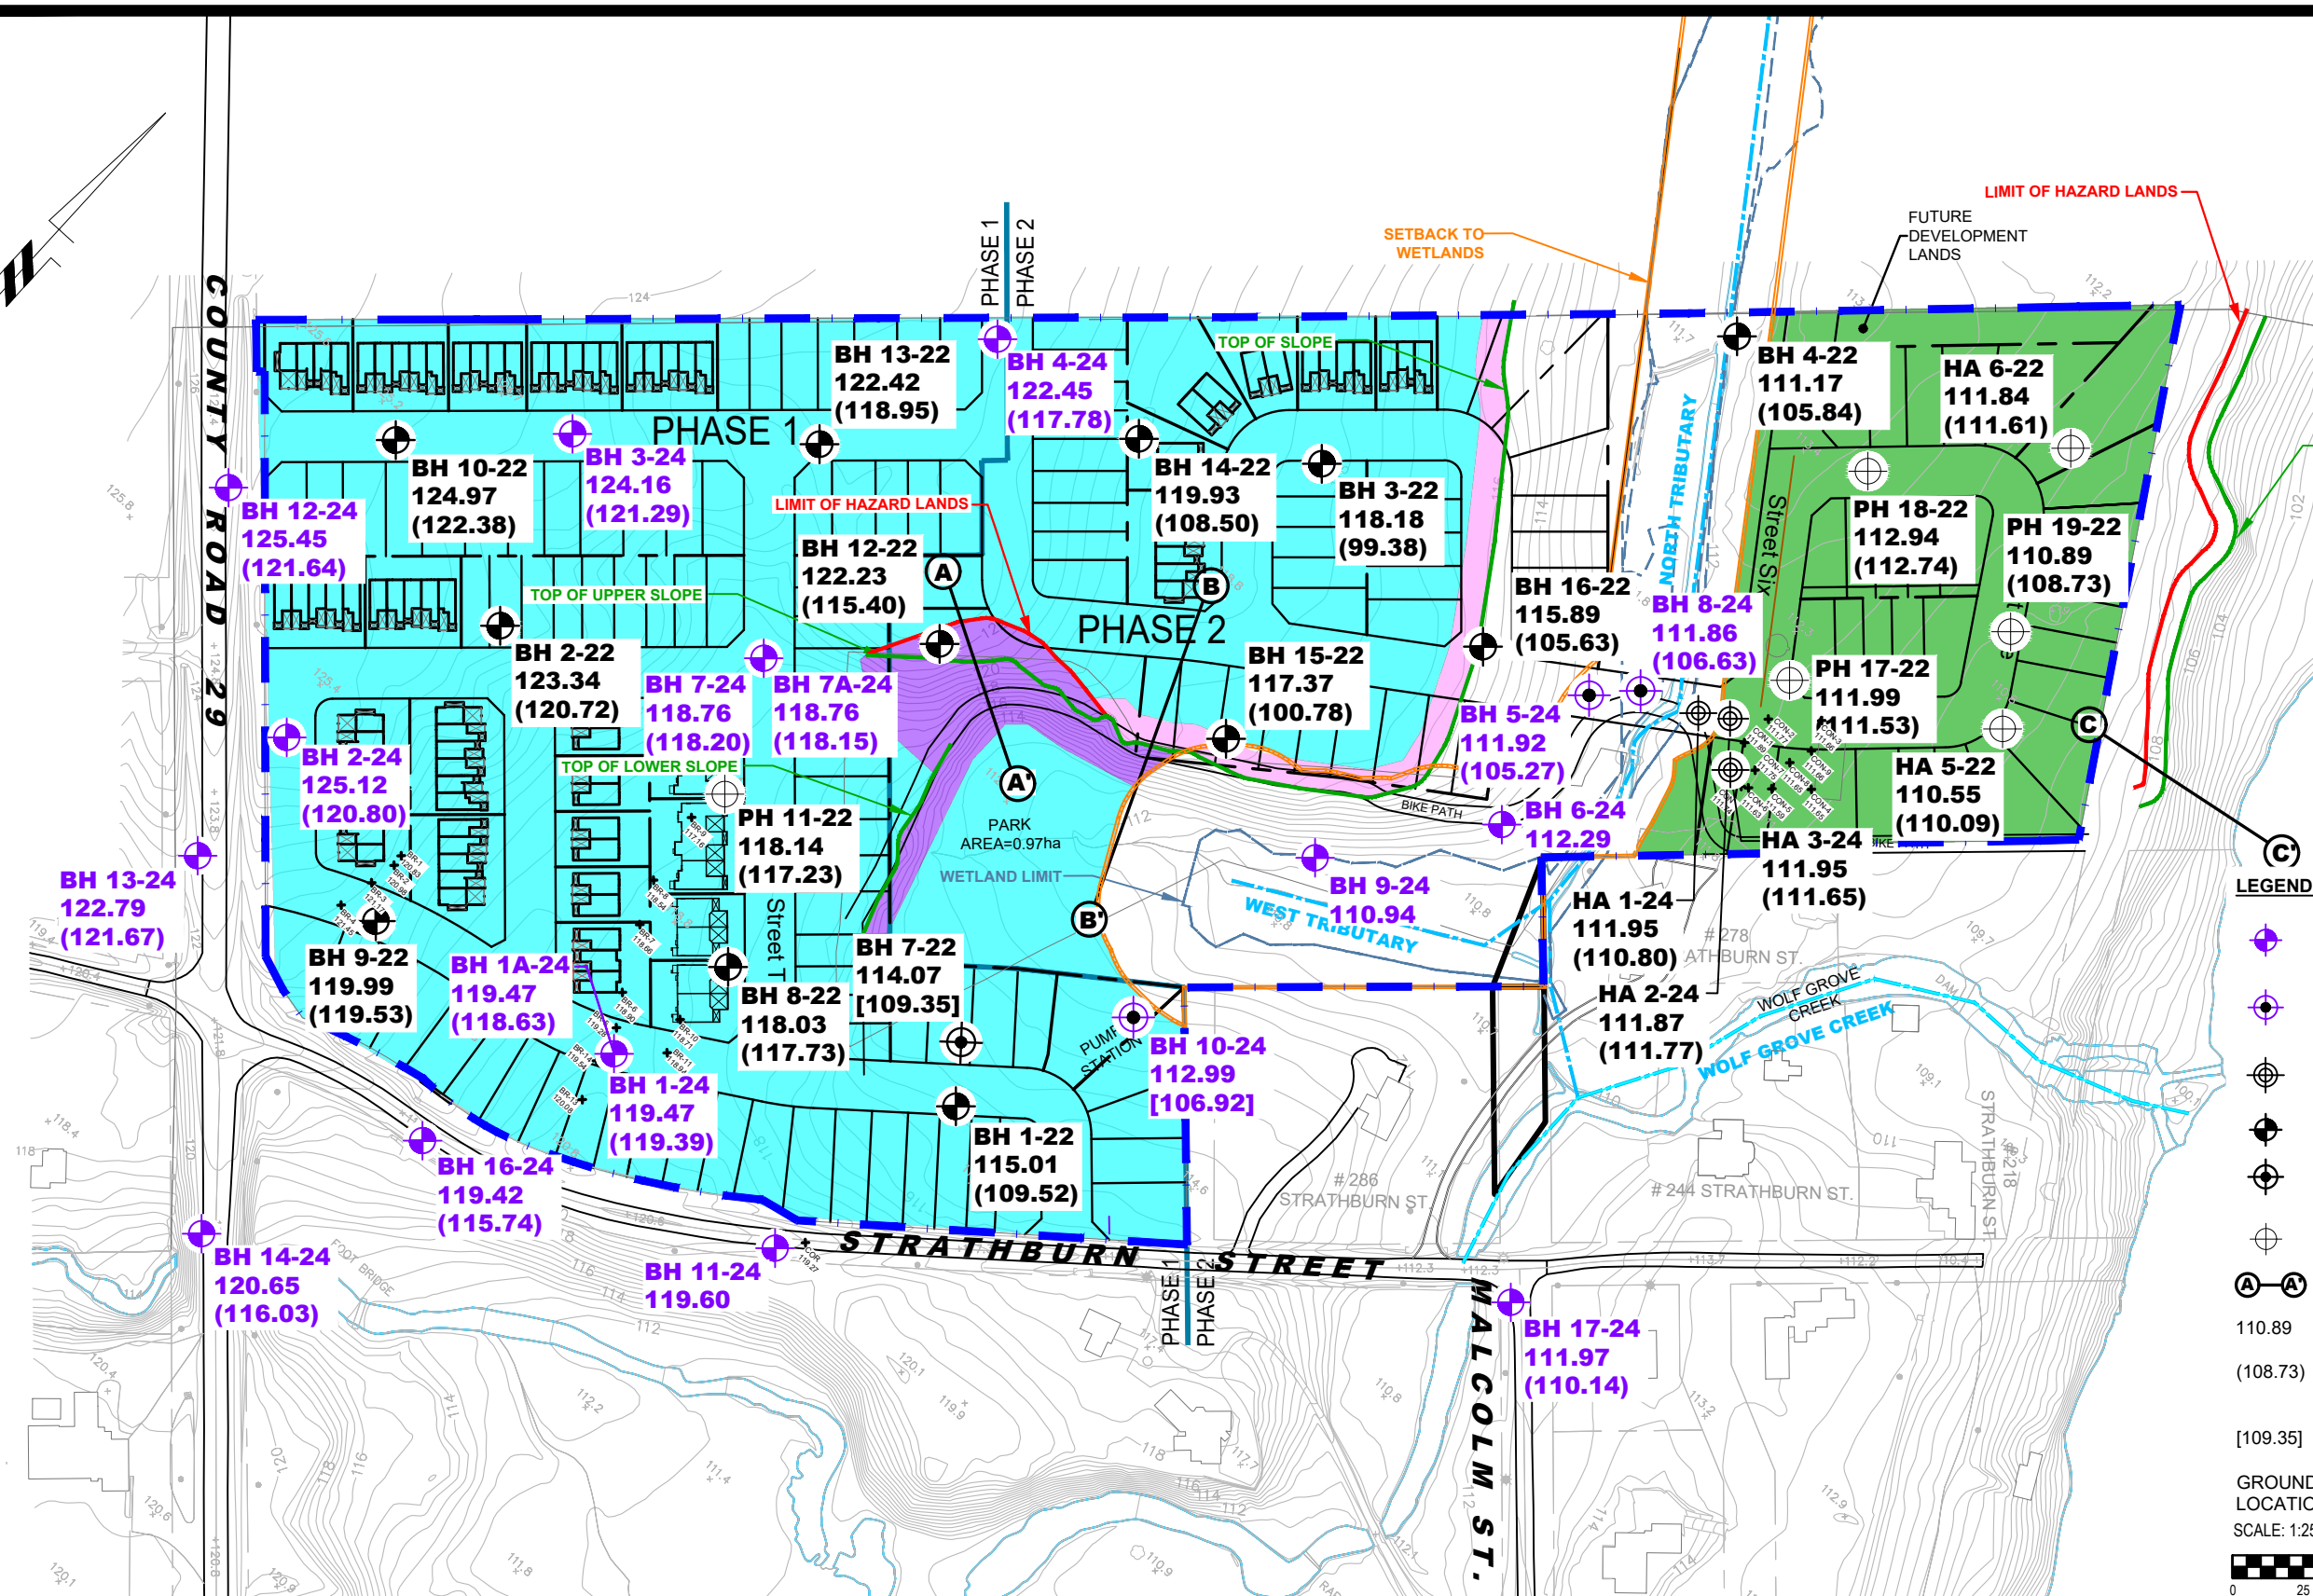
**PERMISSIBLE GRADE RAISE:**

NO GRADE RESTRICTIONS
	NO PERMISSIBLE GRADE RAISE RECOMMENDED
	UP TO 1.0 m (FROM THE TOP OF SLOPE TO A DISTANCE OF 10 m AWAY FROM SLOPE)
	UP TO 3.0 m

Due to the presence of the silty clay deposit throughout the western portion of the subject site, a permissible grade raise restriction is recommended for grading at the subject site where silty clay is present. Reference should be made to Drawing PG6260-2 – Permissible Grade Raise Plan in Appendix 2 of this report for the areas where the permissible grade raise restriction are recommended.
