**THE CORPORATION OF THE MUNICIPALITY OF MISSISSIPPI MILLS
HERITAGE ADVISORY COMMITTEE AGENDA**

1. Renovations to the St. Paul's Rectory

70 Clyde Ave, Almonte, ON May 22, 2018

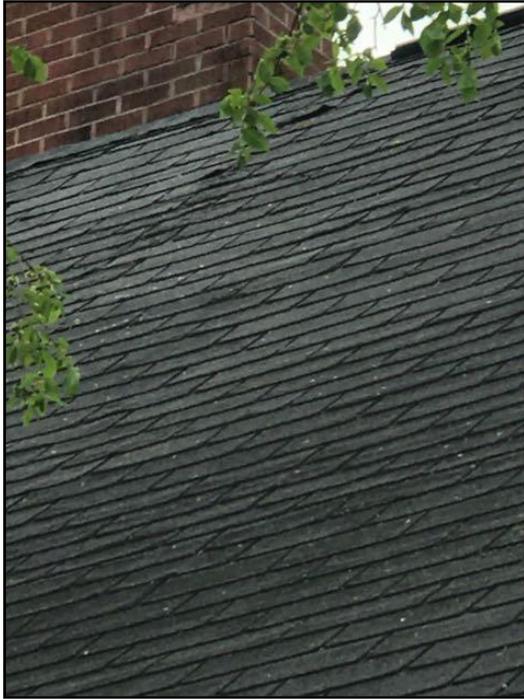
9. Strip old shingles. Install Ice Guard prio...

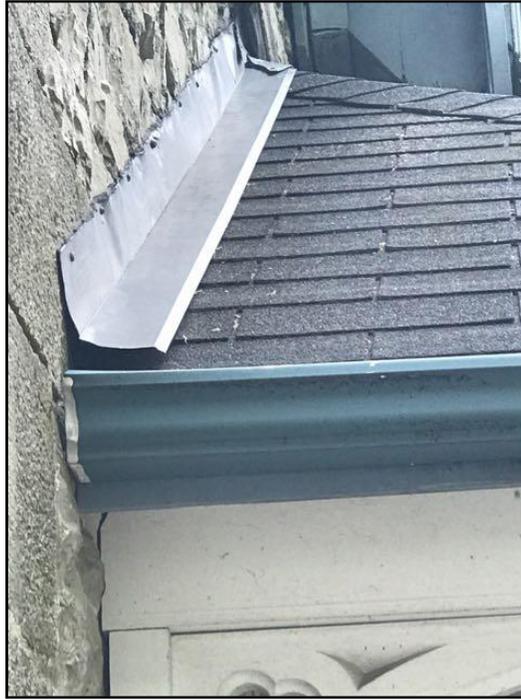
13.

Condition: • There is shingle and roof damage at the north side porch.

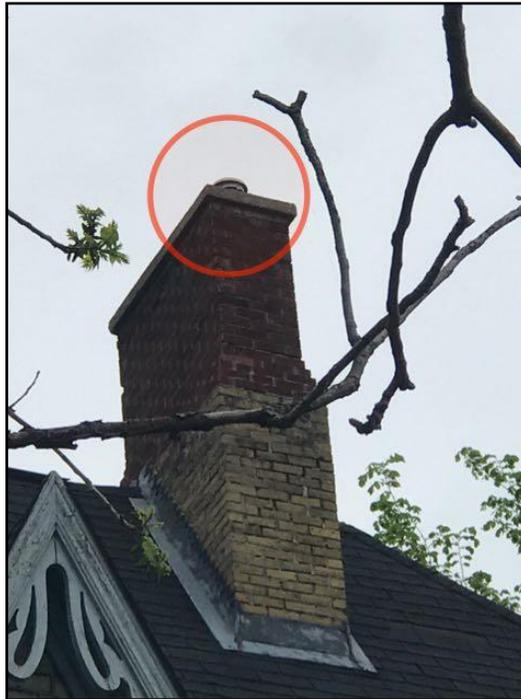
16. Consider metal flashing over cement chimney...

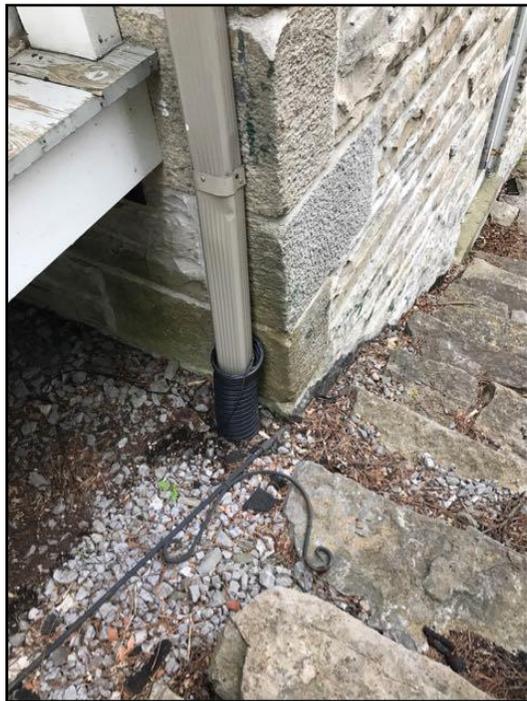
17. Discharge below grade

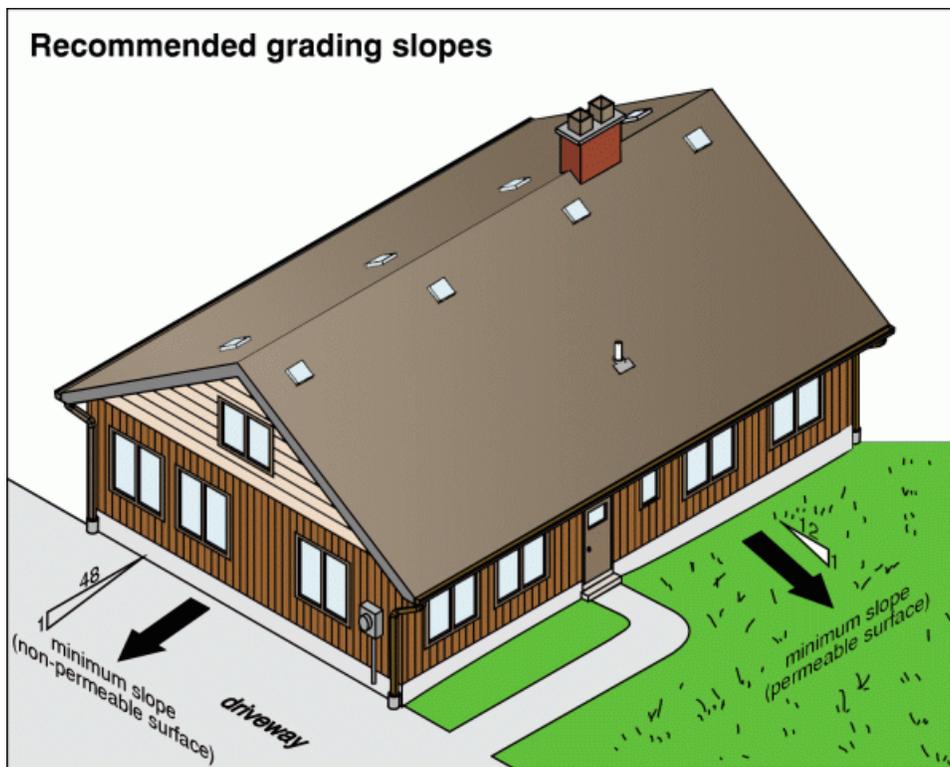
Condition: • [Improper slope or drainage](#)

when the overall lot drainage is toward the house, swales can be used to direct surface water away from the foundation

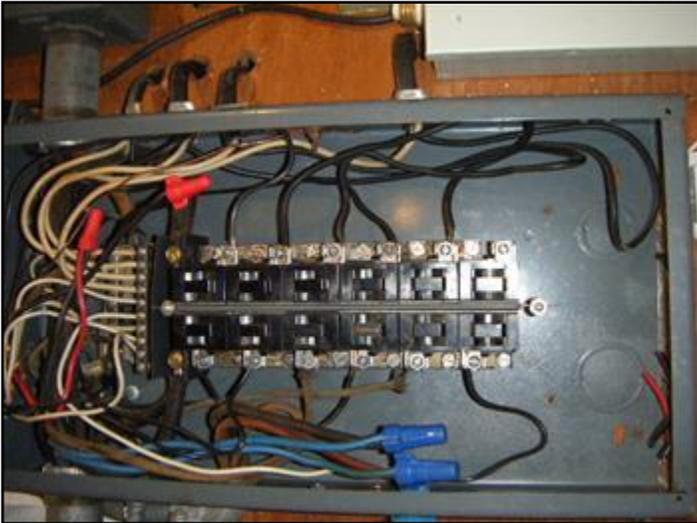
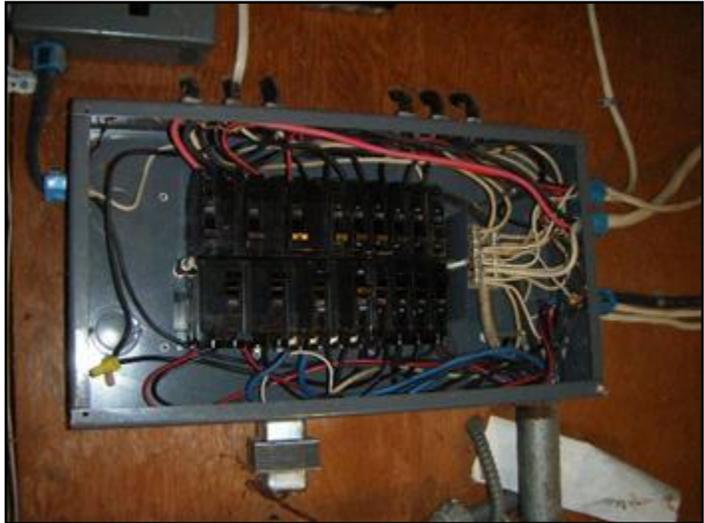
42. 200 Amps (240 Volts)

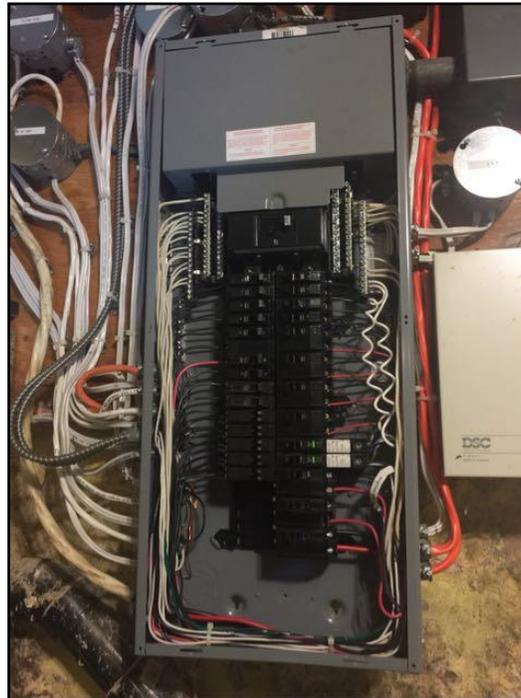
45. 200 Amps

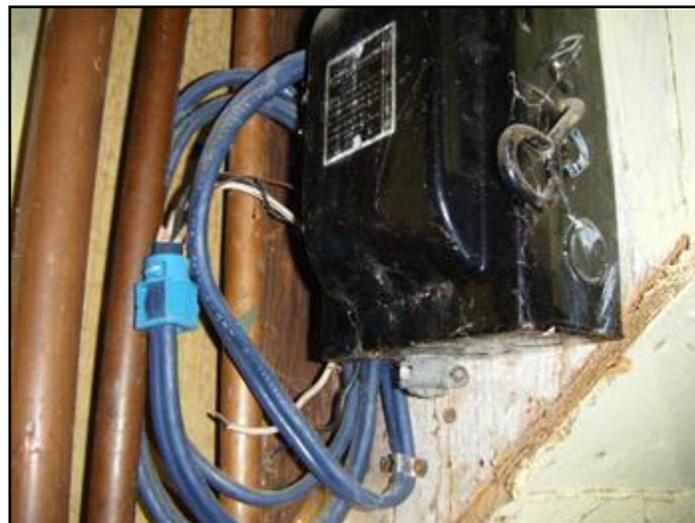
53.

DISTRIBUTION SYSTEM \ Wiring - damaged or exposed

Condition: • [Exposed on walls or ceilings](#)

Location: East Basement

Task: Correct

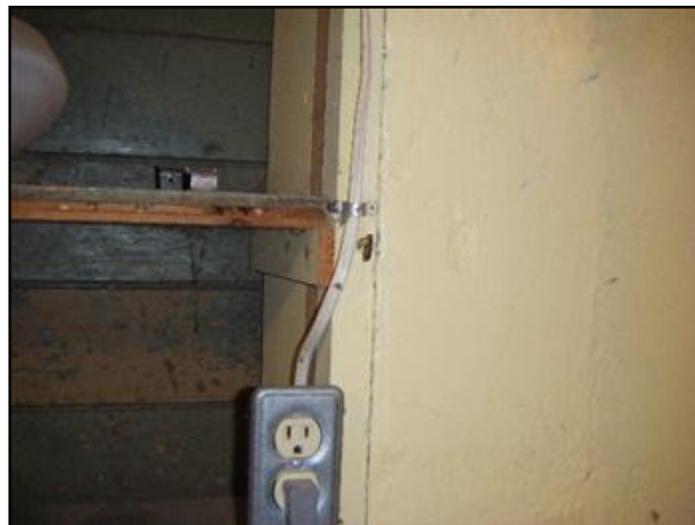
54.

DISTRIBUTION SYSTEM \ Outdoor wiring

Condition: • Exterior Outlets are not GFCI or the outlets have a faulty GFCI. Upgrade all exterior outlets to GFCI or replace faulty GFCI's

Task: Upgrade

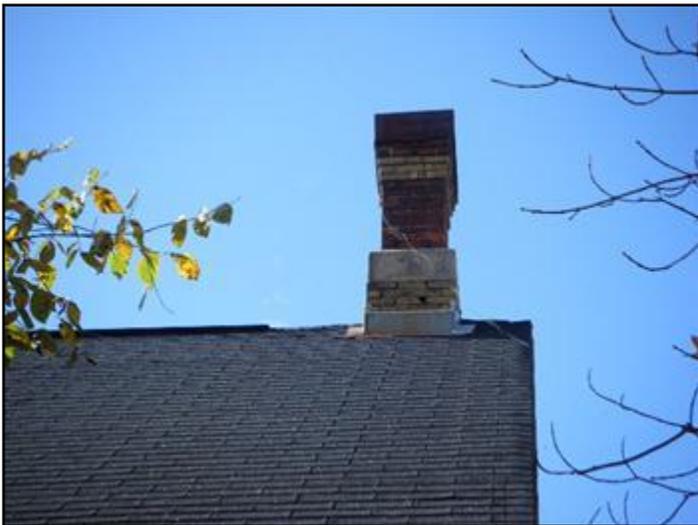
61.

Condition: • [Loose, missing or deteriorated mortar](#)

Loose brick and mortar at the masonry chimney. repair this condition before bricks start to fall off the roof.

Implication(s): Material deterioration

Task: Repair

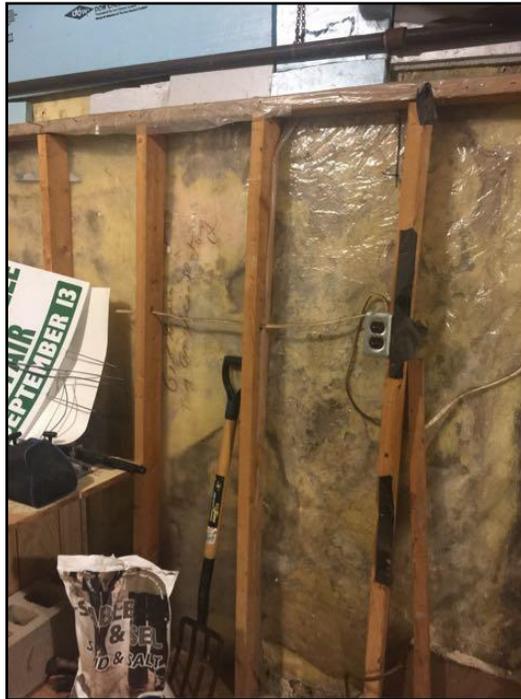
Condition: • [Vapor barrier in wrong location](#)

Implication(s): Chance of condensation damage to finishes and/or structure

63. Vapor barrier in wrong location

Remove the vapour barrier from the stone wall. It's important to allow the Stone foundations to breathe.

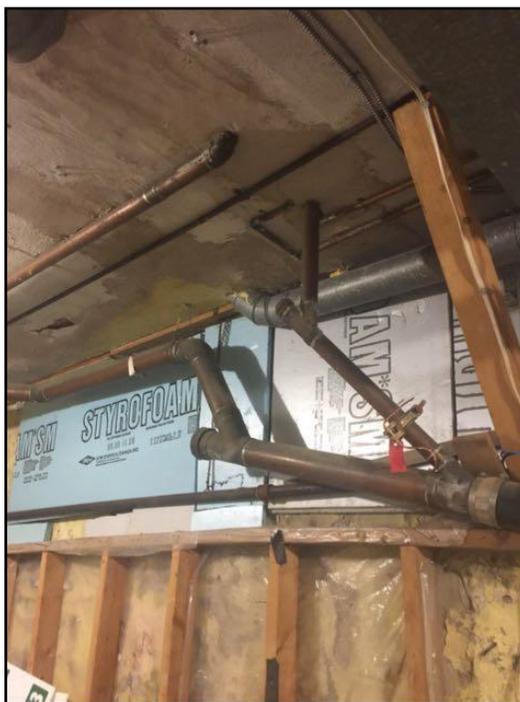
Condition: • [Exposed combustible insulation](#)

Implication(s): Fire hazard

64. Exposed combustibles

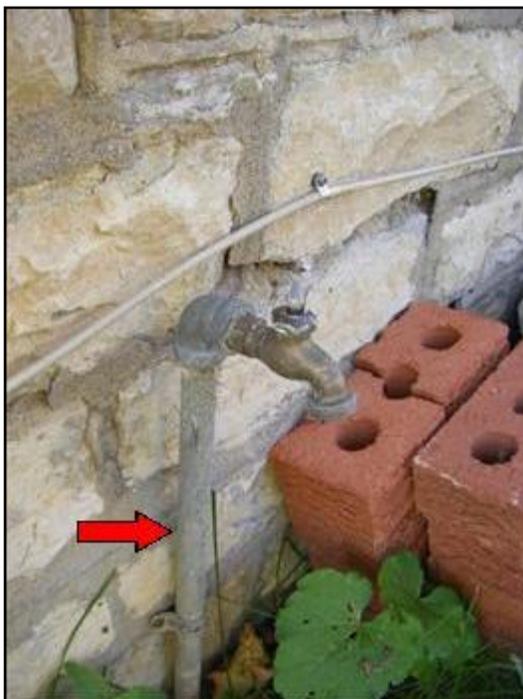
72.

- Galvanized Water Supply Lines
- Replace small section of galvanized water pipe and install a Frost Free Hose spigot
- Implication(s):** Split and leak
- Location:** Exterior Wall
- Task:** Replace
- Cost:** \$200

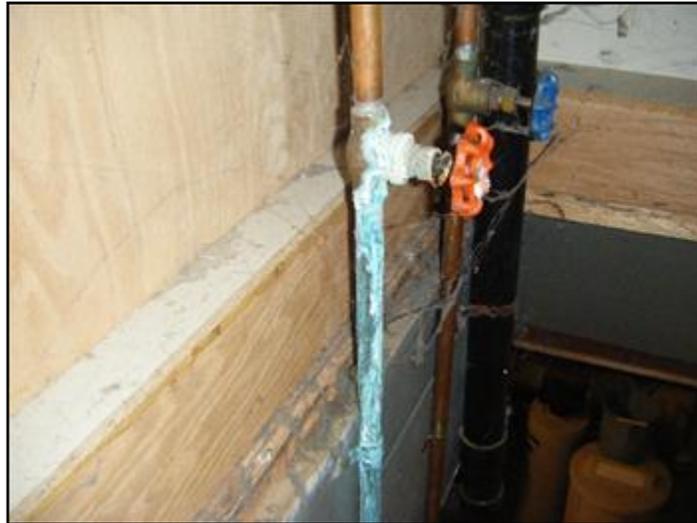
74.

SUPPLY PLUMBING \ Supply piping in building

Location: Basement Staircase

Task: Repair or replace

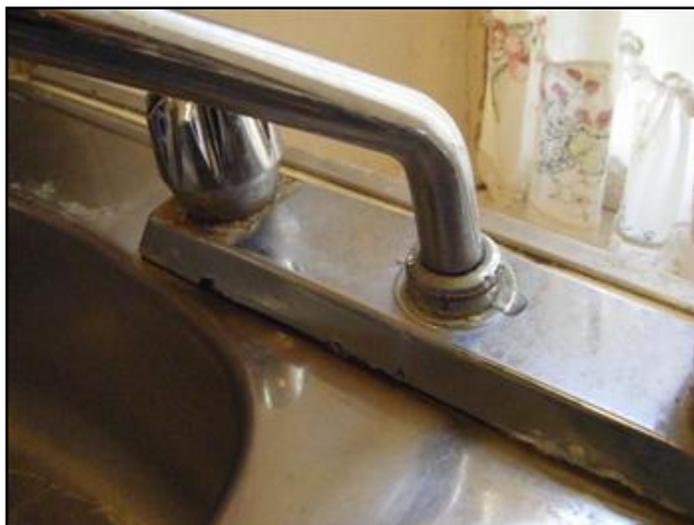
76.

WASTE PLUMBING \ Venting system

Location: First Floor Kitchen

Task: Replace

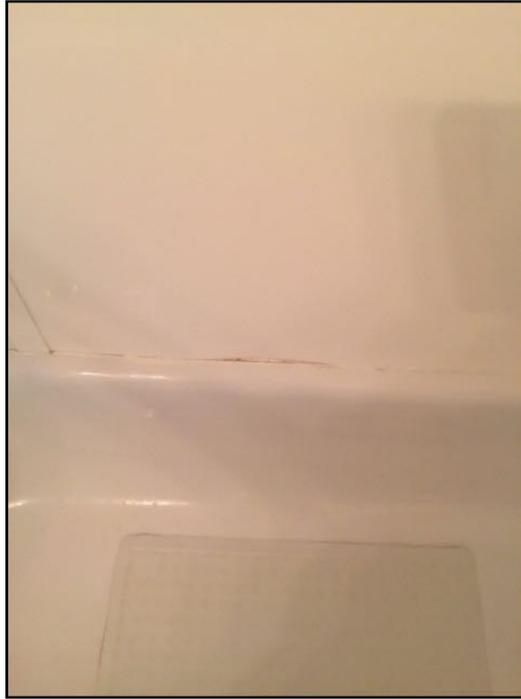
78. Ensure there is a proper caulking seal at...

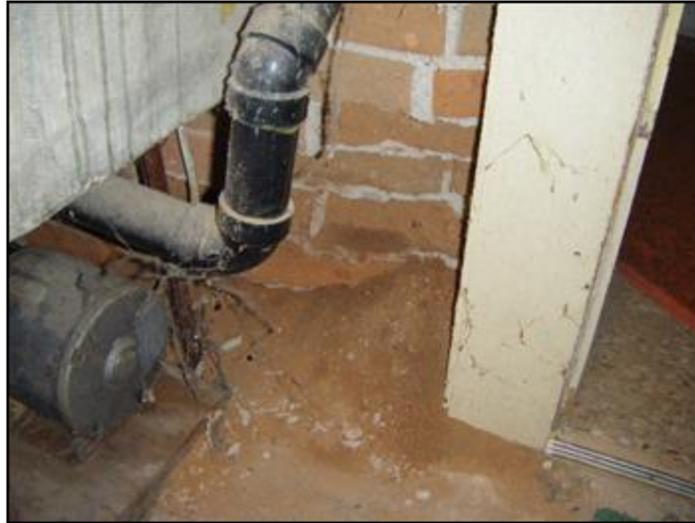
81.

Condition: • [Crumbling or powdery](#)

Task: Further evaluation

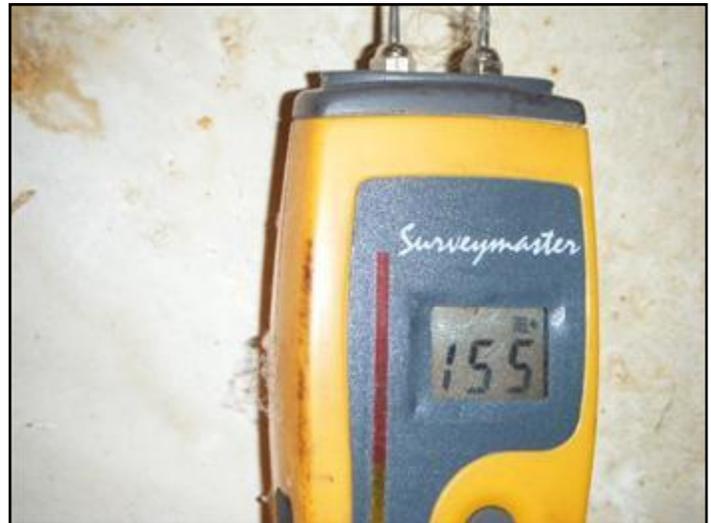
91.

The floor in the powder room has lifted as well there is very high moisture readings indicating an active leak. Budget to remove the toilet from the flange, replace a section of the subfloor, replace floor tiles and reset the toilet to the floor flange with a new wax ring.

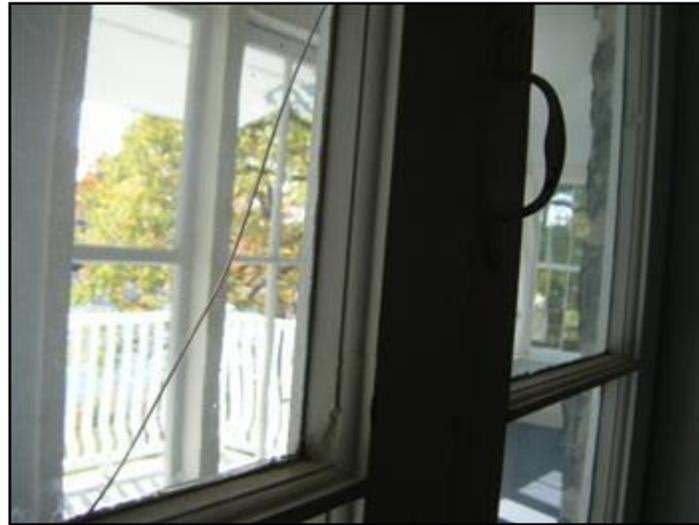
100.

Condition: • [Cracked](#)

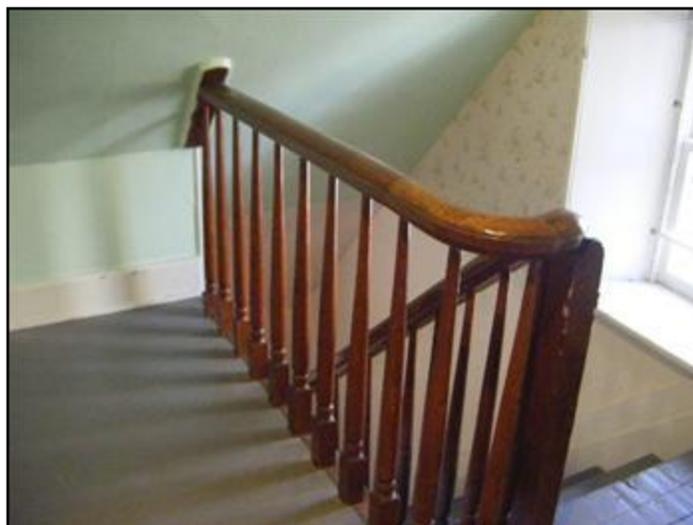
101.

Condition: • [Loose](#)

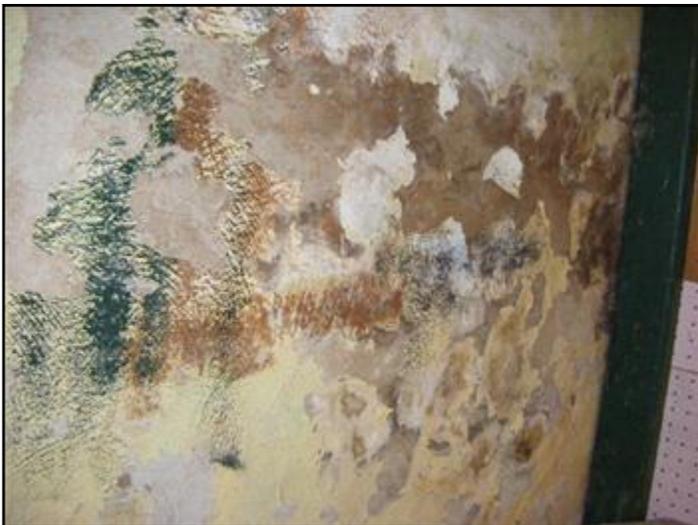
102.

The east wall is the most affected area by exterior moisture for a multitude of reasons. Firstly is exterior grading. Try to create a swale along the walkway between the back of the church and the rectory to allow surface water to naturally drain away from the buildings and onto the north lawn. Secondly the grading under the north porch needs to slope away from the house wall not towards it. Consider installing a drainage pipe along the walk way and then building up the grading under the porch, followed by a small retaining wall to act as a barrier to water draining towards the house wall. Improve the down spout extensions as well. For the interior, you must be careful not to trap moisture in a stone wall. Water proofing must be done on the exterior if you are going to insulate and vapor seal the interior walls. My advice here is to improve the moisture control on the exterior wall and allow the stones to naturally breath at the front part of the basement. The finished walls along the walk out towards the river are at less risk since the grading drops to the slab level.
